PACP Report with Pipe Run and Incident Snapshots

Surveyed by: ANDREW		Certificate number: T-507-4975		Owner: CITY OF MARION		Customer:		Drainage area:		P/O number:		Sheet number:							
Pipe segment ref.: MH4_MH3				Start date/time: 20240627 10:30		Street: 1432 HOLLAND RD.				City: MARION, OHIO									
Location details:				Upstream MH No: MH4				Rim to invert:		Grade to invert:		Rim to grade:							
Pipe use: CB		Direction: D		Flow control:		Downstream MH No: MH3				Rim to invert:		Grade to invert:		Rim to grade:					
Height: 72 in.		Width:		Shape: C		Material: BR		Lining method:		Pipe joint length:		Total length: 1,329.100 ft.		Length surveyed: 1,329.100 ft.		Purpose: B		Sewer category:	
Media label:				Pre-cleaning: N		Date cleaned:		Weather: 1		Location code: C		Pressure value:							
Project name: ROCK SWALE 72 IN INSPECTION				Additional info:

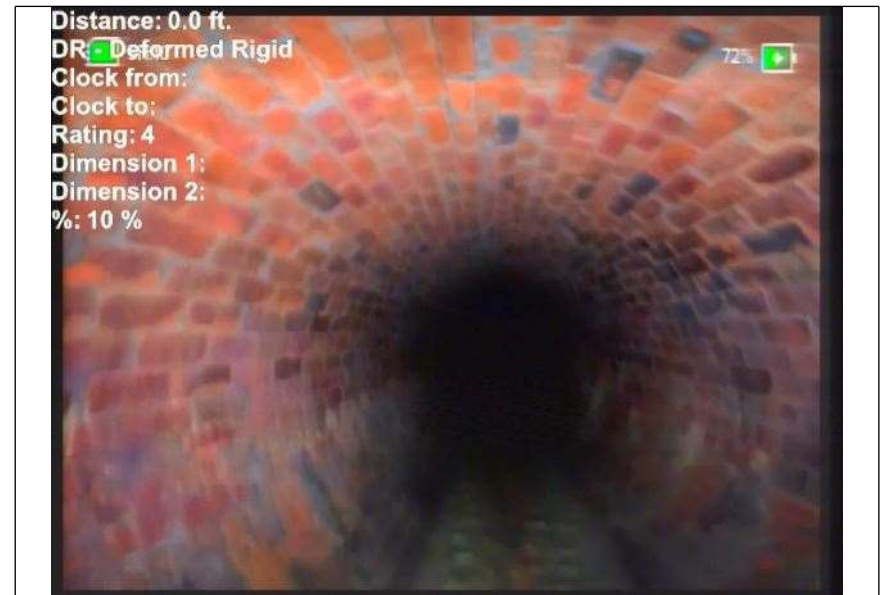
At: 0 ft. DR - Deformed Rigid
Joint: No 10 %

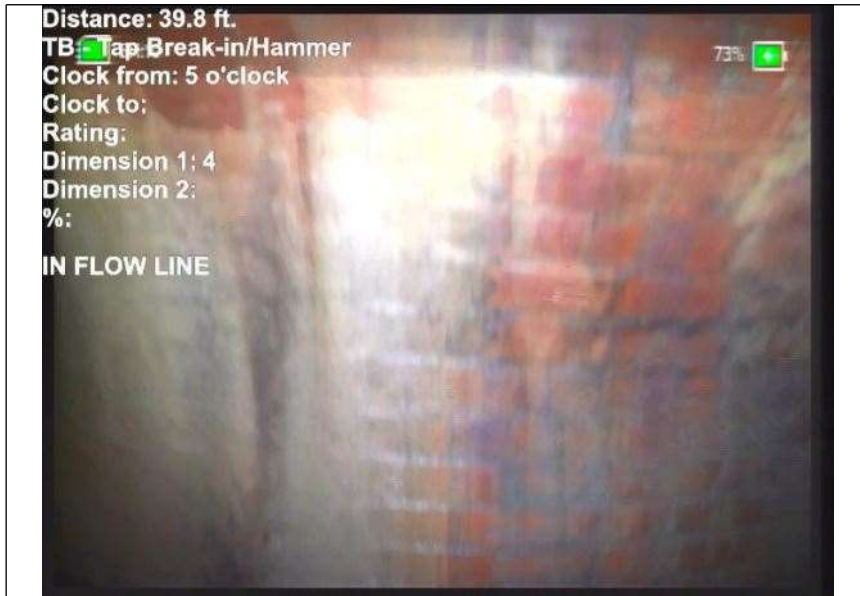
0.0 ft.	00:00:41	DR					10	<input type="checkbox"/>	/		5	ROCK SWALE 72 IN INSPECTION-AMH 'MH4'-AMH 'MH3'-DR at 0.0 ft.JPG	
39.8 ft.	00:02:00	TB			4.000			<input type="checkbox"/>	5 /			ROCK SWALE 72 IN INSPECTION-AMH 'MH4'-AMH 'MH3'-TB at 39.8 ft.JPG	IN FLOW LINE

At: 39. TB - Tap Break-in/Hammer
7999992370
605 ft. 5/.

Joint: No IN FLOW LINE

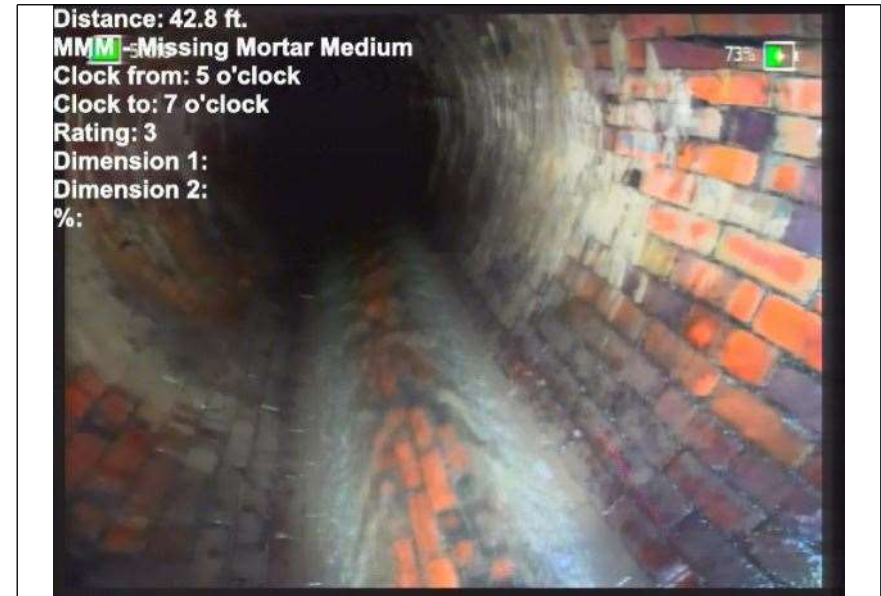
At: 42. MMM - Missing Mortar Medium
7999992370
605 ft. 5/7

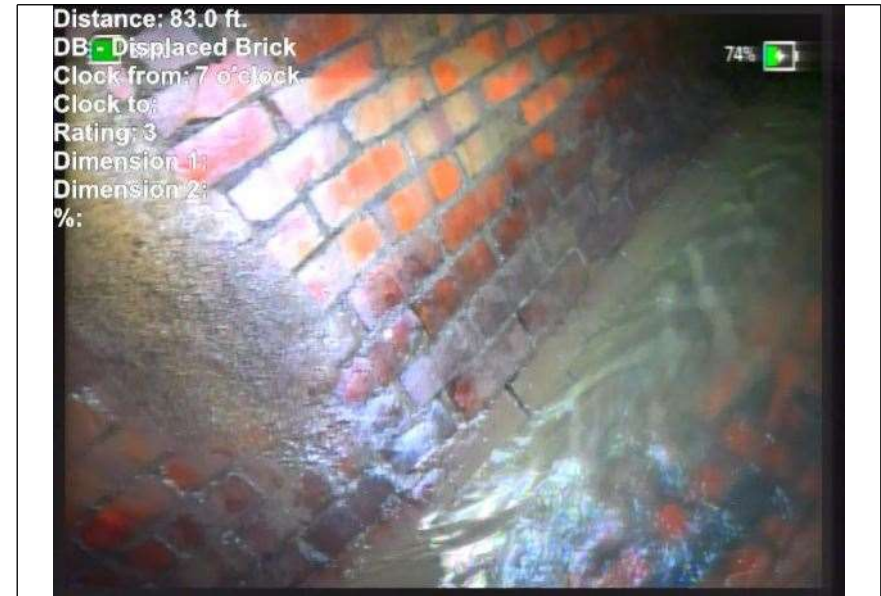
At: 83 ft. 7/. DB - Displaced Brick

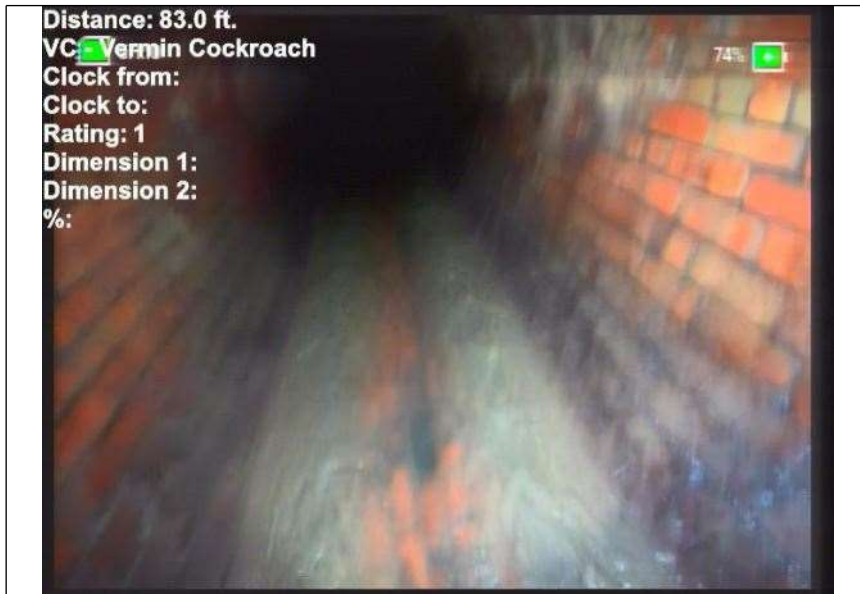
At: 83 ft. VC - Vermin Cockroach

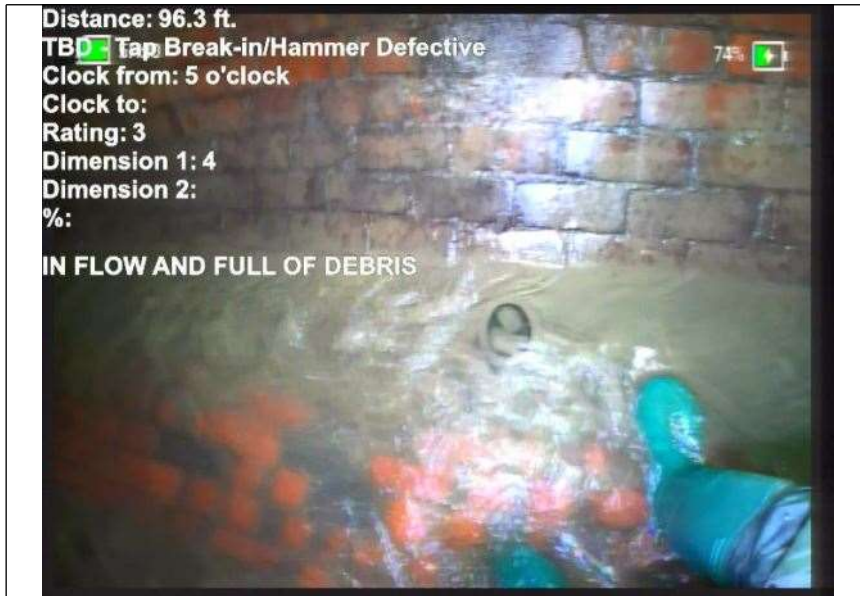
96.3 ft.	00:04:06	TBD			4.000			<input type="checkbox"/>	5 /		3	ROCK SWALE 72 IN INSPECTION-AMH 'MH4'-AMH 'MH3'-TBD at 96.3 ft.JPG	IN FLOW AND FULL OF DEBRIS

At: 96. TBD - Tap Break-in/Hammer Defective
3000030517
578 ft. 5/.

Joint: No IN FLOW AND FULL OF DEBRIS

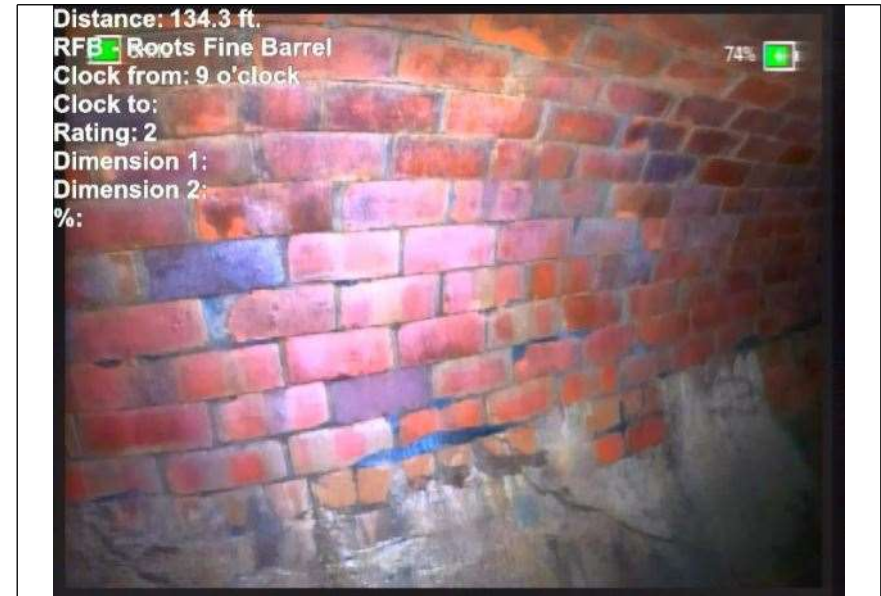
At: 134. RFB - Roots Fine Barrel
3000030517
58 ft. 9/.

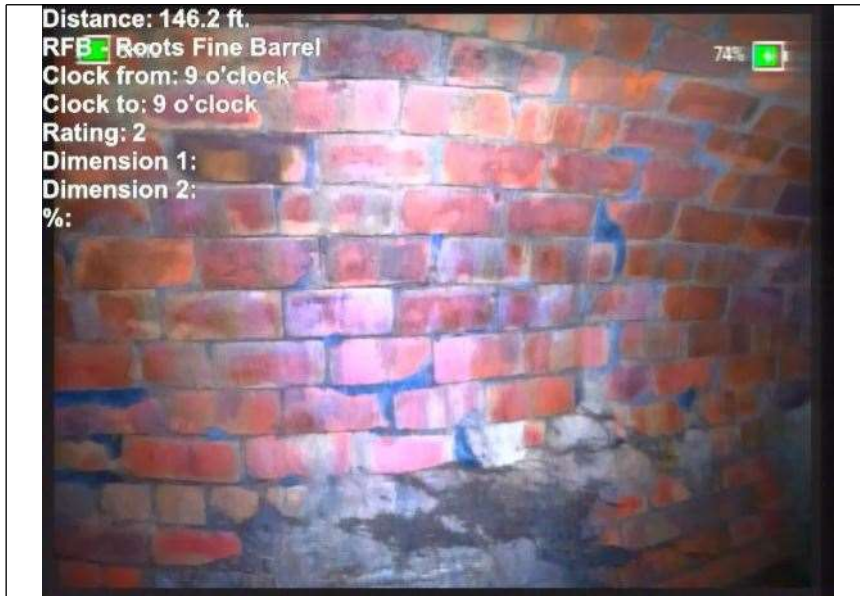
At: 146. RFB - Roots Fine Barrel
1999969482
42 ft. 9/.

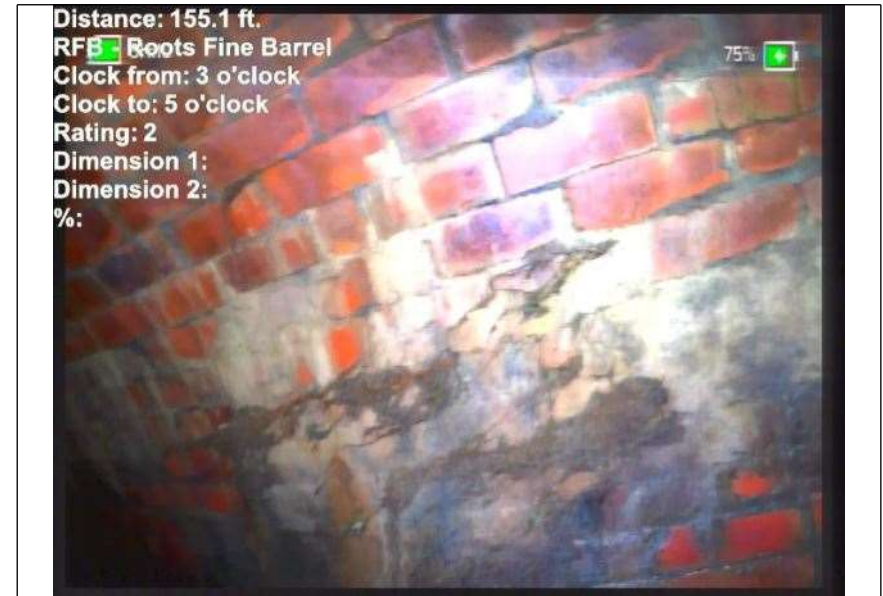
At: 155. RFB - Roots Fine Barrel
1000061035
16 ft. 3/5

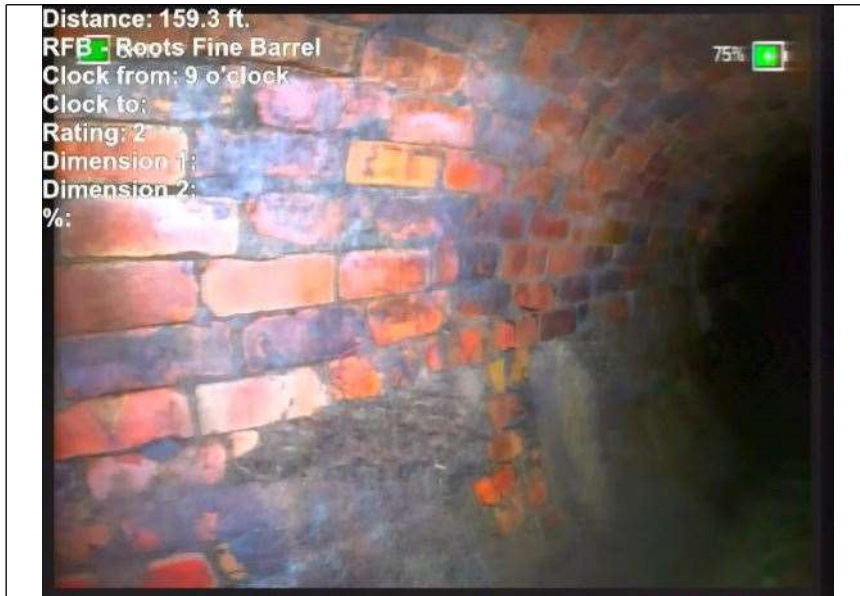
At: 159. RFB - Roots Fine Barrel
3000030517
58 ft. 9/.

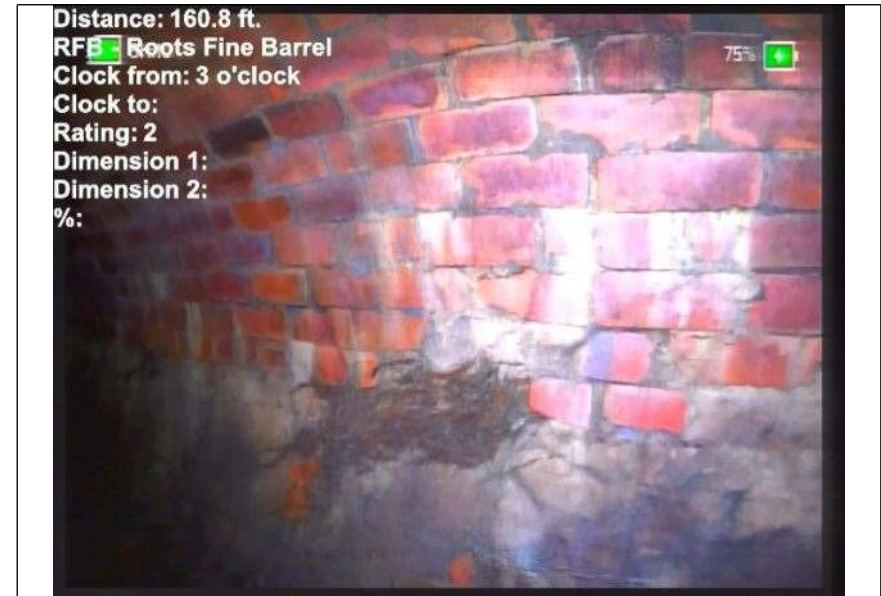
At: 160. RFB - Roots Fine Barrel
8000030517
58 ft. 3/.

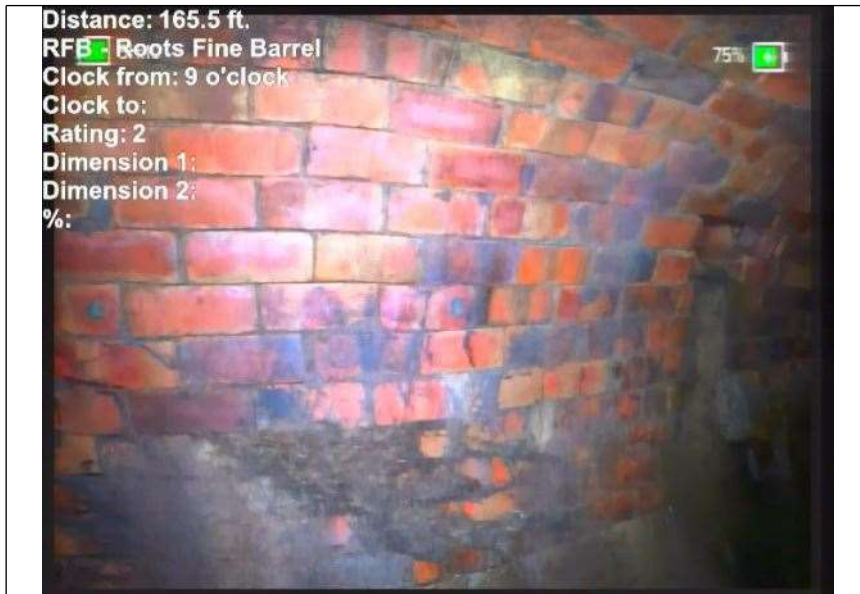
At: 165.5 ft. 9/. RFB - Roots Fine Barrel

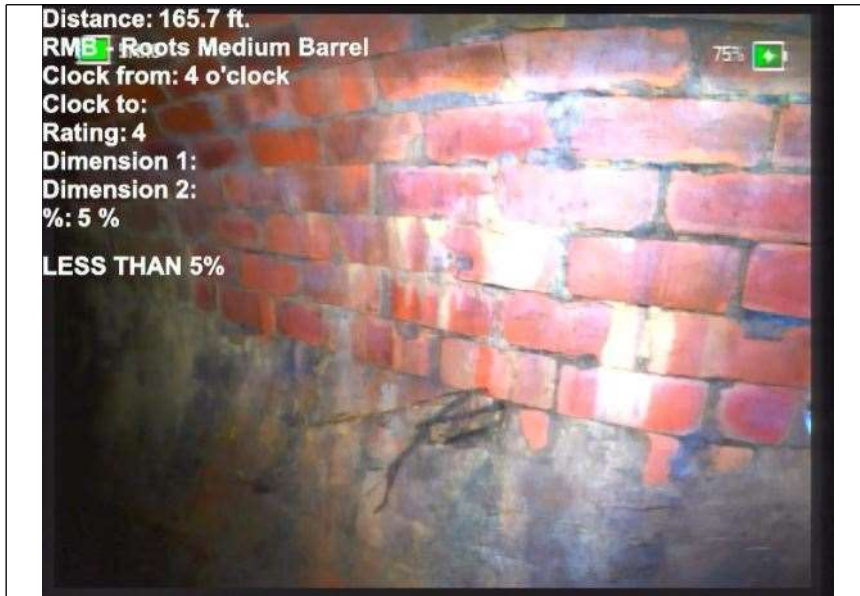
165.7 ft.	00:06:25	RMB					5	<input type="checkbox"/>	4 /		4	ROCK SWALE 72 IN INSPECTION-AMH 'MH4'-AMH 'MH3'-RMB at 165.7 ft.JPG	LESS THAN 5%

At: 165. RMB - Roots Medium Barrel
6999969482
42 ft. 4/.

Joint: No 5 % LESS THAN 5%

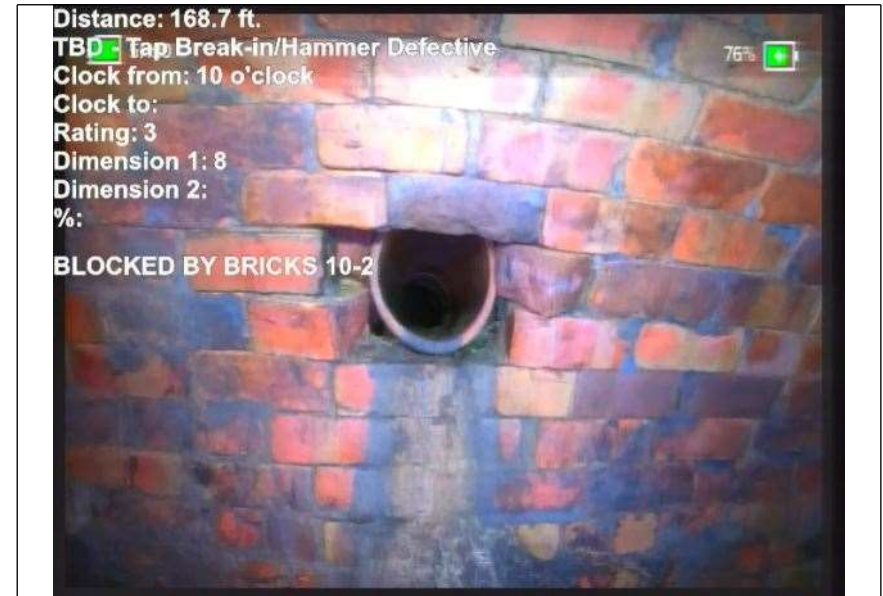
168.7 ft.	00:06:59	TBD			8.000			<input type="checkbox"/>	10 /		3	ROCK SWALE 72 IN INSPECTION-AMH 'MH4'-AMH 'MH3'-TBD at 168.7 ft.JPG	BLOCKED BY BRICKS 10-2

At: 168. TBD - Tap Break-in/Hammer Defective
6999969482
42 ft. 10/.

Joint: No BLOCKED BY BRICKS 10-2

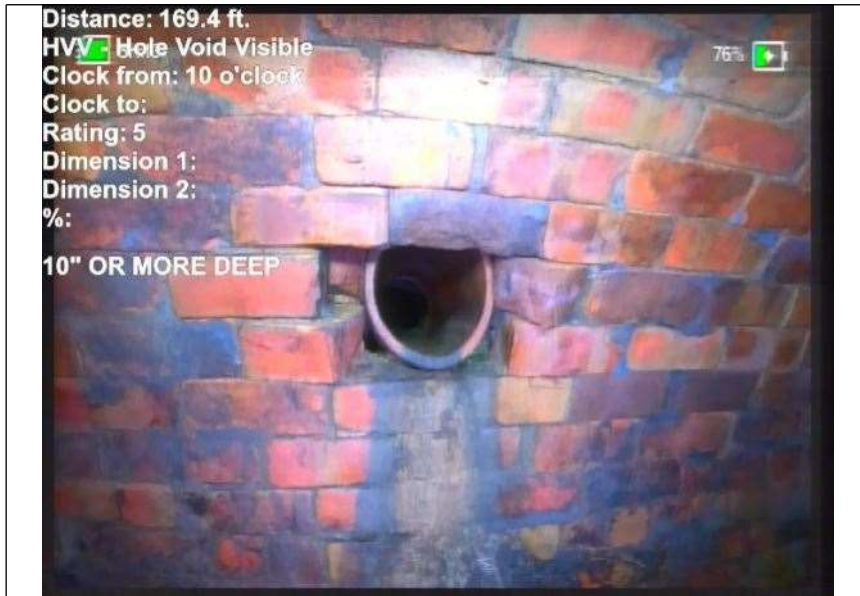
At: 169. 3999938964
HVV - Hole Void Visible

Joint: No 10" OR MORE DEEP

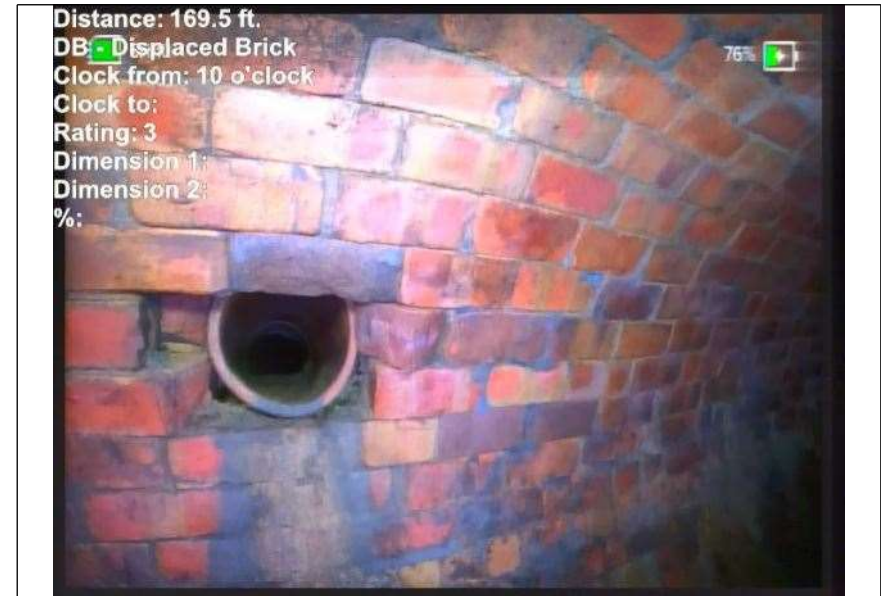
At: 169.5 ft. 10/. DB - Displaced Brick

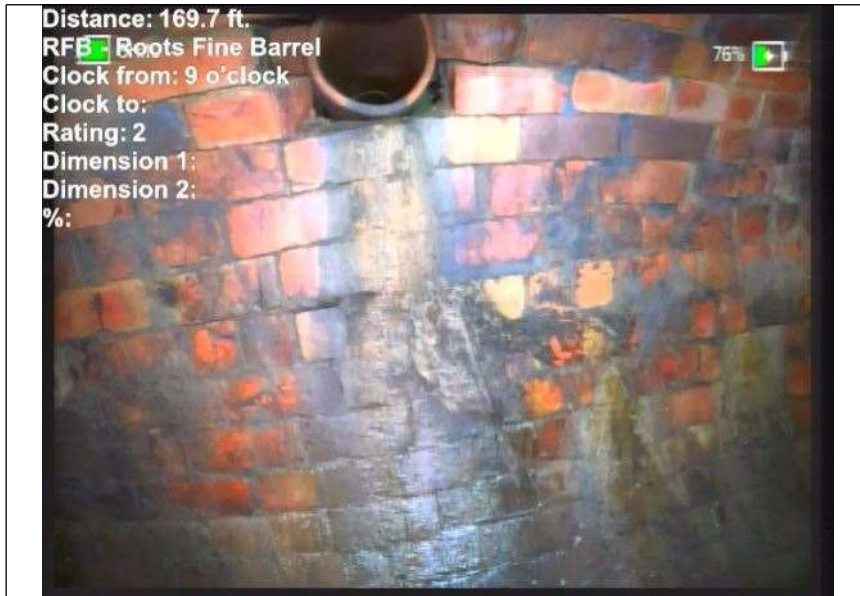
At: 169. RFB - Roots Fine Barrel
6999969482
42 ft. 9/.

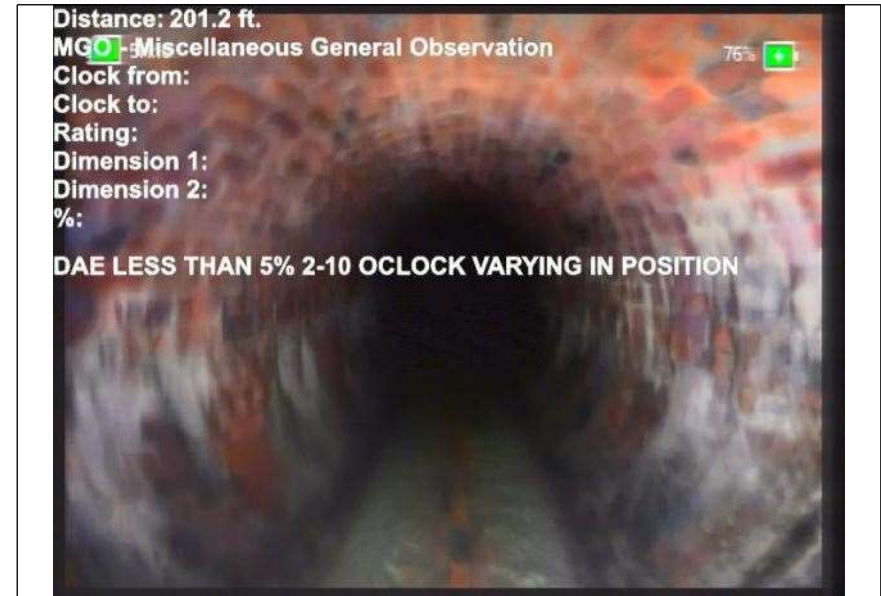
At: 201. MGO - Miscellaneous General Observation
1999969482
42 ft.

Joint: No DAE LESS THAN 5% 2-10 OCLOCK VARYING IN POSITION

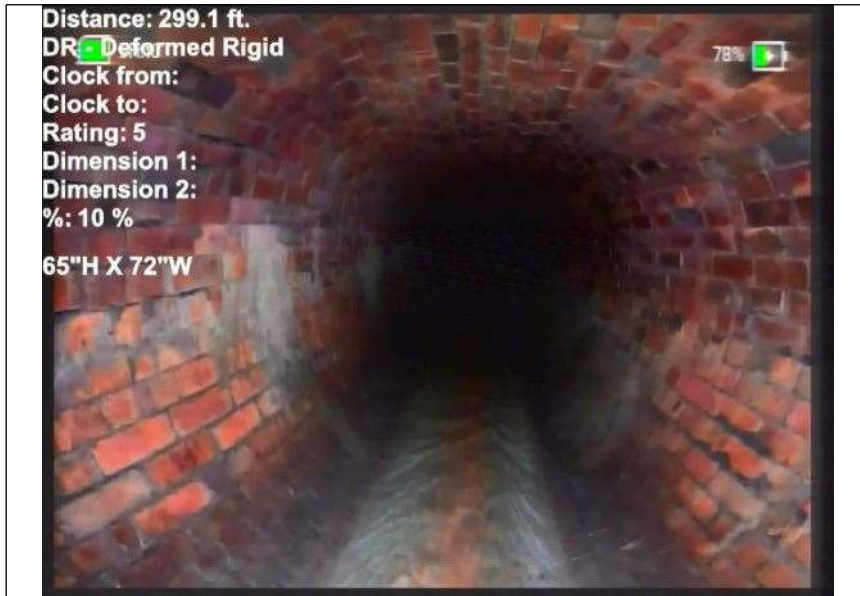
299.1 ft.	00:09:58	DR					10	<input type="checkbox"/>	/		5	ROCK SWALE 72 IN INSPECTION-AMH 'MH4'-AMH 'MH3'-DR at 299.1 ft.JPG	65"H X 72"W - 10' IN LENGTH

At: 299. DR - Deformed Rigid
1000061035
16 ft.

Joint: No 10 % 65"H X 72"W - 10' IN LENGTH

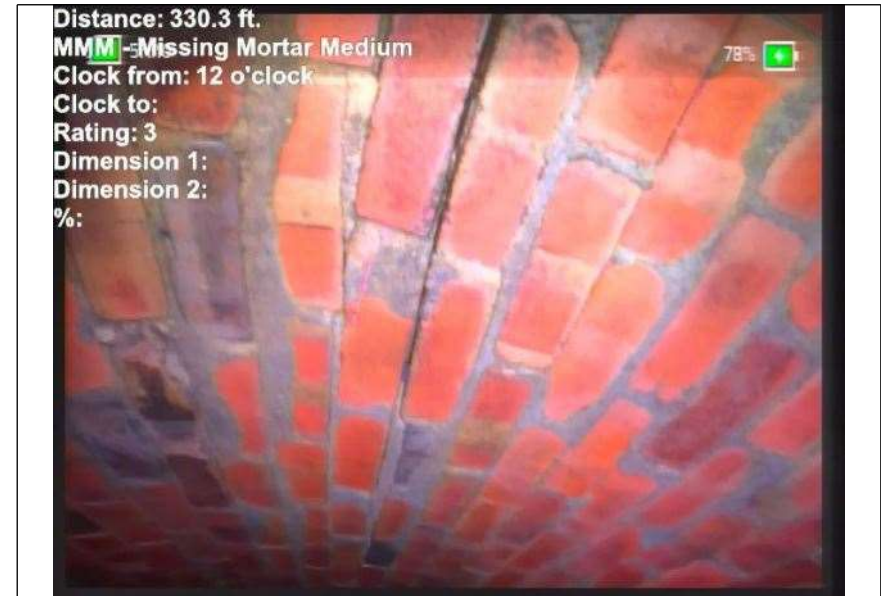
At: 330. MMM - Missing Mortar Medium
2999877929
69 ft. 12/.

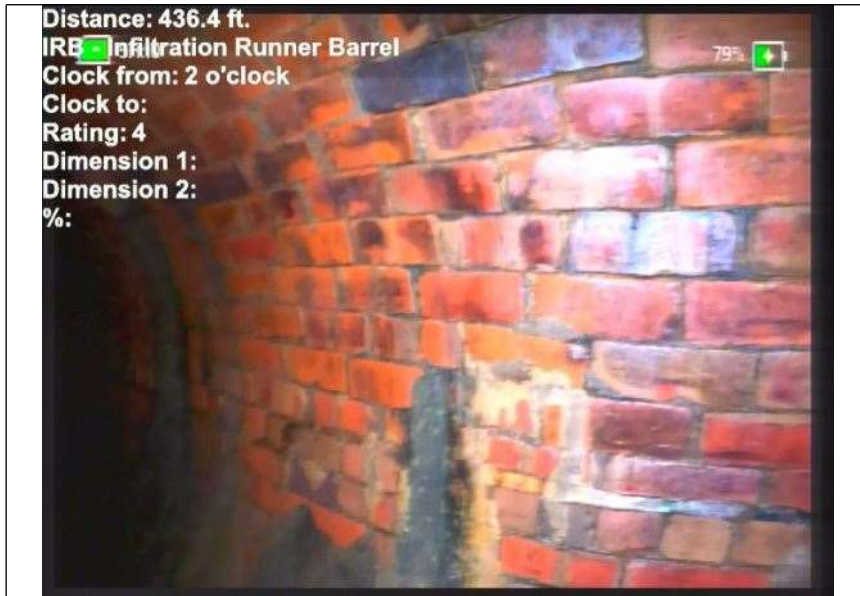
At: 436. IRB - Infiltration Runner Barrel
3999938964
84 ft. 2/.

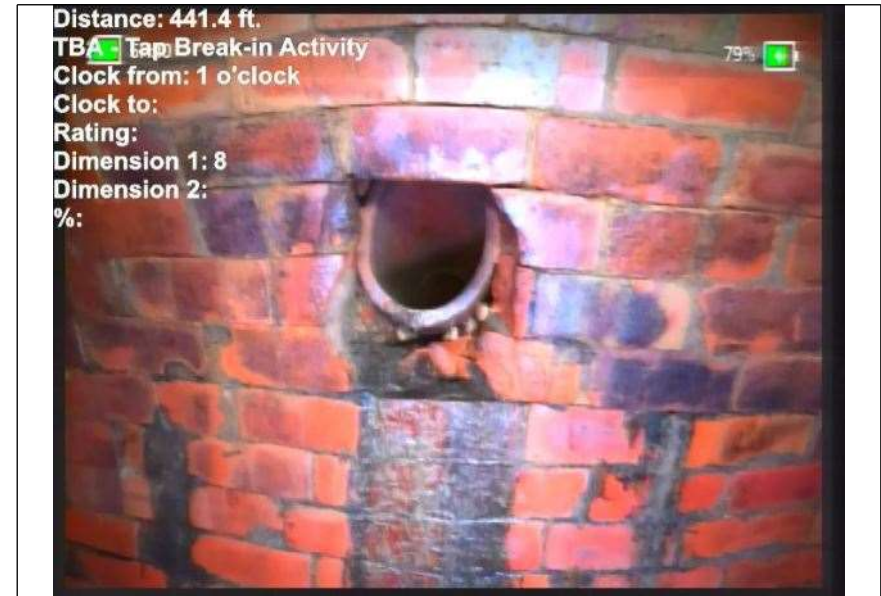
At: 441. TBA - Tap Break-in Activity
3999938964
84 ft. 1/.

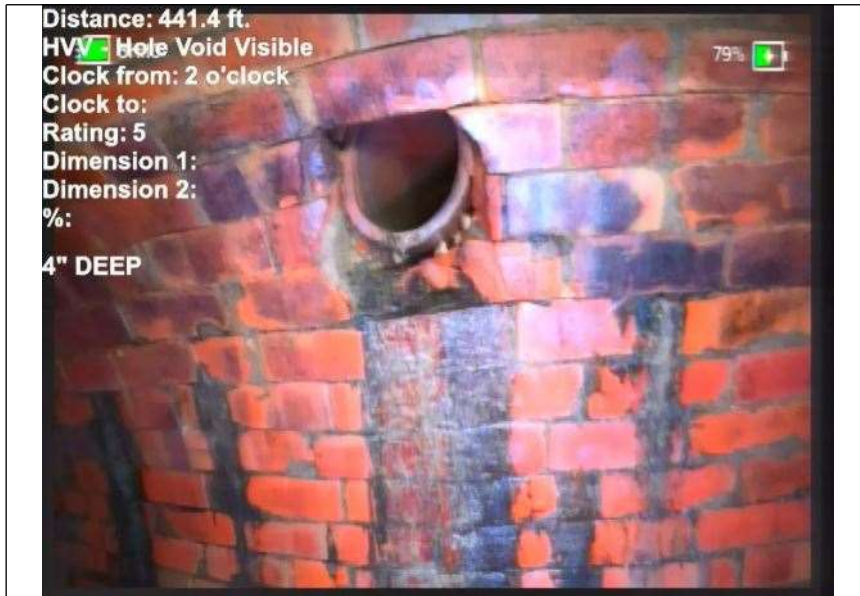
At: 441. HVV - Hole Void Visible
3999938964
84 ft. 2/.

Joint: No 4" DEEP

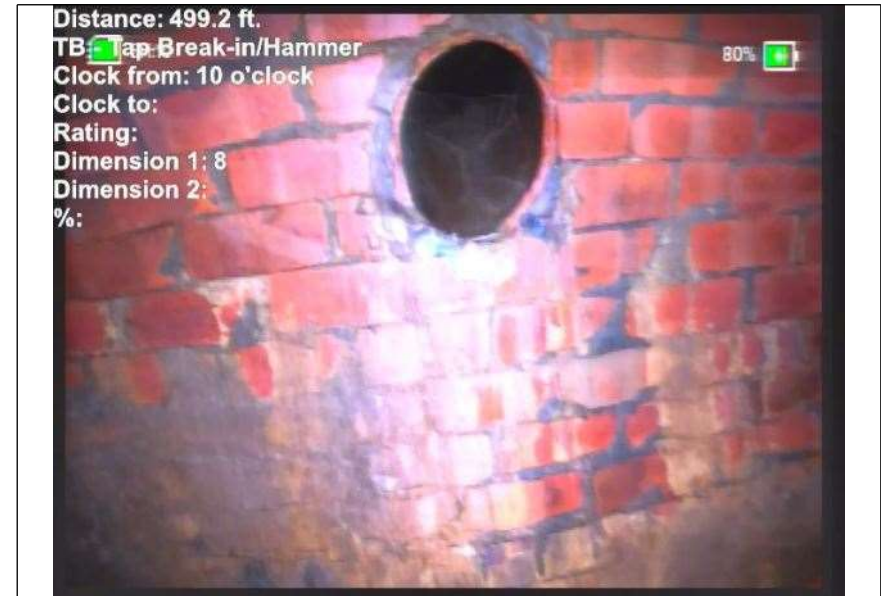
At: 499. TB - Tap Break-in/Hammer
2000122070
31 ft. 10/.

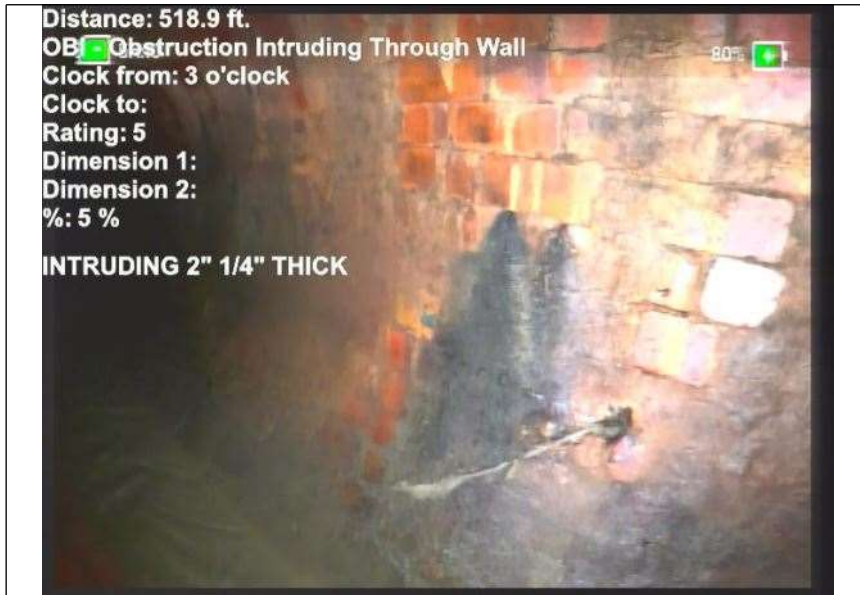
At: 518. 9000244140
63 ft. 3/.

Joint: No 5 % INTRUDING 2" 1/4" THICK

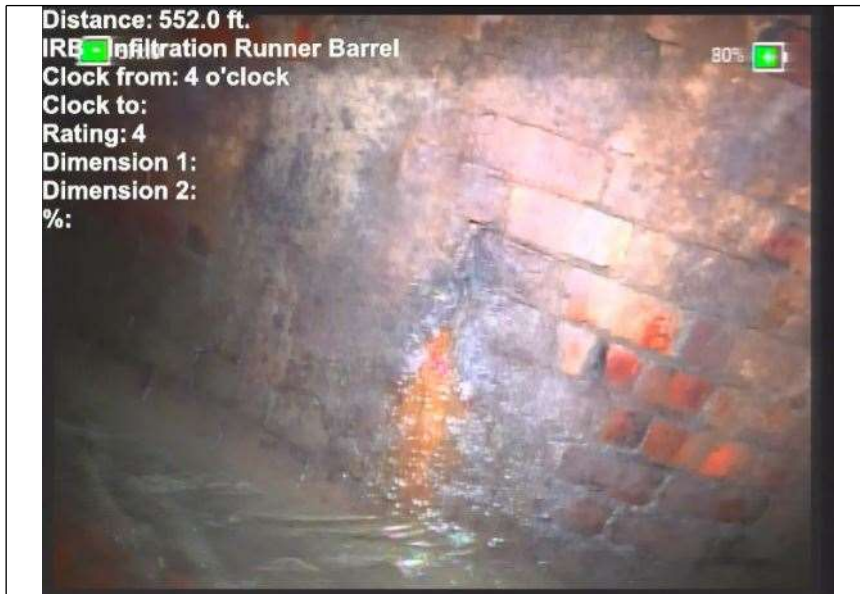
At: 552 ft. 4/. IRB - Infiltration Runner Barrel

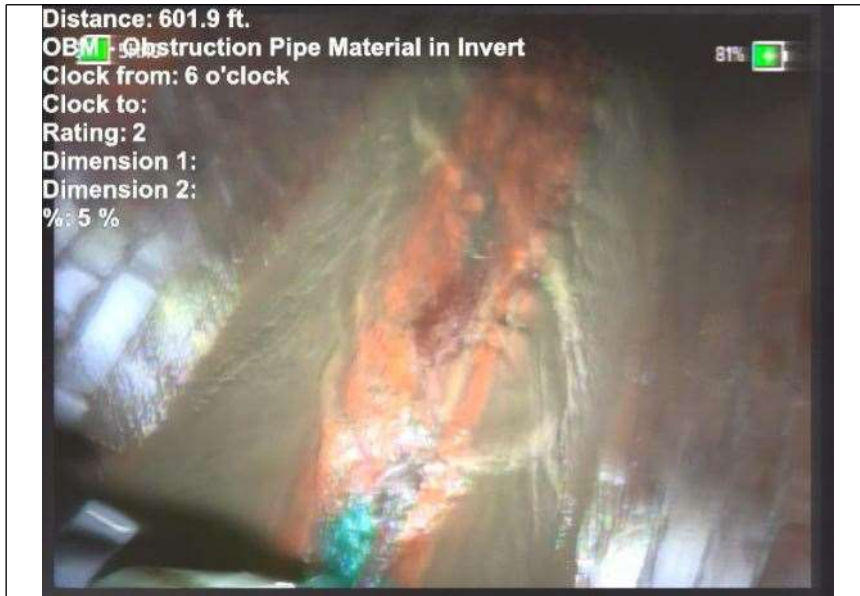
At: 601.9 ft. OBM - Obstruction Pipe Material in Invert
9000244140
63 ft. 6/.

Joint: Yes 5 %

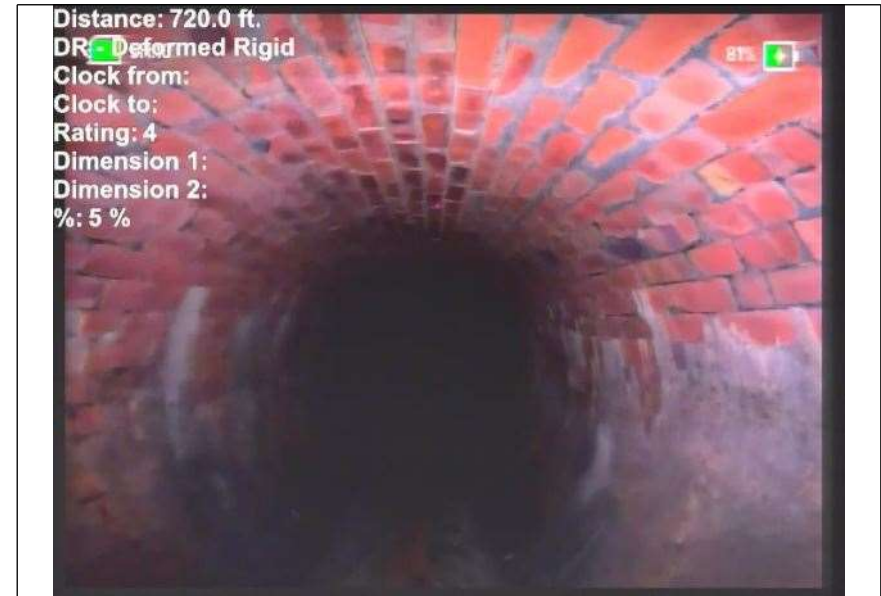
At: 720 ft. DR - Deformed Rigid
Joint: No 5 %

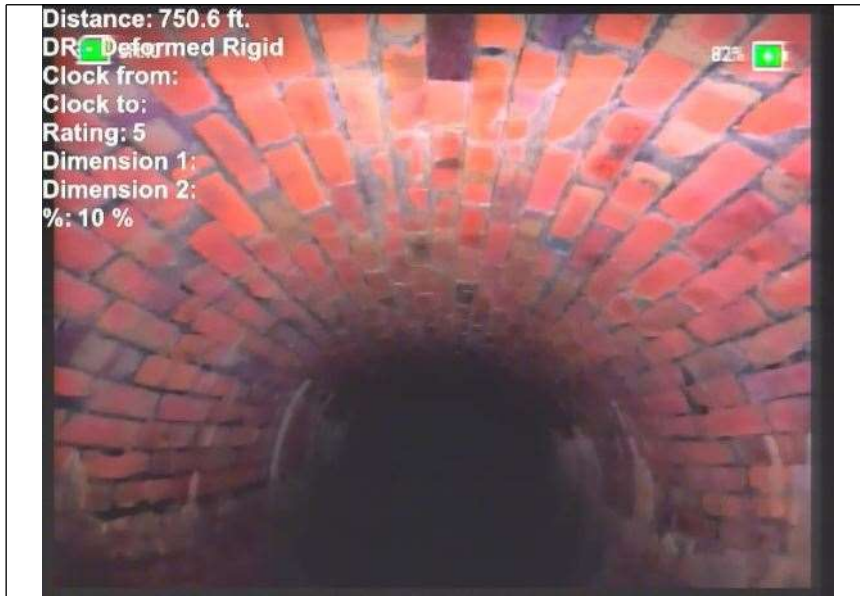
At: 750. DR - Deformed Rigid
5999755859
38 ft.

Joint: No 10 % 67"H X 72"W

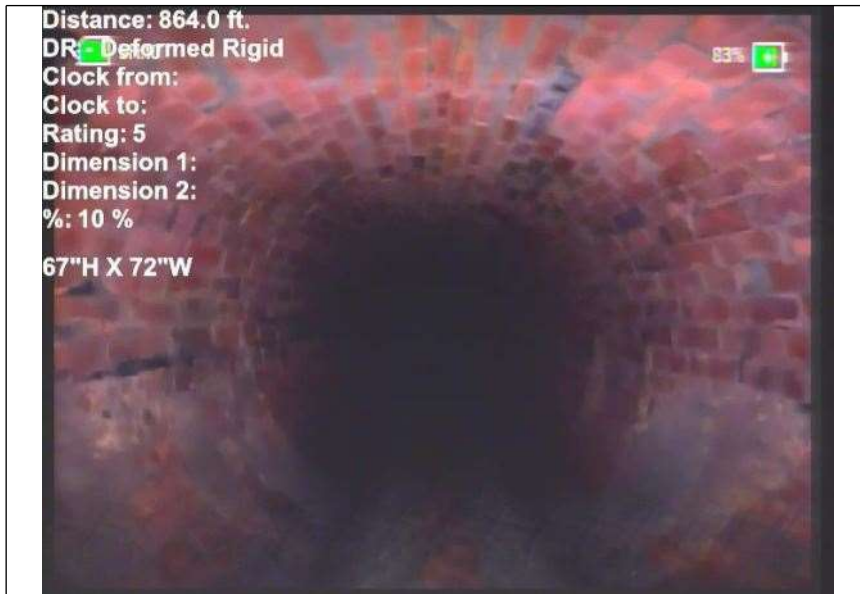
At: 864 ft. DR - Deformed Rigid

Joint: No 10 % 67"H X 72"W

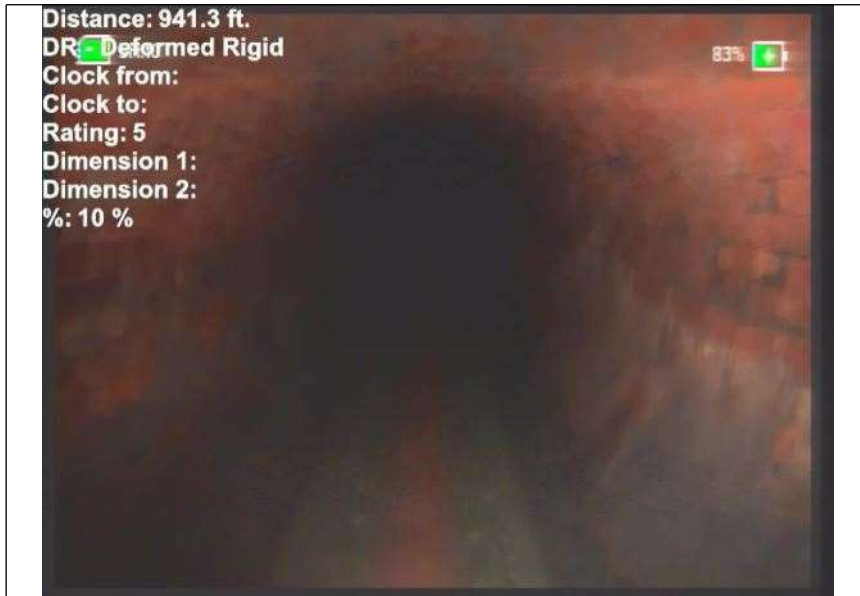
At: 941. DR - Deformed Rigid
2999877929
69 ft.

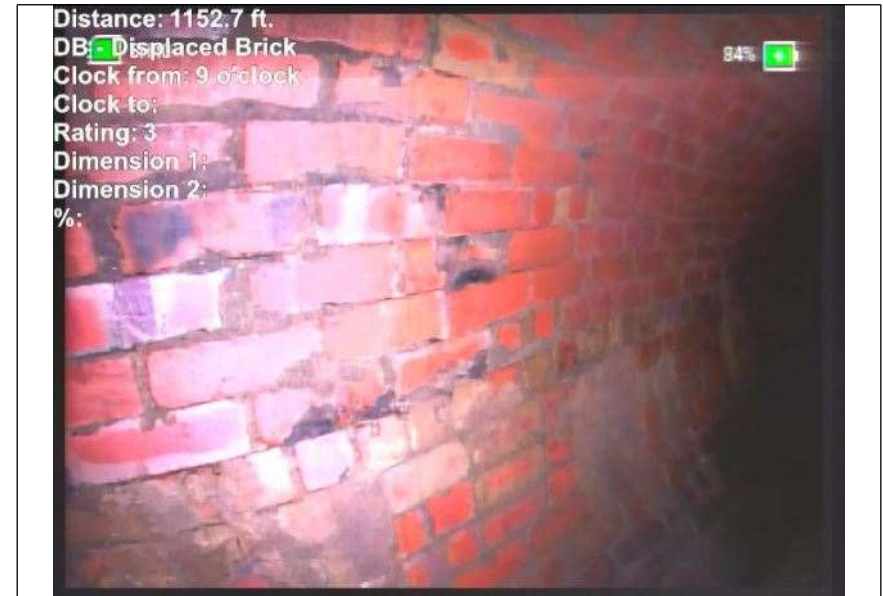
At: 1152. DB - Displaced Brick
6999511718
8 ft. 9/.

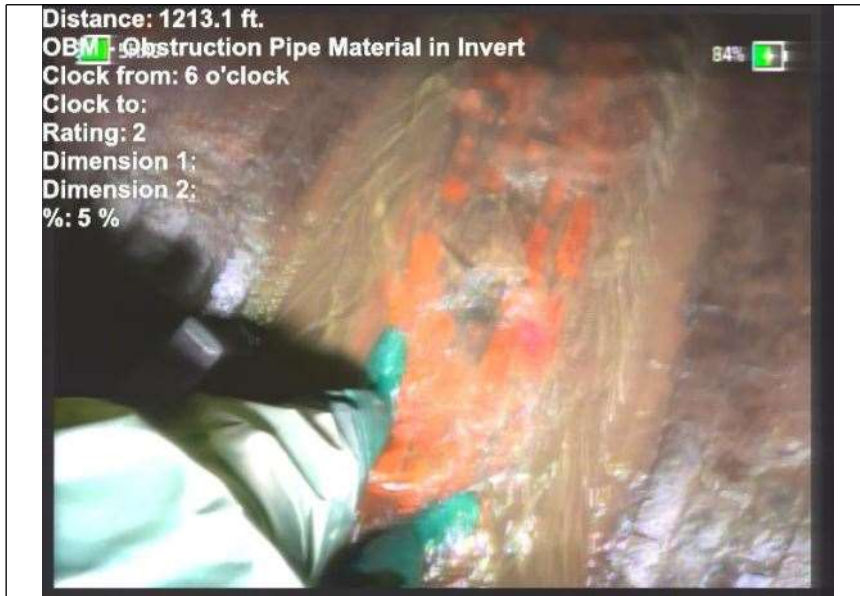
At: 1213. OBM - Obstruction Pipe Material in Invert
0999755859
4 ft. 6/.

Joint: No 5 %

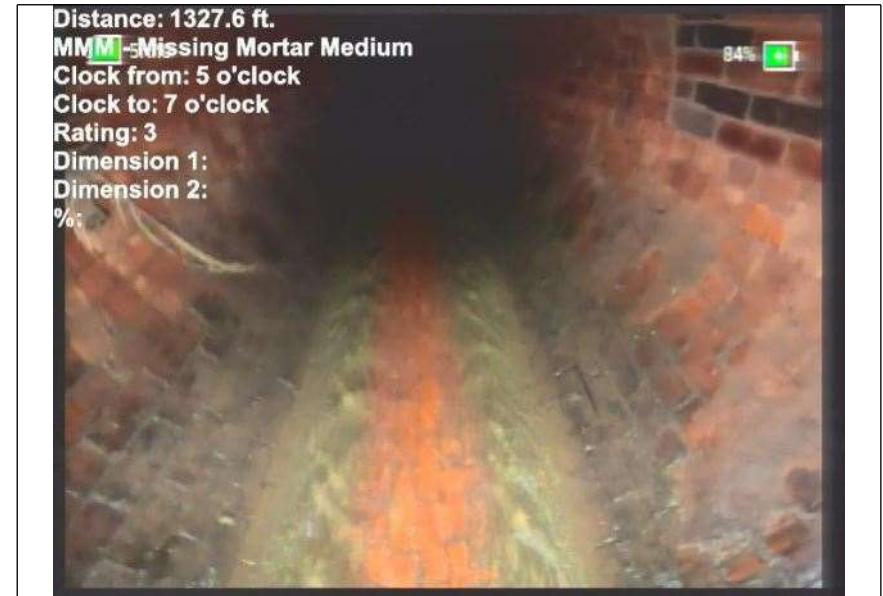
At: 1327. MMM - Missing Mortar Medium
5999755859
4 ft. 5/7
