PACP Report with Pipe Run and Incident Snapshots

Surveyed by: ANDREW		Certificate number: T-507-4975		Owner: CITY OF MARION		Customer:		Drainage area:		P/O number:		Sheet number:							
Pipe segment ref.: MH5_MH4A				Start date/time: 20240627 10:04		Street: HOLLAND RD				City: MARION, OH									
Location details:				Upstream MH No: MH5				Rim to invert:		Grade to invert:		Rim to grade:							
Pipe use: CB		Direction: U		Flow control:		Downstream MH No: MH4A`				Rim to invert:		Grade to invert:		Rim to grade:					
Height: 72 in.		Width:		Shape: C		Material: BR		Lining method:		Pipe joint length:		Total length: 207.800 ft.		Length surveyed: 207.800 ft.		Purpose: B		Sewer category:	
Media label:				Pre-cleaning: N		Date cleaned:		Weather: 1		Location code: C		Pressure value:							
Project name: ROCK SWALE 72 IN INSPECTION				Additional info:

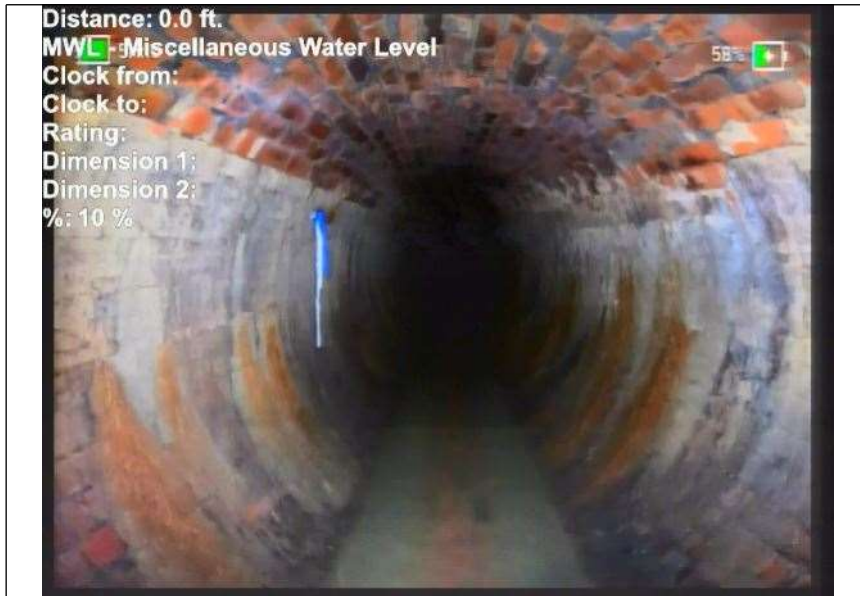
At: 0 ft. MWL - Miscellaneous Water Level

Joint: No 10 %

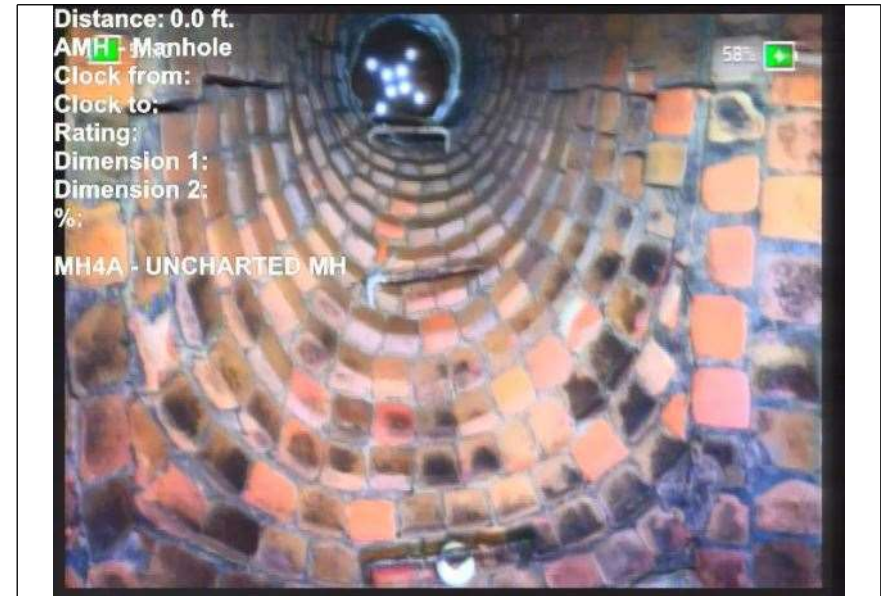
At: 0 ft. AMH - Manhole

Joint: No MH4A - UNCHARTED MH

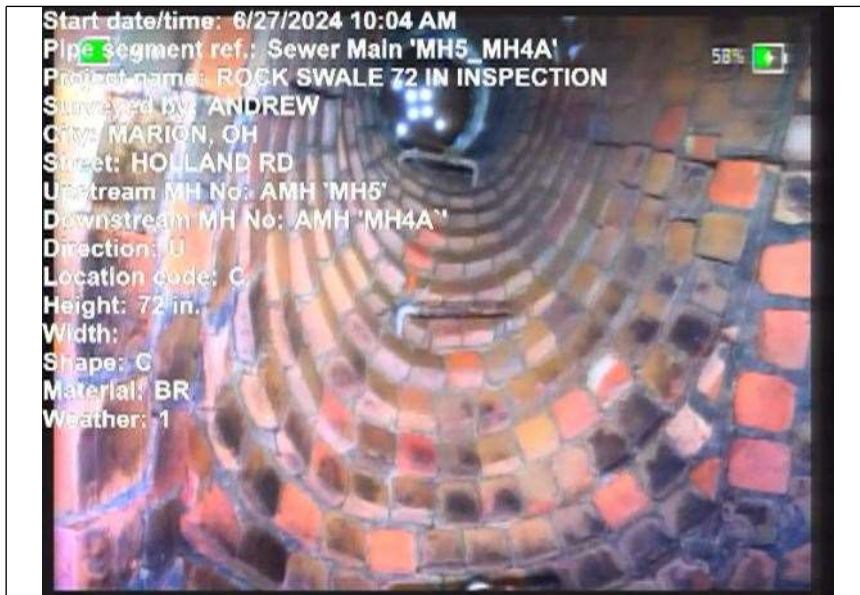
At: 0 ft. AMH - Manhole

Joint: No MH4A - UNCHARTED MH

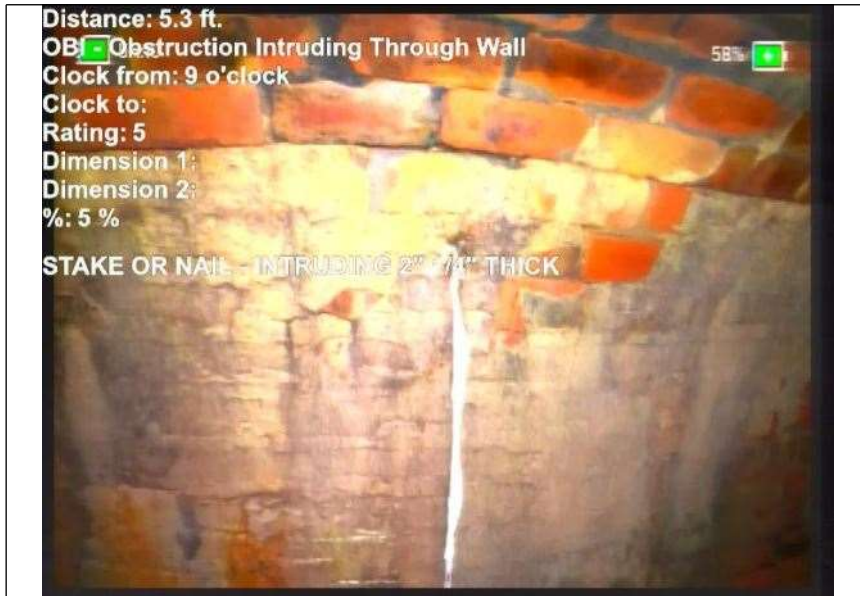
At: 5. OBI - Obstruction Intruding Through Wall
3000001907
3486 ft. 9/.
Joint: No 5 % STAKE OR NAIL - INTRUDING 2" 1/4" THICK

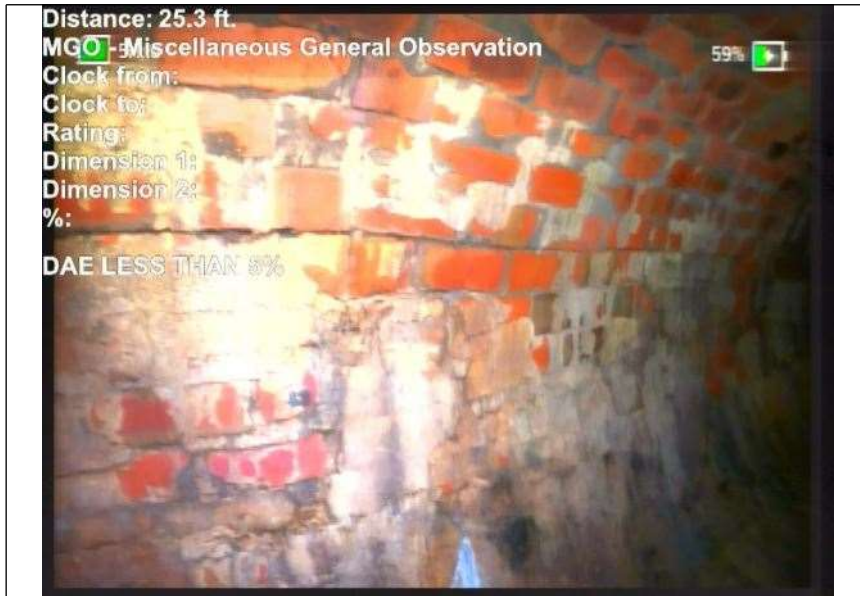
At: 25. 2999992370
605 ft. MGO - Miscellaneous General Observation

Joint: No DAE LESS THAN 5%

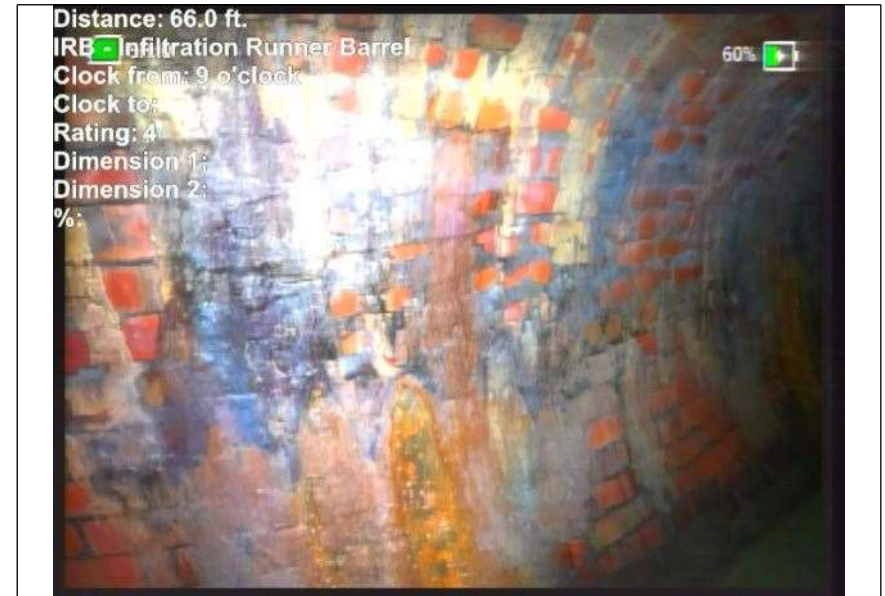
66.0 ft.	00:03:36	IRB						<input type="checkbox"/>	9 /		4	ROCK SWALE 72 IN INSPECTION-AMH 'MH5'-AMH 'MH4A`'-IRB at 66.0 ft.JPG

At: 66 ft. 9/. IRB - Infiltration Runner Barrel

Joint: No

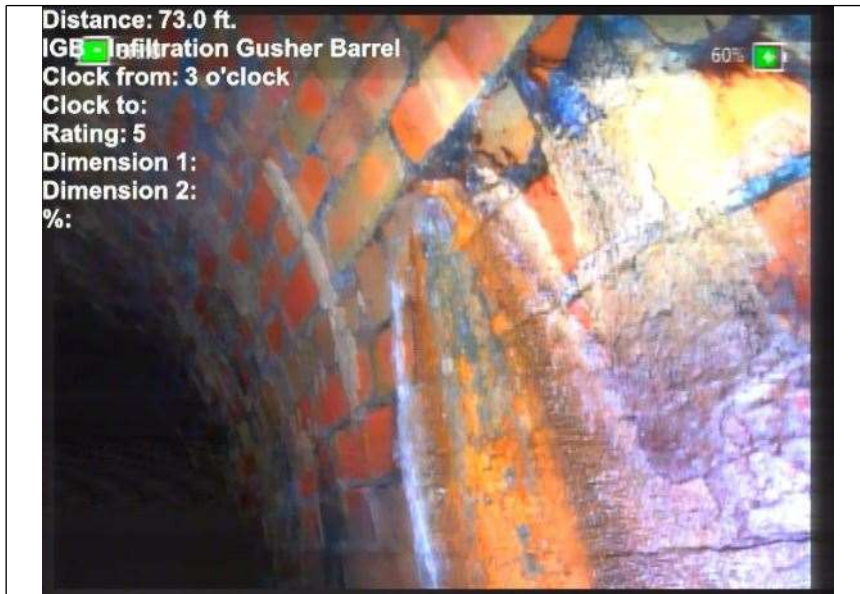
73.0 ft.	00:04:01	IGB						<input type="checkbox"/>	3 /		5	ROCK SWALE 72 IN INSPECTION-AMH 'MH5'-AMH 'MH4A`'-IGB at 73.0 ft.JPG	
73.1 ft.	00:04:13	H						<input type="checkbox"/>	3 /		4	ROCK SWALE 72 IN INSPECTION-AMH 'MH5'-AMH 'MH4A`'-H at 73.1 ft.JPG

At: 73 ft. 3/. IGB - Infiltration Gusher Barrel

Joint: No

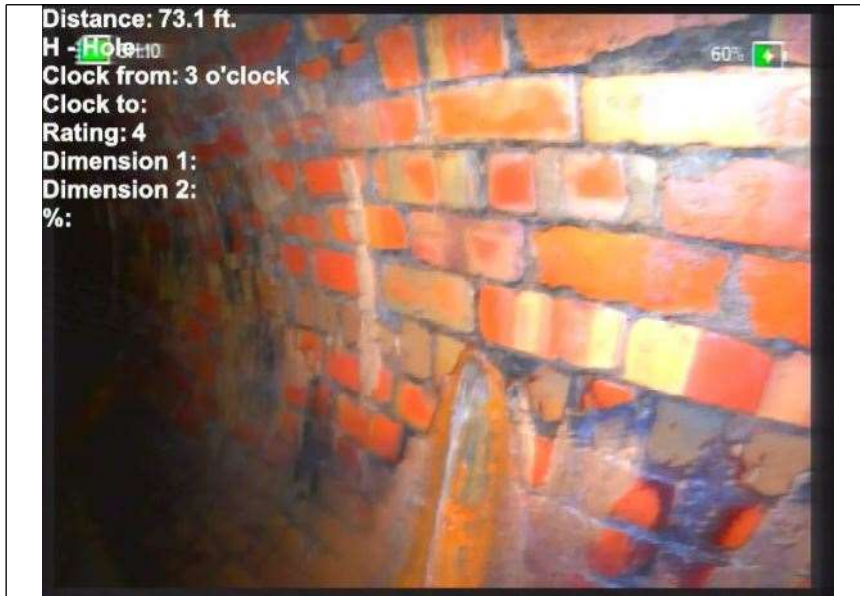
At: 73. H - Hole
0999984741
211 ft. 3/.

Joint: No

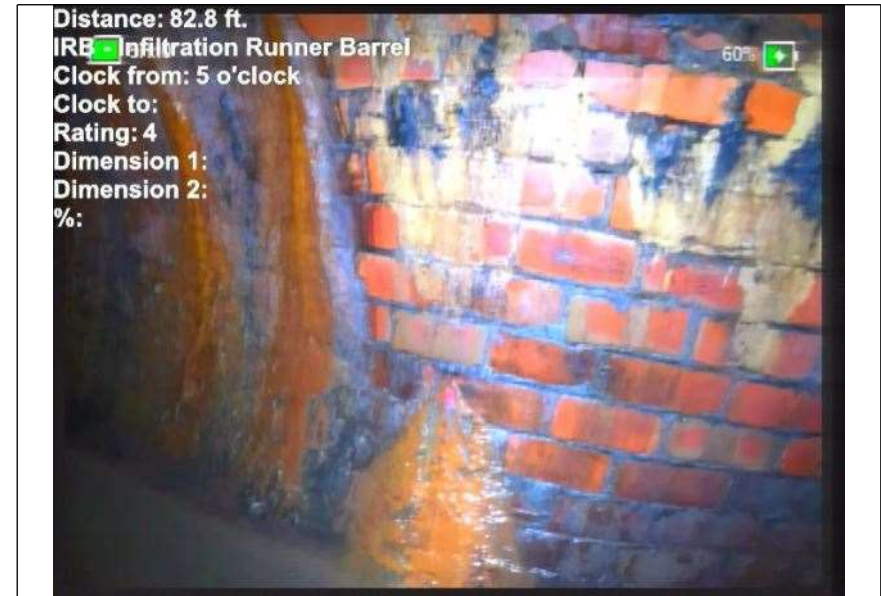
At: 82. IRB - Infiltration Runner Barrel
8000030517
578 ft. 5/.

Joint: No

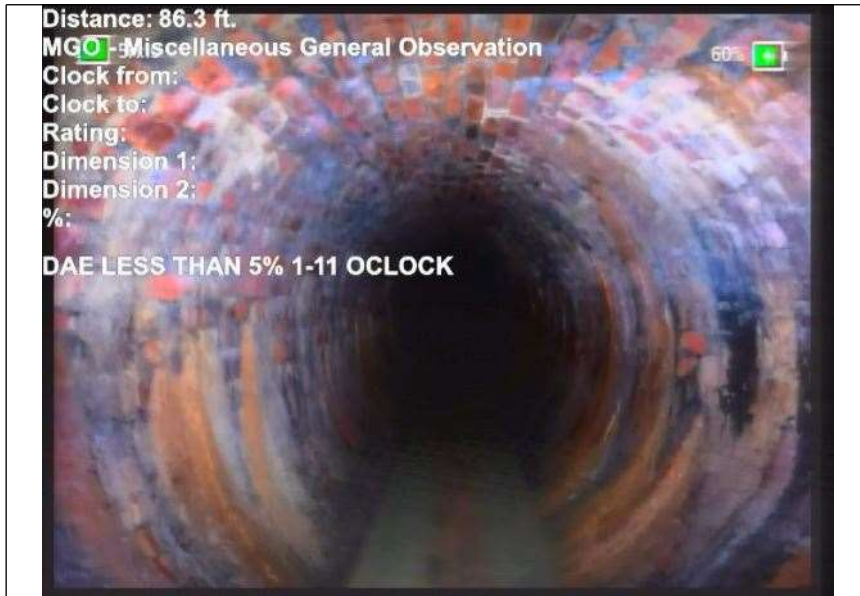
At: 86. 3000030517
578 ft. MGO - Miscellaneous General Observation

Joint: No DAE LESS THAN 5% 1-11 OCLOCK

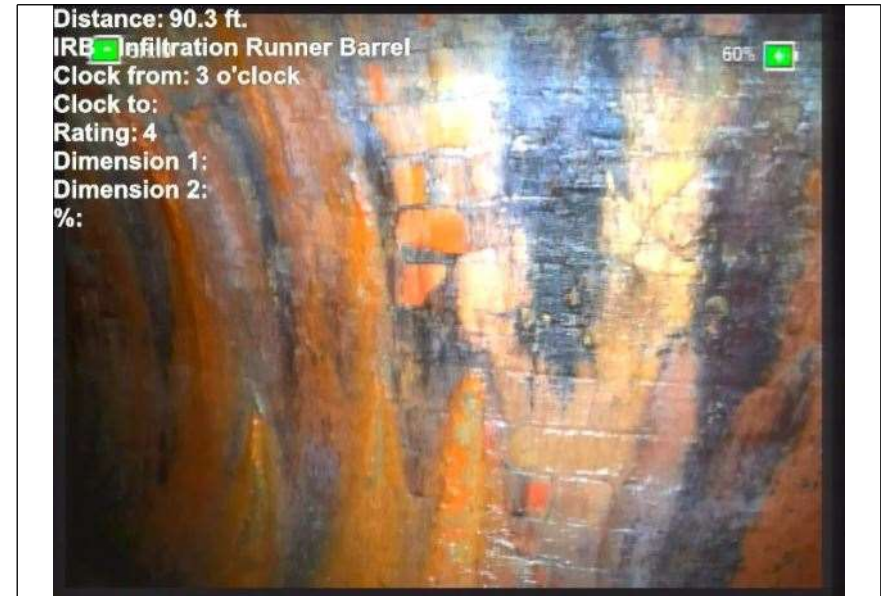
At: 90. 3000030517
578 ft. 3/. IRB - Infiltration Runner Barrel

Joint: No

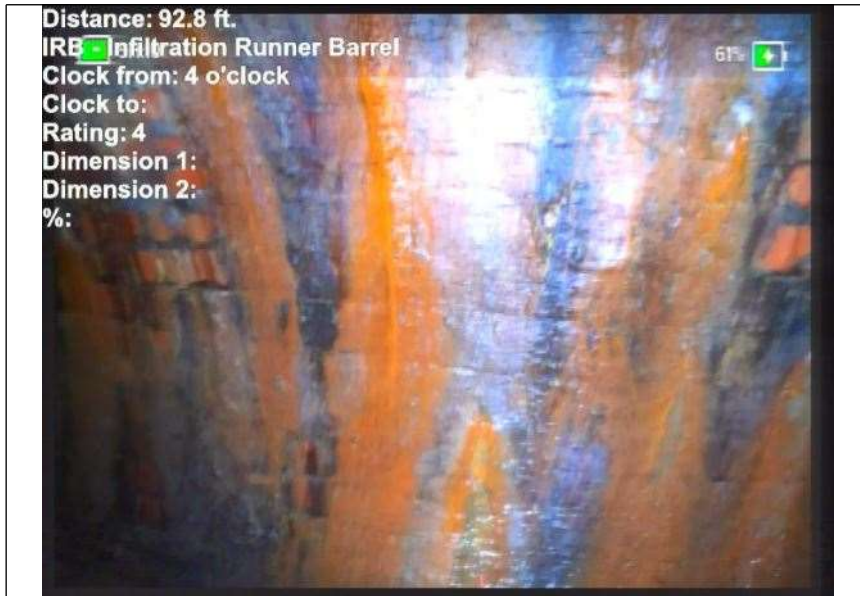
At: 92. IRB - Infiltration Runner Barrel
8000030517
578 ft. 4/.

Joint: No

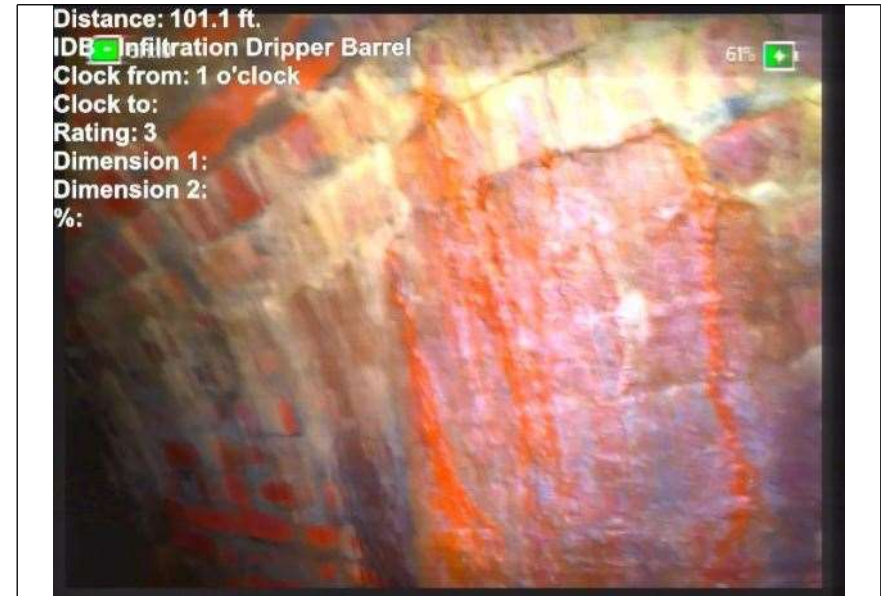
101.1 ft.	00:05:49	IDB						<input type="checkbox"/>	1 /		3	ROCK SWALE 72 IN INSPECTION-AMH 'MH5'-AMH 'MH4A`'-IDB at 101.1 ft.JPG

At: 101. IDB - Infiltration Dripper Barrel
0999984741
21 ft. 1/.

Joint: No

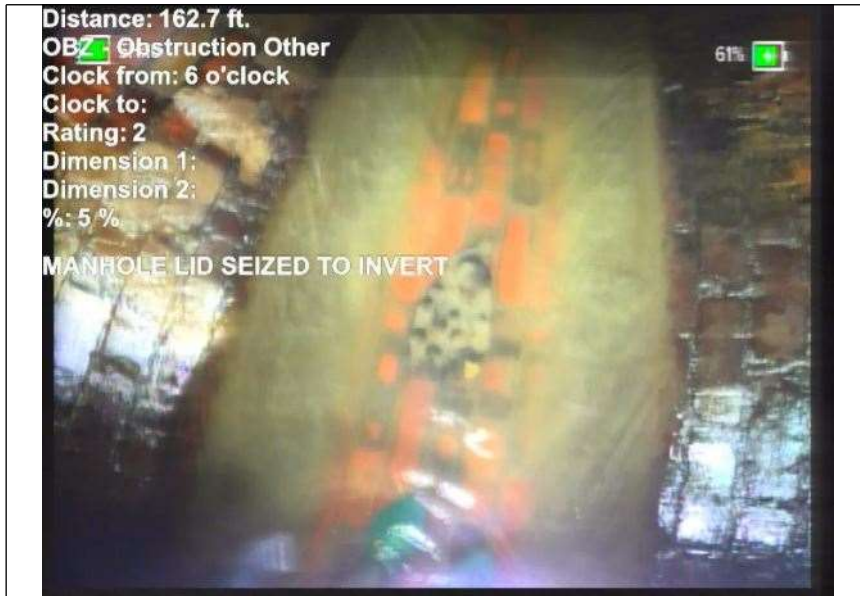
At: 162. OBZ - Obstruction Other
6999969482
42 ft. 6/.

Joint: No 5 % MANHOLE LID SEIZED TO INVERT

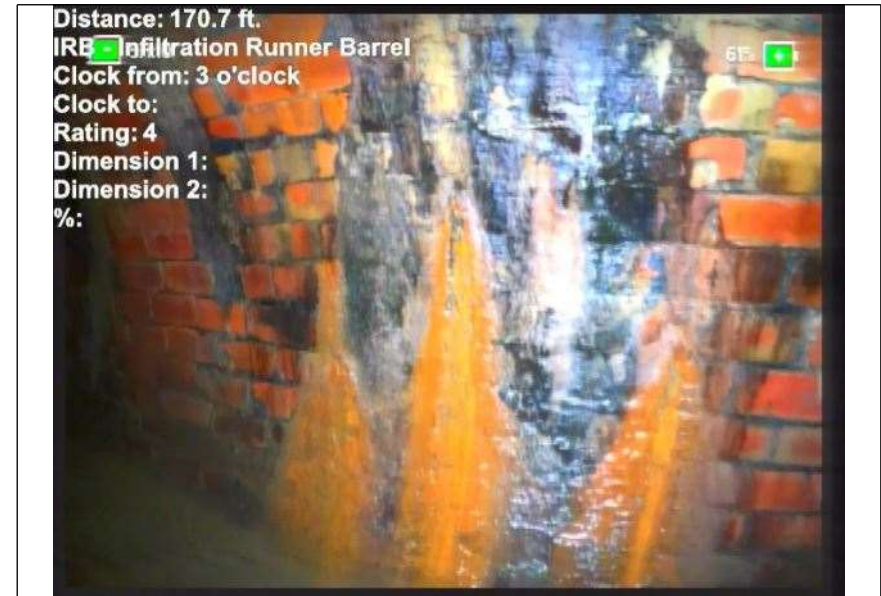
At: 170. IRB - Infiltration Runner Barrel
6999969482
42 ft. 3/.

Joint: No

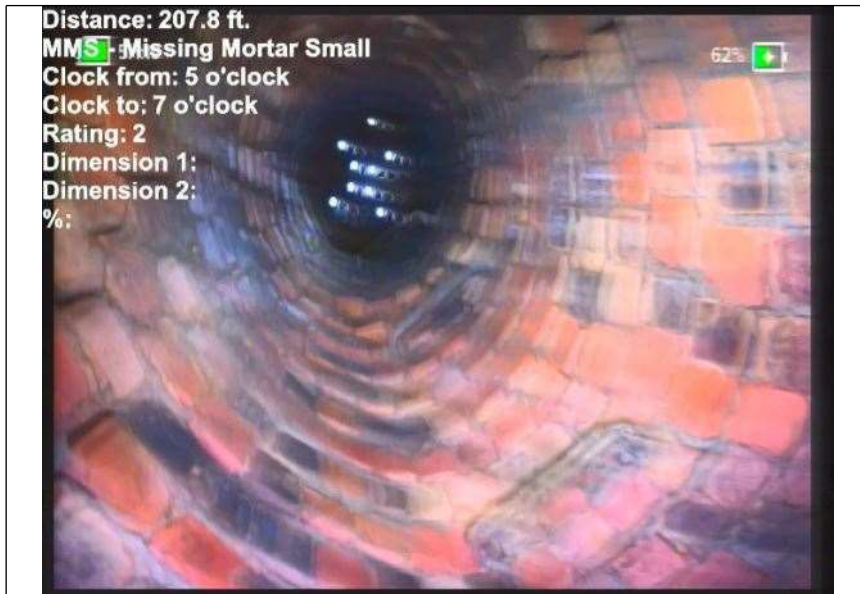
At: 207.7 ft. 5/7 MMS - Missing Mortar Small

Joint: No

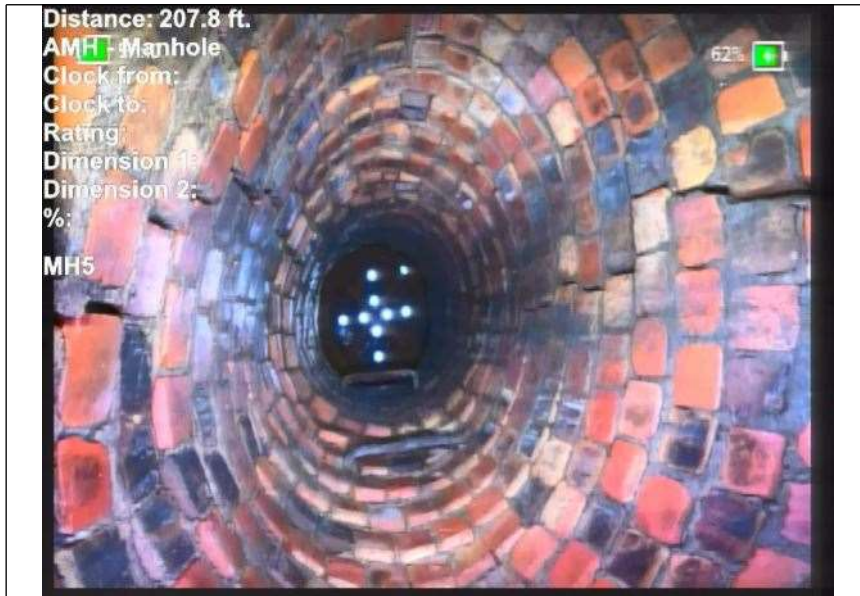
At: 207. AMH - Manhole
8000030517
58 ft.

Joint: No MH5
