## PACP Report with Pipe Run and Incident Snapshots

Surveyed by: <b>ANDREW</b>		Certificate number: <b>T-507-4975</b>		Owner: <b>CITY OF MARION</b>		Customer:		Drainage area:		P/O number:		Sheet number:							
Pipe segment ref.: <b>MH6_MH5</b>				Start date/time: <b>20240626 14:07</b>		Street: <b>1045 HOLLAND RD.</b>				City: <b>MARION, OH</b>									
Location details:				Upstream MH No: <b>MH6</b>				Rim to invert:		Grade to invert:		Rim to grade:							
Pipe use: <b>CB</b>		Direction: <b>D</b>		Flow control:		Downstream MH No: <b>MH5</b>				Rim to invert:		Grade to invert:		Rim to grade:					
Height: <b>72 in.</b>		Width:		Shape: <b>C</b>		Material: <b>BR</b>		Lining method:		Pipe joint length:		Total length: <b>995.000 ft.</b>		Length surveyed: <b>995.000 ft.</b>		Purpose: <b>B</b>		Sewer category:	
Media label:				Pre-cleaning: <b>N</b>		Date cleaned:		Weather: <b>1</b>		Location code: <b>C</b>		Pressure value:							
Project name: <b>ROCK SWALE 72 IN INSPECTION</b>				Additional info:

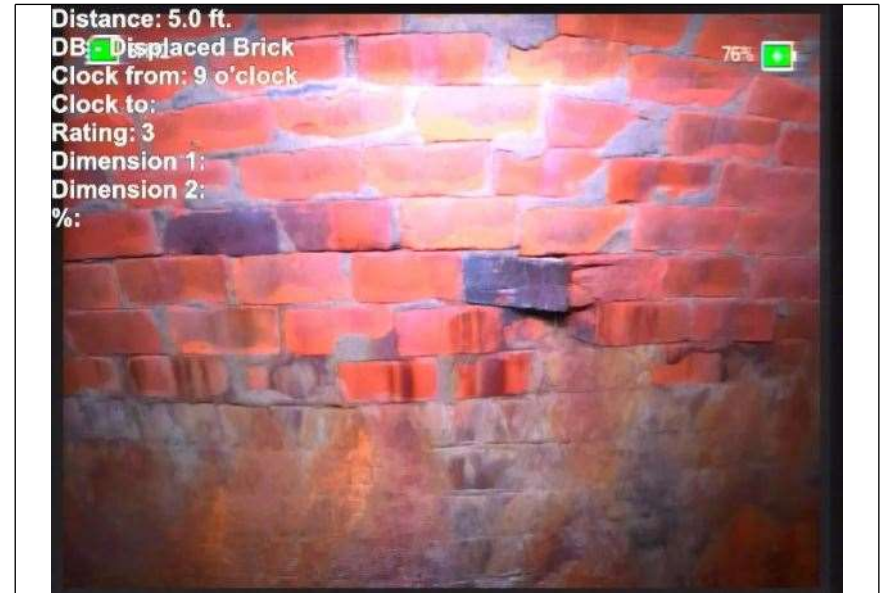
5.0 ft.	00:01:00	DB						<input type="checkbox"/>	9 /		3	ROCK SWALE 72 IN INSPECTION-AMH 'MH6'-AMH 'MH5'-DB at 5.0 ft.JPG	
5.0 ft.	00:01:19	SSS						<input type="checkbox"/>	9 /		2	ROCK SWALE 72 IN INSPECTION-AMH 'MH6'-AMH 'MH5'-SSS at 5.0 ft.JPG	CHIPPED SURFACE

Distance: 5.0 ft.  
DB - Displaced Brick  
Clock from: 9 o'clock  
Clock to:  
Rating: 3  
Dimension 1:  
Dimension 2:  
%:

At: 5 ft. 9/. DB - Displaced Brick  
Joint: No

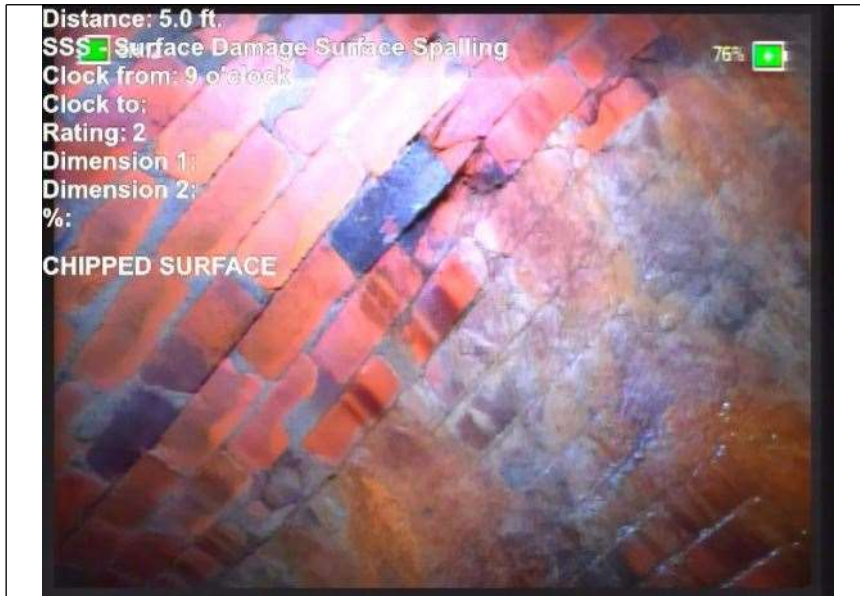
At: 5 ft. 9/ SSS - Surface Damage Surface Spalling  
Joint: No CHIPPED SURFACE

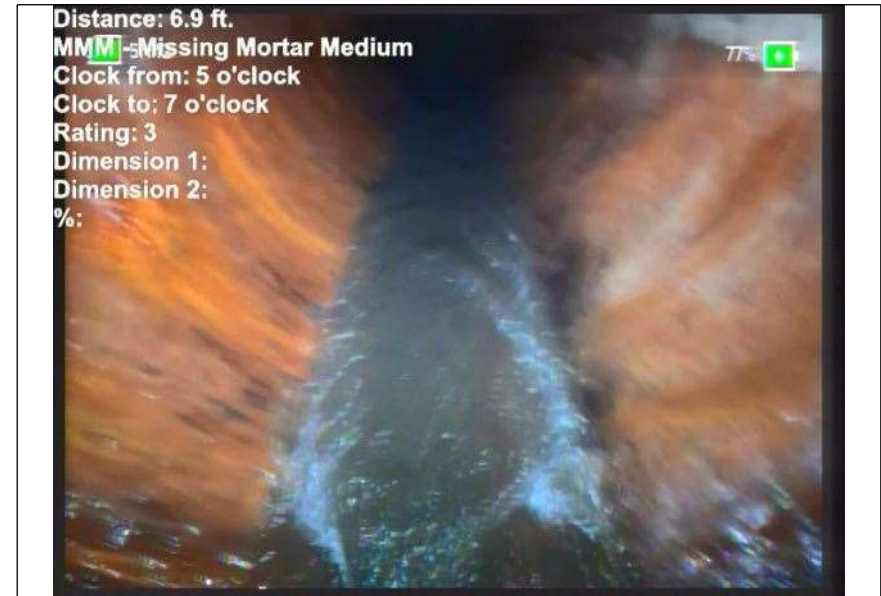
At 6.9 ft. 5/7  
S01: MMM - Missing Mortar  
Medium  
Rating: 3  
Category: Structural

At: 6. MMM - Missing Mortar Medium  
9000000953  
6743 ft. 5/7  
Joint: No

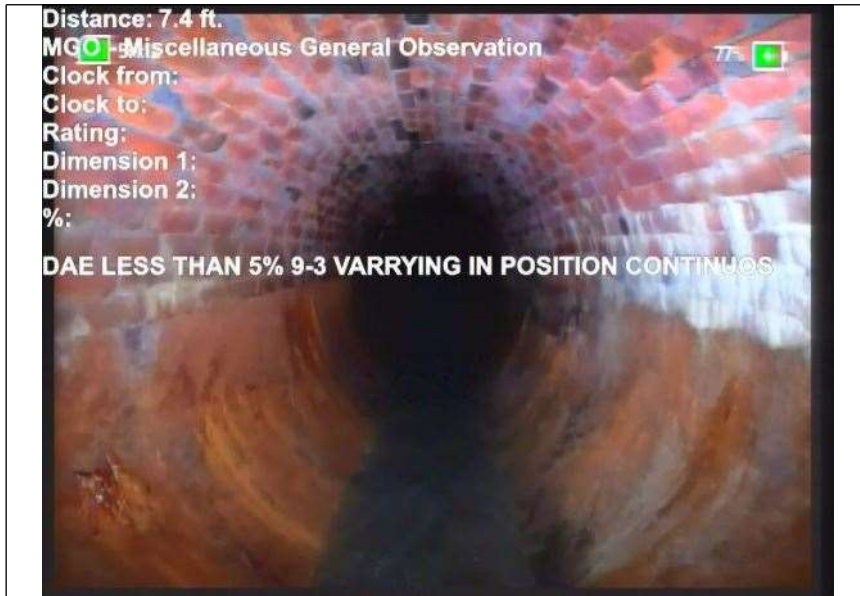
At: 7. MGO - Miscellaneous General Observation  
4000000953  
6743 ft.

Joint: No DAE LESS THAN 5% 9-3 VARYING IN POSITION CONTINUOUS

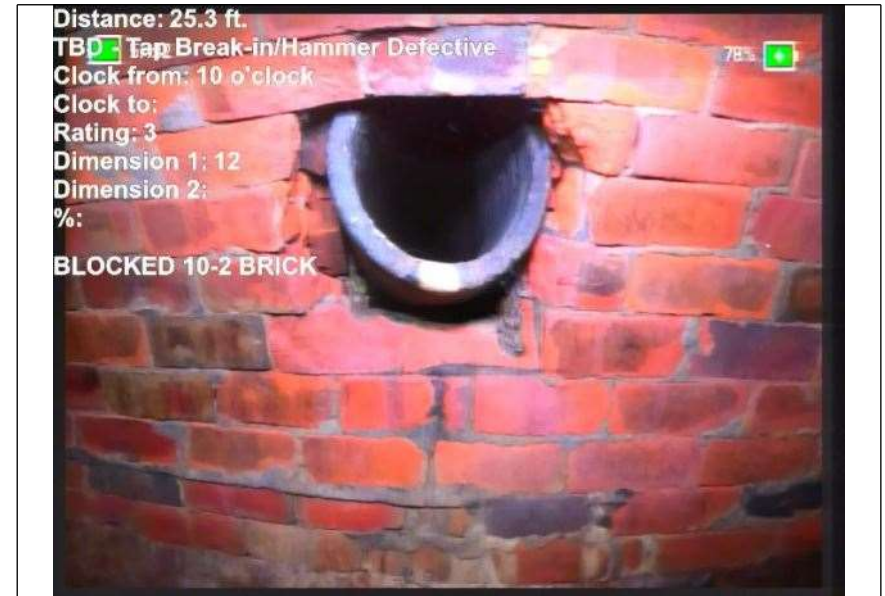
At: 25. TBD - Tap Break-in/Hammer Defective  
2999992370  
605 ft. 10/.

Joint: No BLOCKED 10-2 BRICK

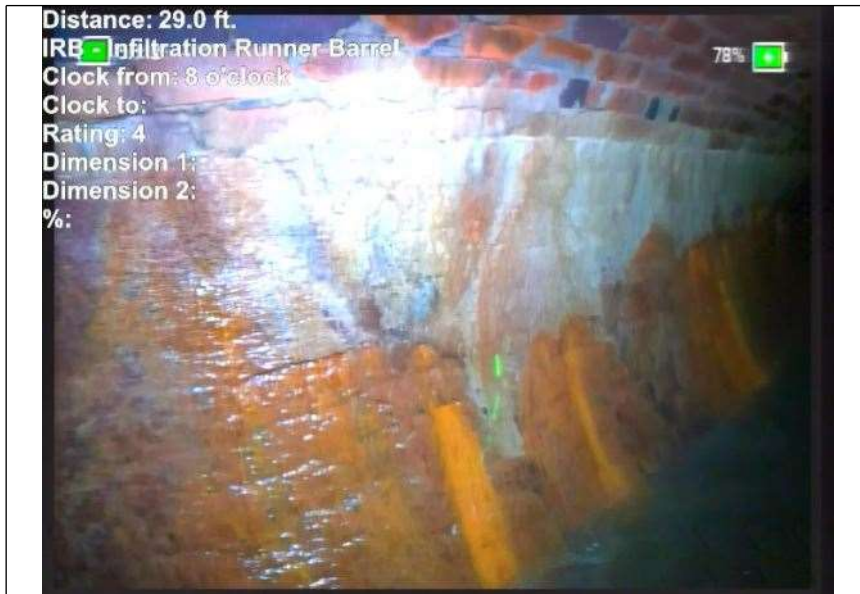
At: 29 ft. 8/. IRB - Infiltration Runner Barrel

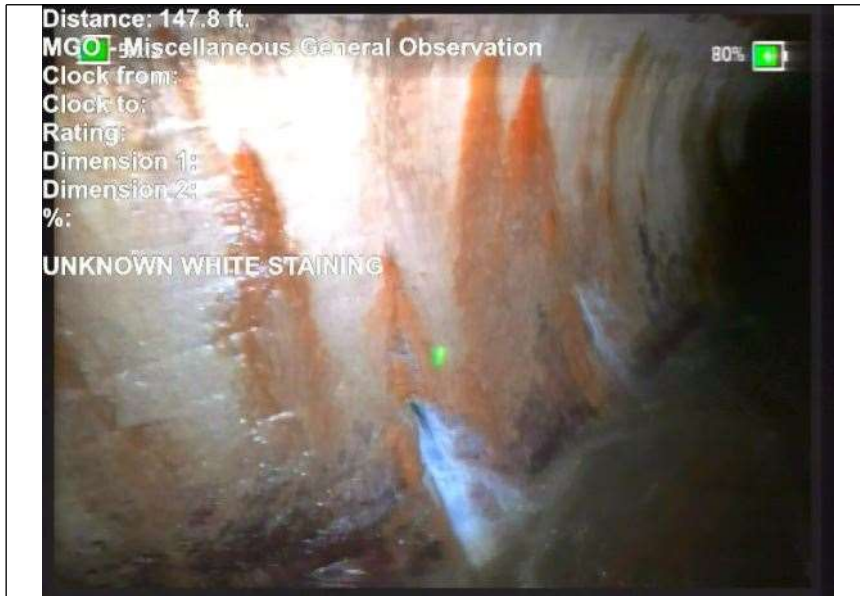
At: 147. MGO - Miscellaneous General Observation  
8000030517  
58 ft.

Joint: No UNKNOWN WHITE STAINING

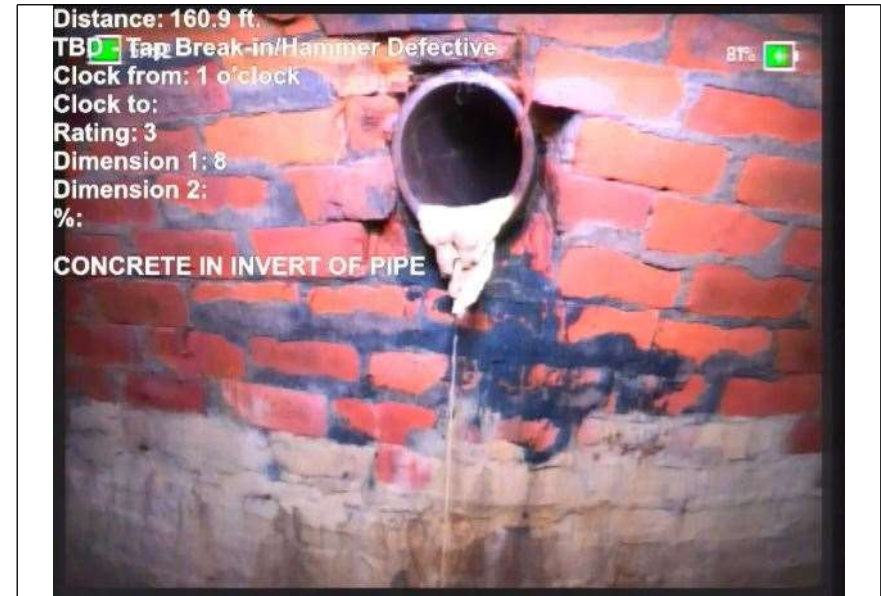
At: 160. TBD - Tap Break-in/Hammer Defective  
8999938964  
84 ft. 1/.

Joint: No CONCRETE IN INVERT OF PIPE

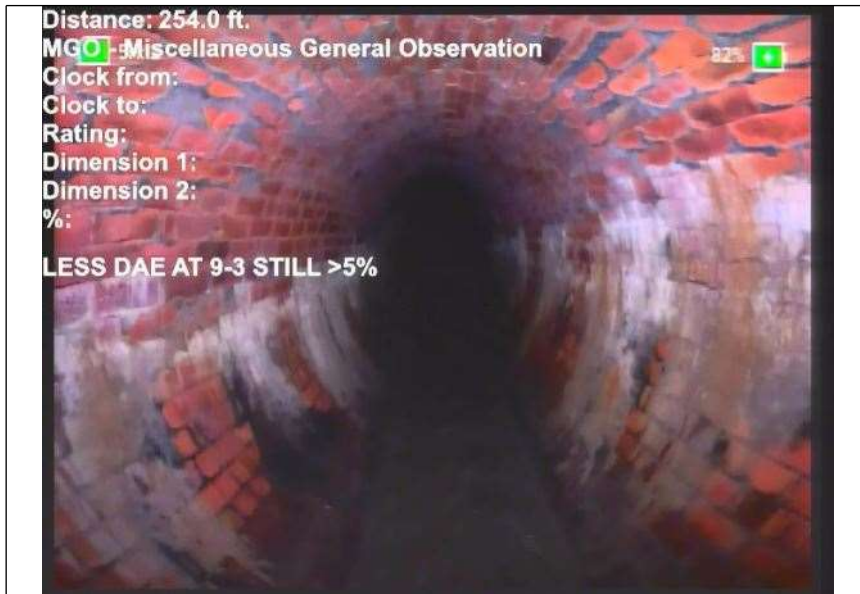
At: 254 ft. MGO - Miscellaneous General Observation  
Joint: No LESS DAE AT 9-3 STILL >5%

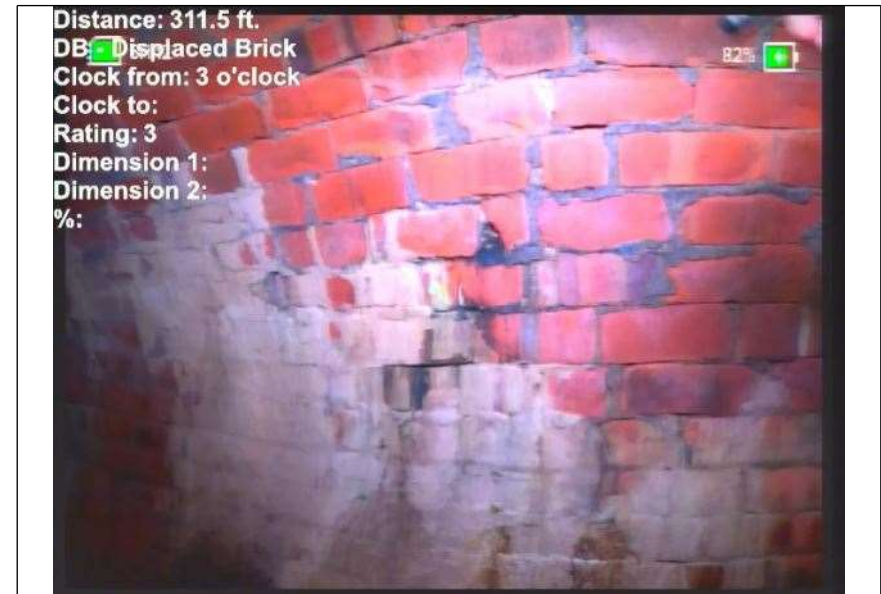
At: 311.5 ft. 3/. DB - Displaced Brick  
Joint: No

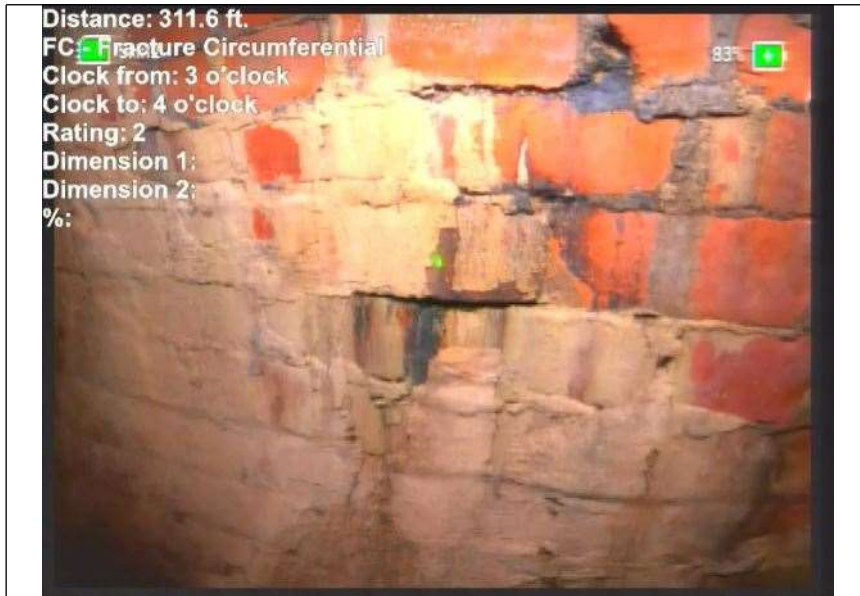
At: 311. FC - Fracture Circumferential  
6000061035  
16 ft. 3/4  
Joint: No

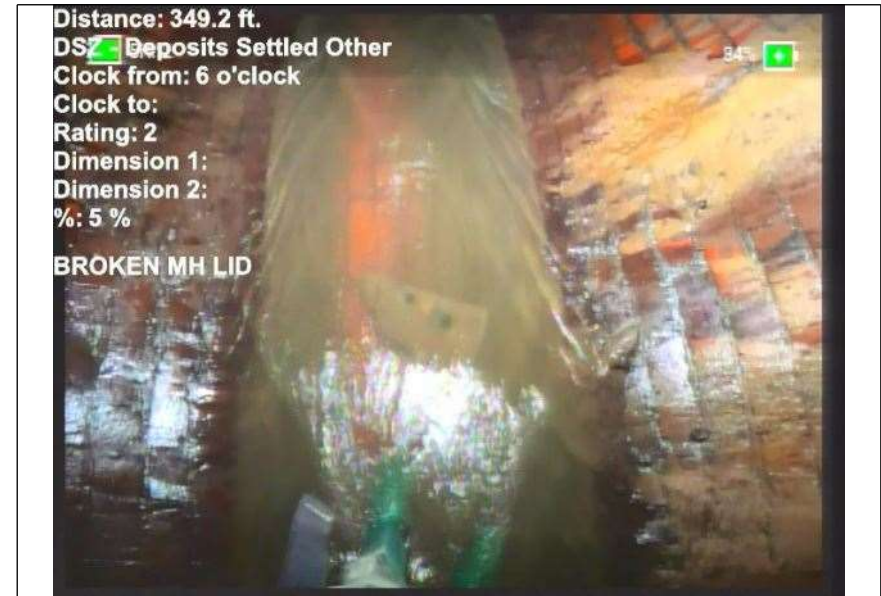
At: 349. DSZ - Deposits Settled Other  
2000122070  
31 ft. 6/.

Joint: No 5 % BROKEN MH LID

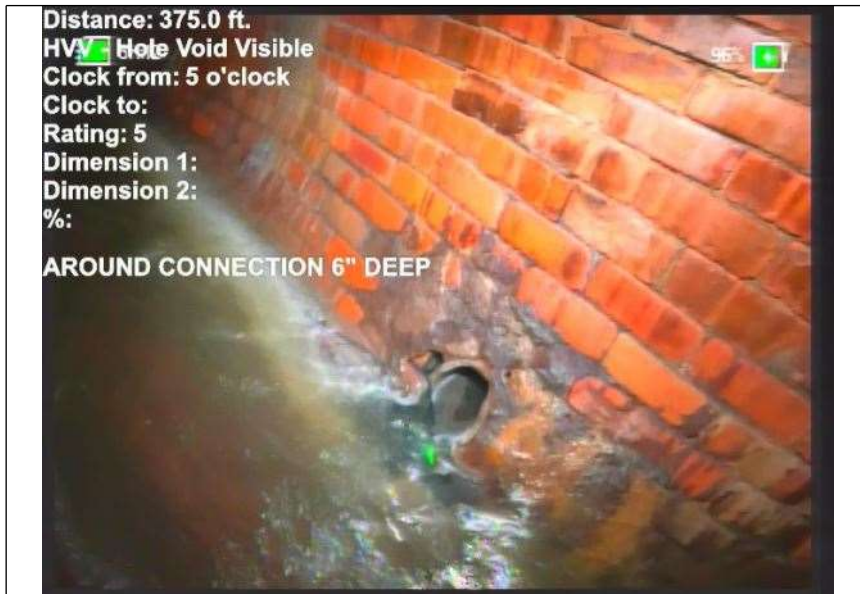
At: 375 ft. 5/. HVV - Hole Void Visible  
Joint: No AROUND CONNECTION 6" DEEP

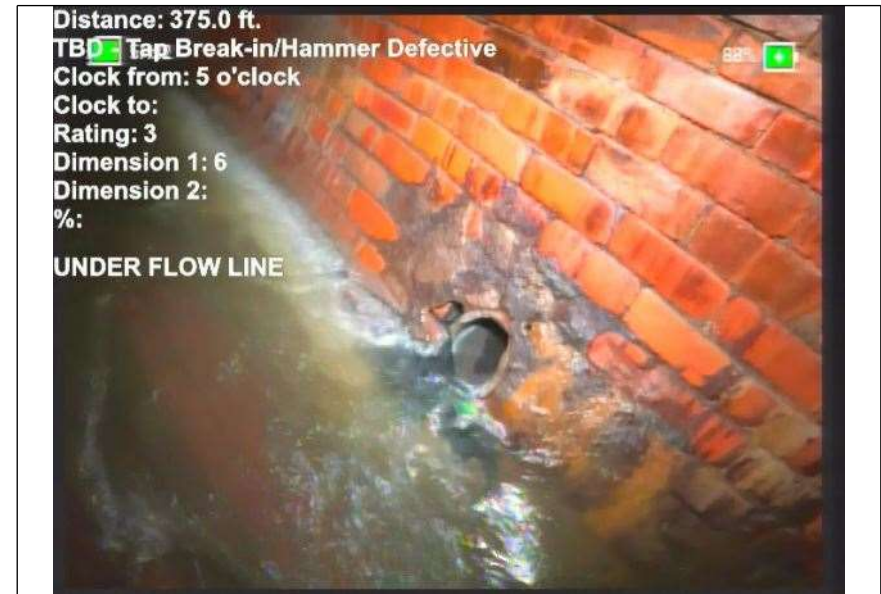
At 375.0 ft. 5/.  
TBD - Tap Break-in/Hammer  
Defective  
Dimension 1: 6.000  
Rating: 3  
Category: O&M  
Comments: UNDER FLOW LINE

At: 375 ft. 5/. TBD - Tap Break-in/Hammer Defective  
Joint: No UNDER FLOW LINE

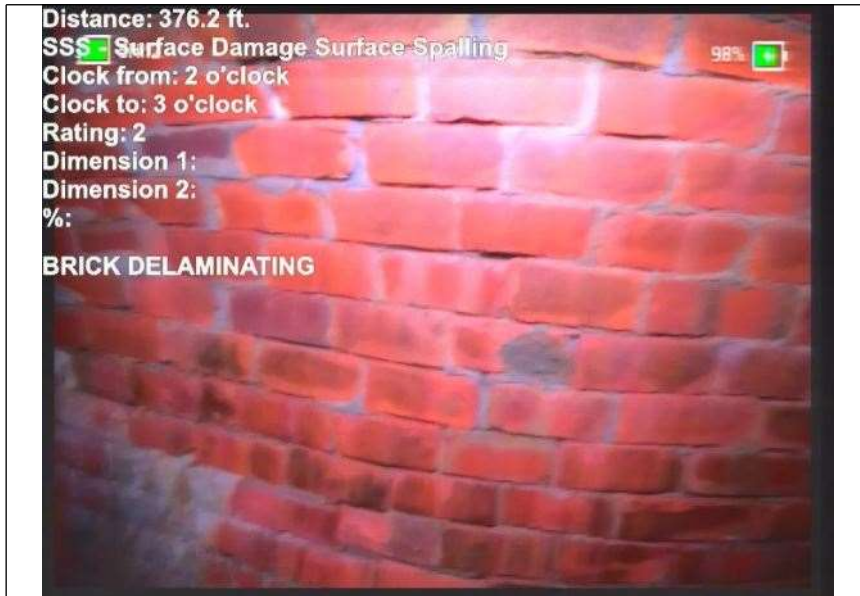
At: 376. SSS - Surface Damage Surface Spalling  
2000122070  
31 ft. 2/3

Joint: No BRICK DELAMINATING

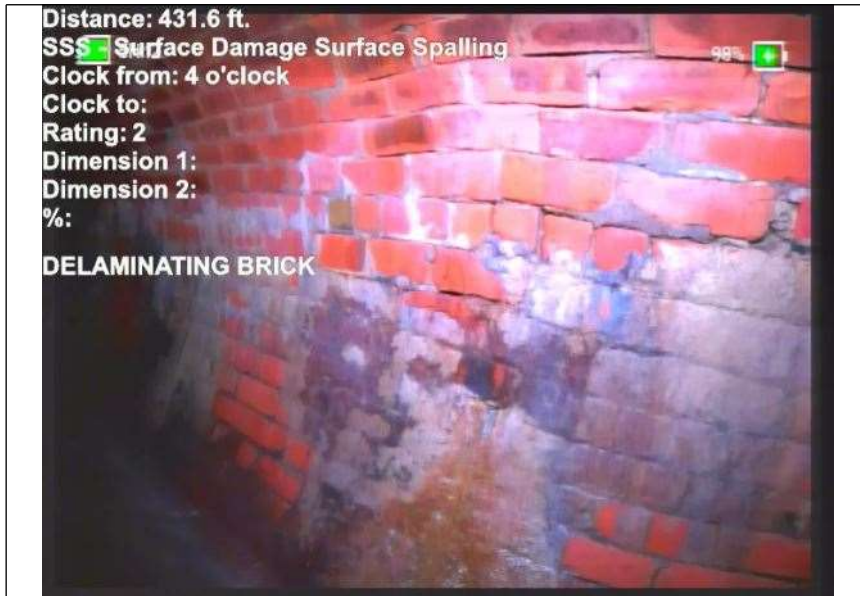
At: 431. SSS - Surface Damage Surface Spalling  
6000061035  
16 ft. 4/.

Joint: No DELAMINATING BRICK

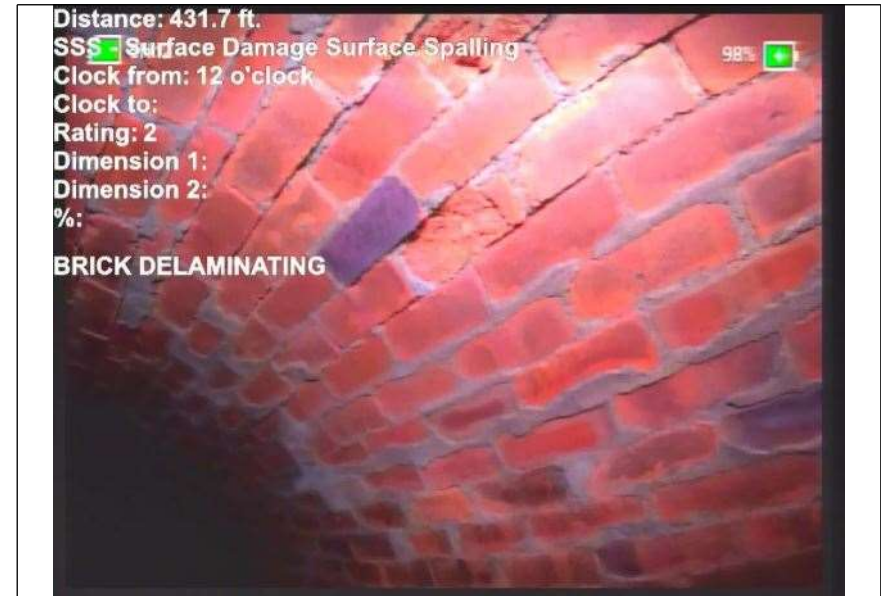
At: 431. SSS - Surface Damage Surface Spalling  
7000122070  
31 ft. 12/.

Joint: No BRICK DELAMINATING

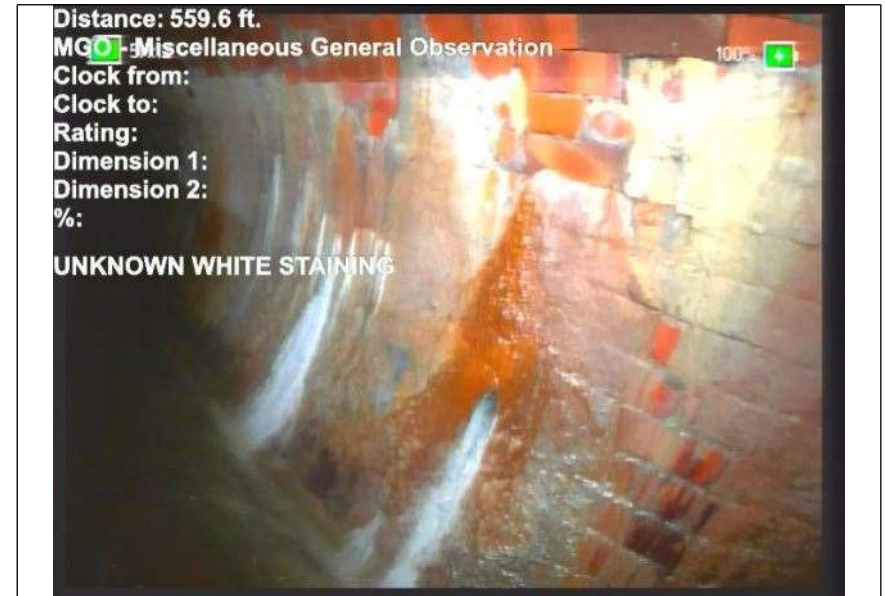
At: 559. MGO - Miscellaneous General Observation  
5999755859  
38 ft.

Joint: No **UNKNOWN WHITE STAINING**

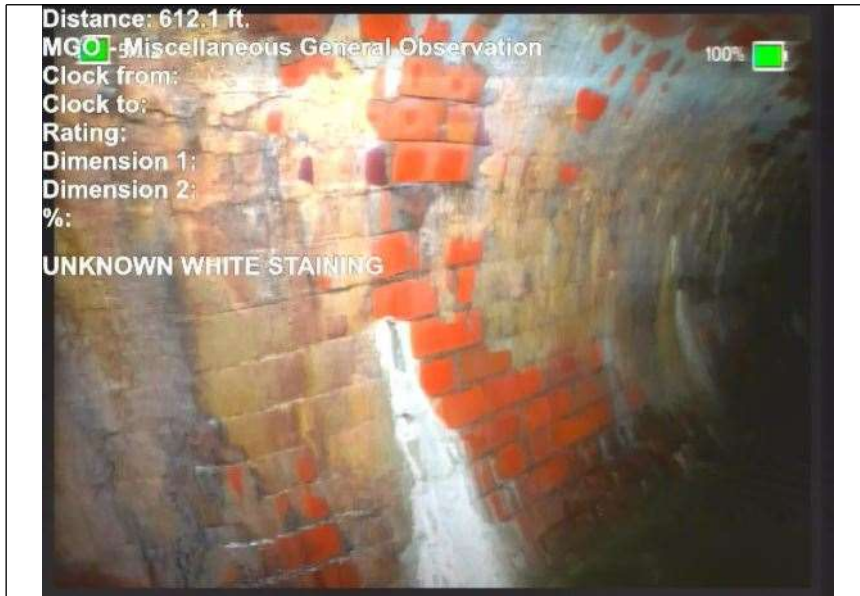
At: 612.0999755859 MGO - Miscellaneous General Observation  
38 ft.

Joint: No UNKNOWN WHITE STAINING

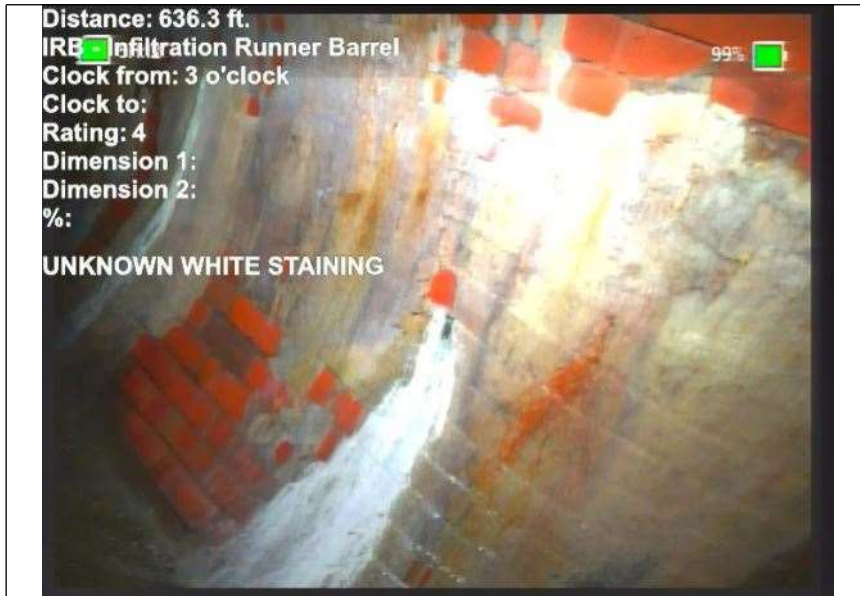
At: 636. IRB - Infiltration Runner Barrel  
2999877929  
69 ft. 3/.

Joint: No UNKNOWN WHITE STAINING

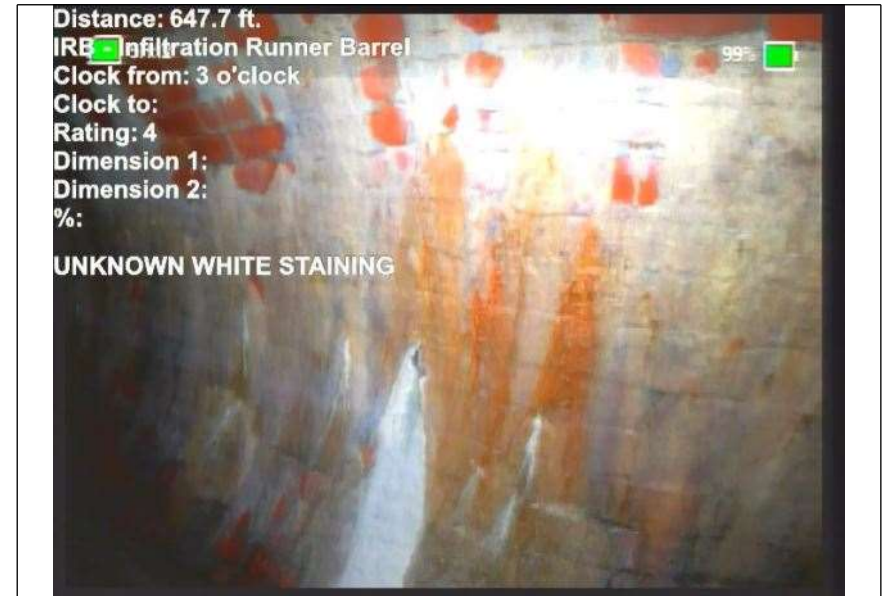
At: 647. IRB - Infiltration Runner Barrel  
7000122070  
31 ft. 3/.

Joint: No UNKNOWN WHITE STAINING

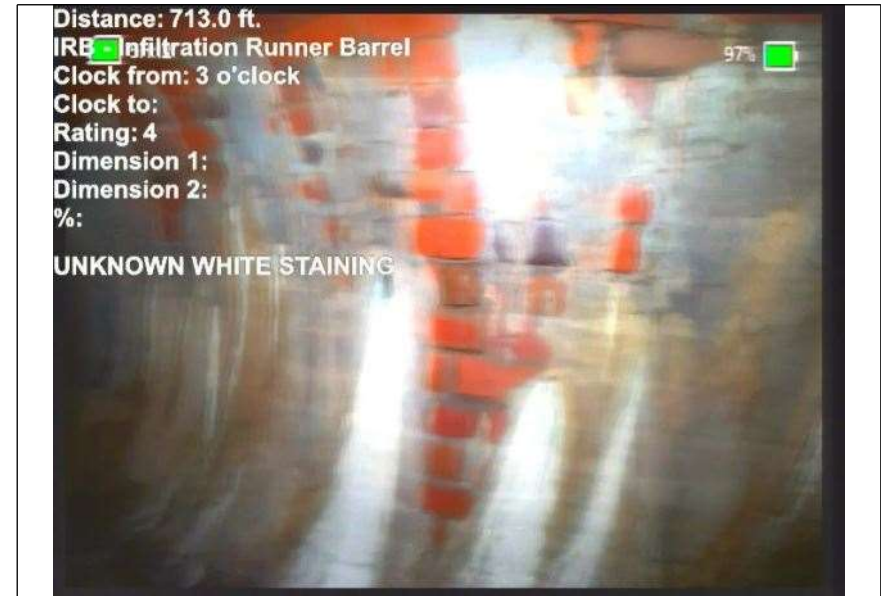
At: 713 ft. 3/. IRB - Infiltration Runner Barrel  
Joint: No UNKNOWN WHITE STAINING

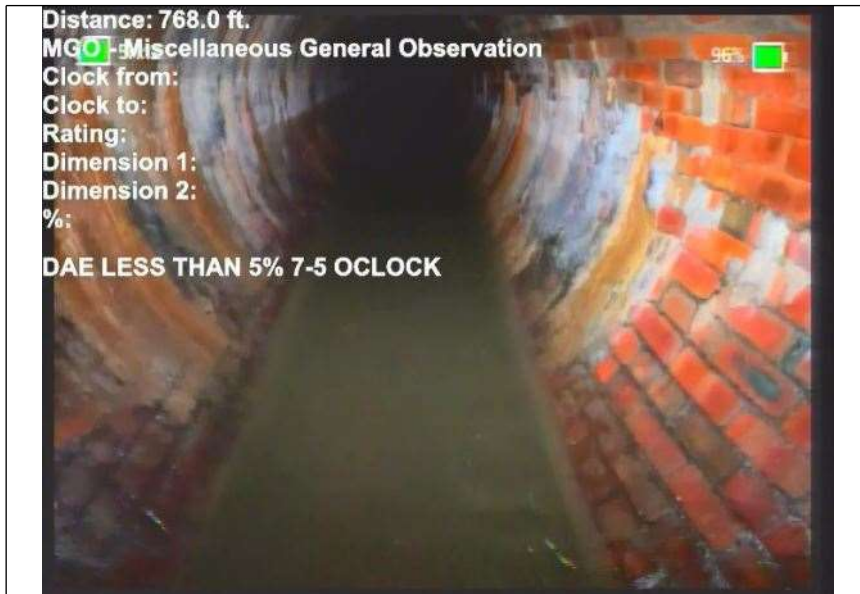
At: 768 ft. MGO - Miscellaneous General Observation  
Joint: No DAE LESS THAN 5% 7-5 OCLOCK

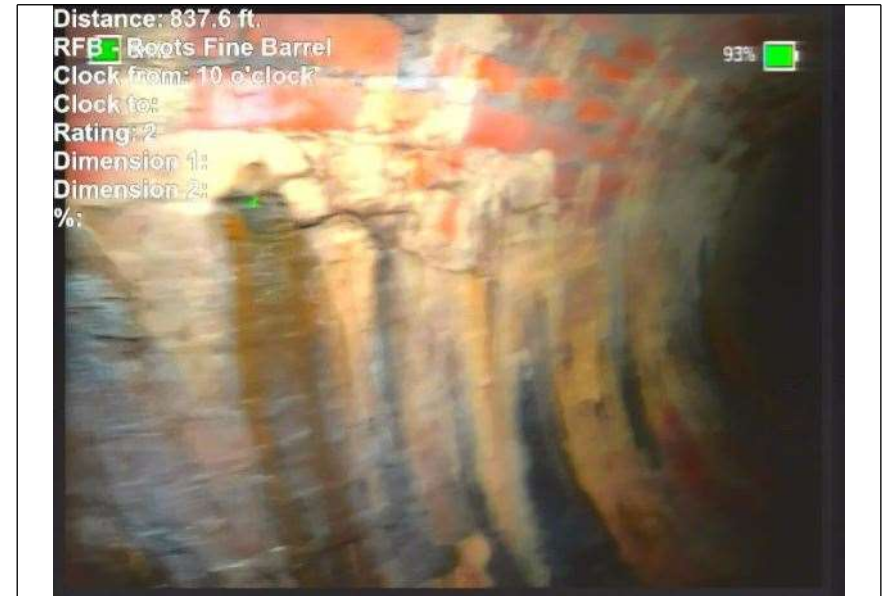
At: 837. RFB - Roots Fine Barrel  
5999755859  
38 ft. 10/.

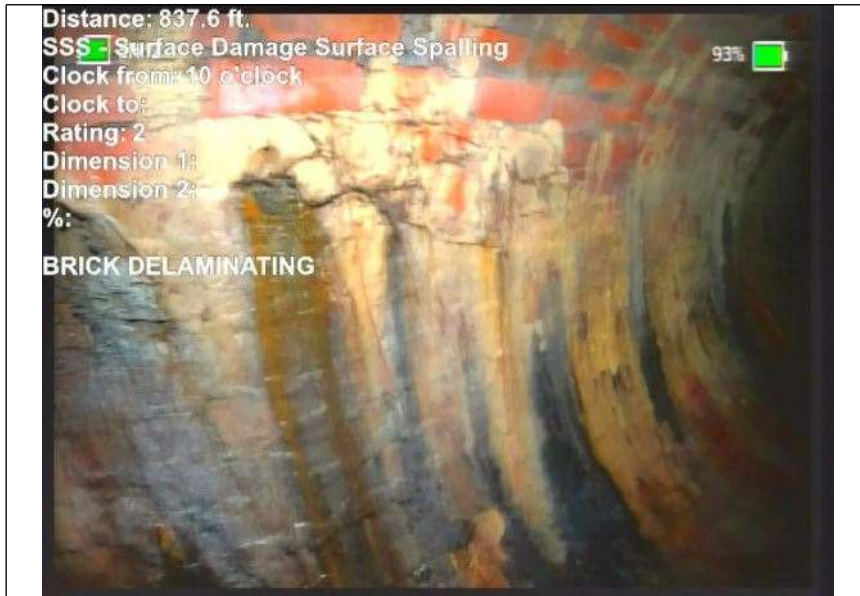
At: 837. 5999755859 SSS - Surface Damage Surface Spalling  
38 ft. 10/.

Joint: No BRICK DELAMINATING

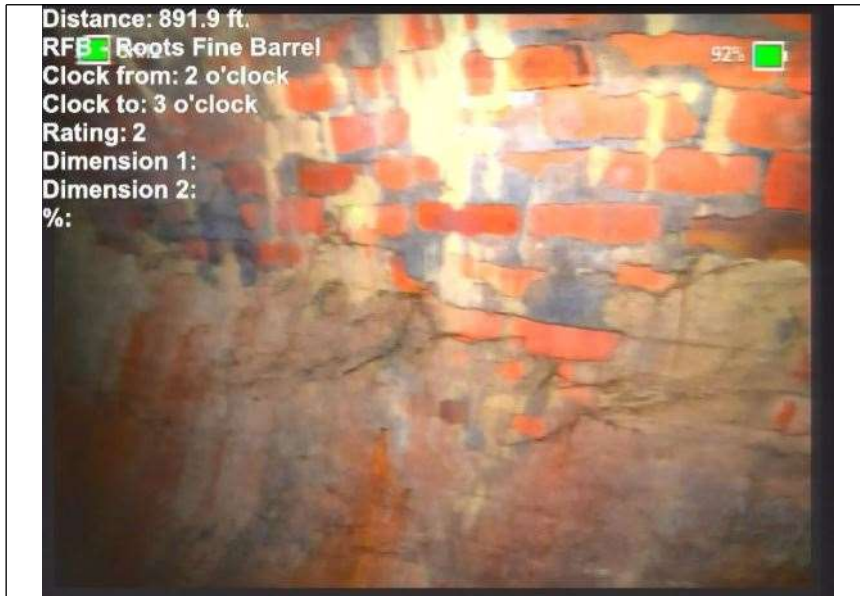
At: 891. RFB - Roots Fine Barrel  
9000244140  
63 ft. 2/3

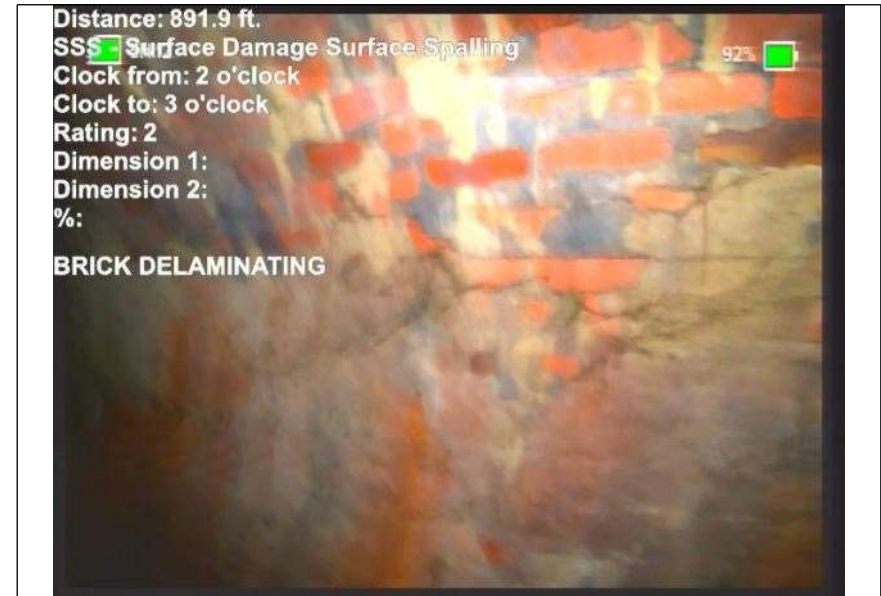
At: 891. SSS - Surface Damage Surface Spalling  
9000244140  
63 ft. 2/3

Joint: No BRICK DELAMINATING

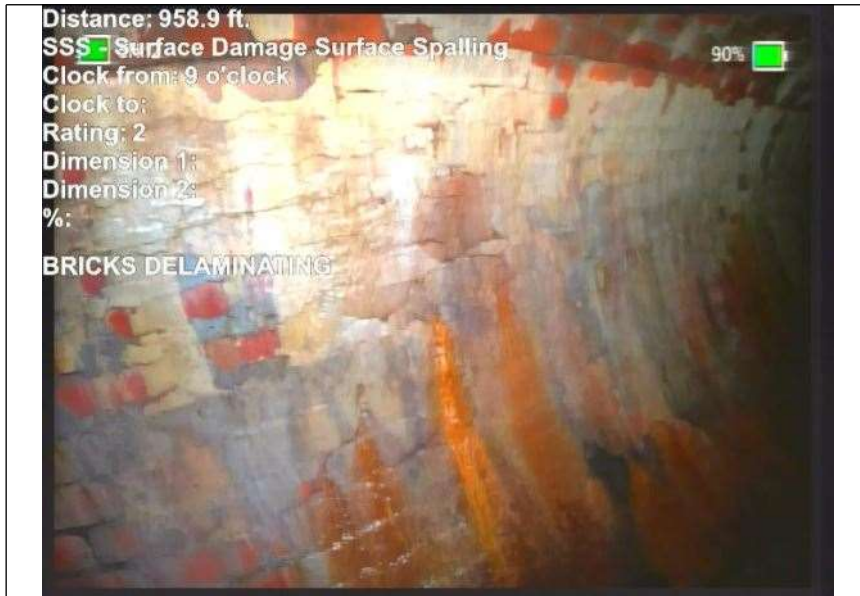
At: 958. SSS - Surface Damage Surface Spalling  
9000244140  
63 ft. 9/.

Joint: No BRICKS DELAMINATING

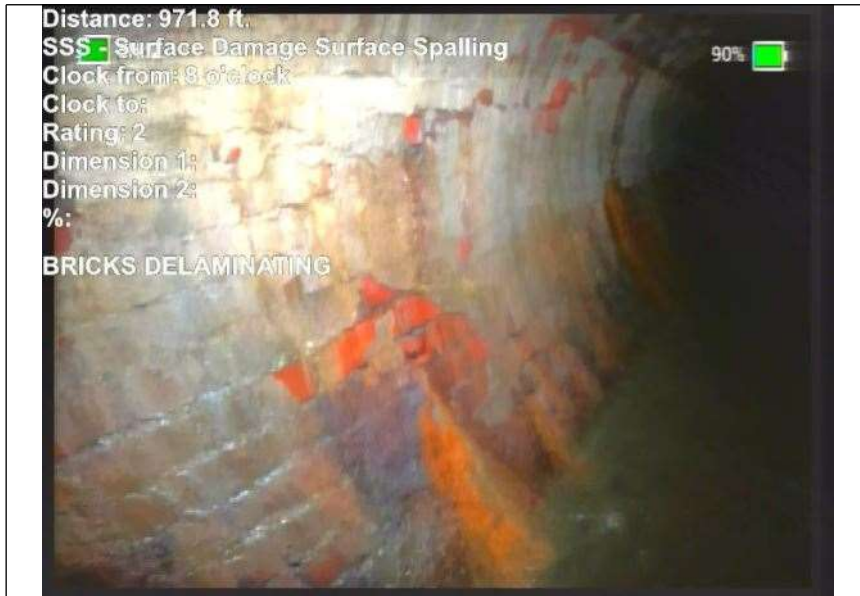
At: 971. SSS - Surface Damage Surface Spalling  
7999877929  
69 ft. 8/.

Joint: No BRICKS DELAMINATING

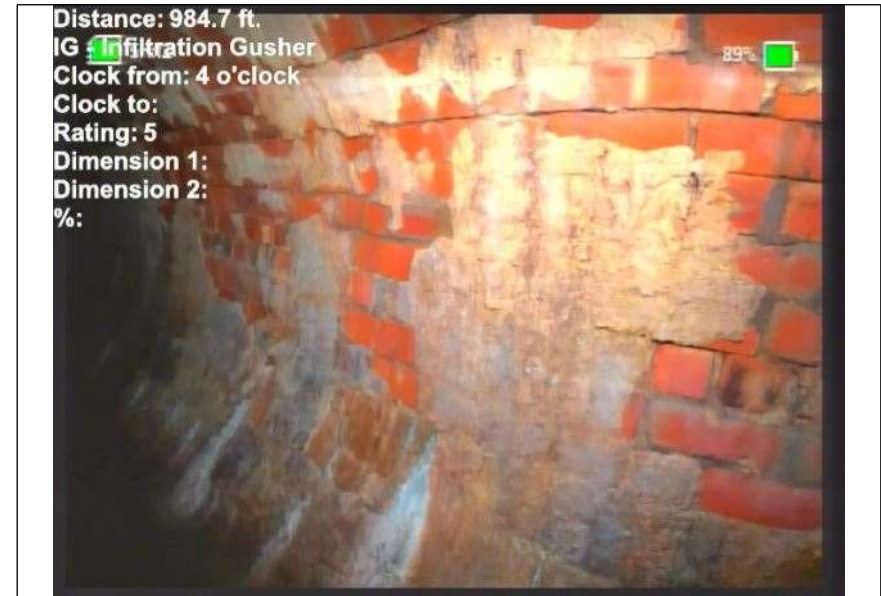
At: 984. IG - Infiltration Gusher  
7000122070  
31 ft. 4/.

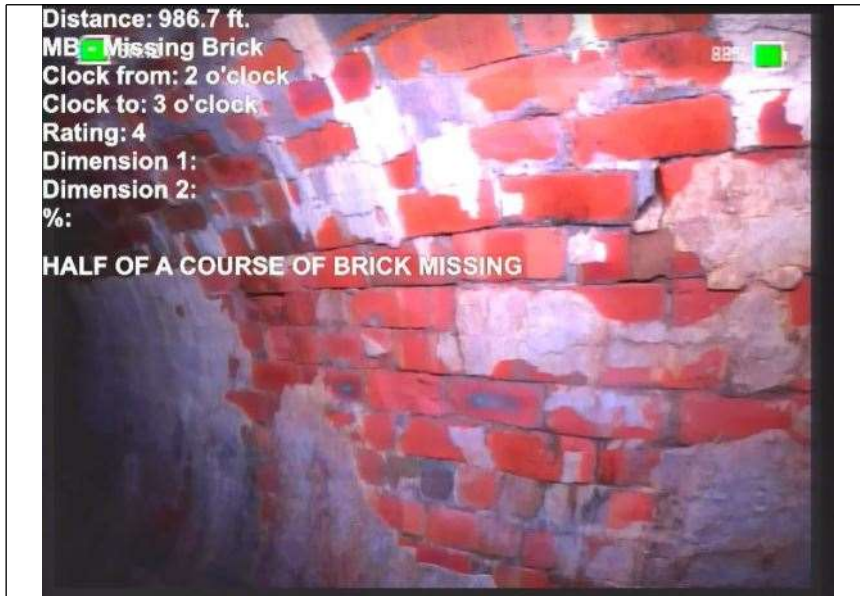
At: 986. MB - Missing Brick  
7000122070  
31 ft. 2/3

Joint: No HALF OF A COURSE OF BRICK MISSING

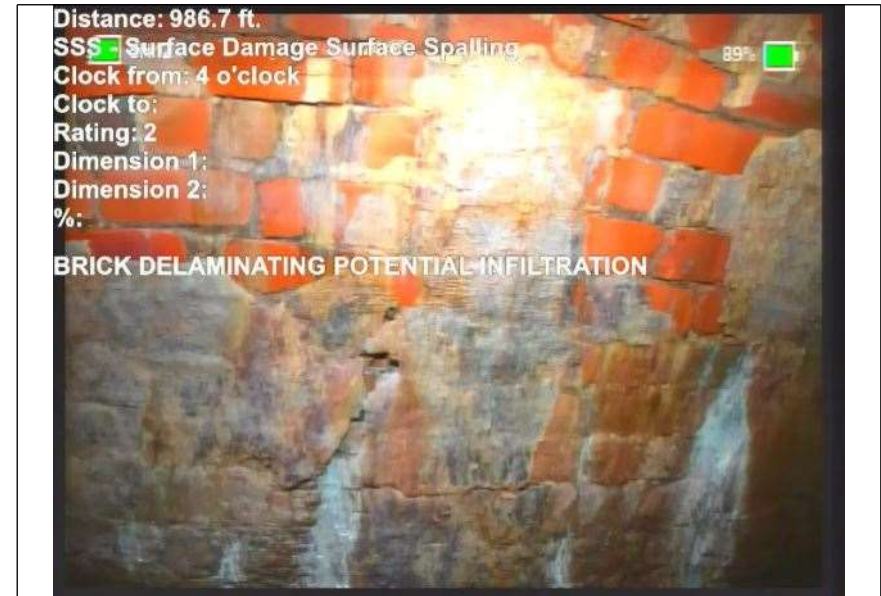
At: 986. SSS - Surface Damage Surface Spalling  
7000122070  
31 ft. 4/.

Joint: No BRICK DELAMINATING POTENTIAL INFILTRATION

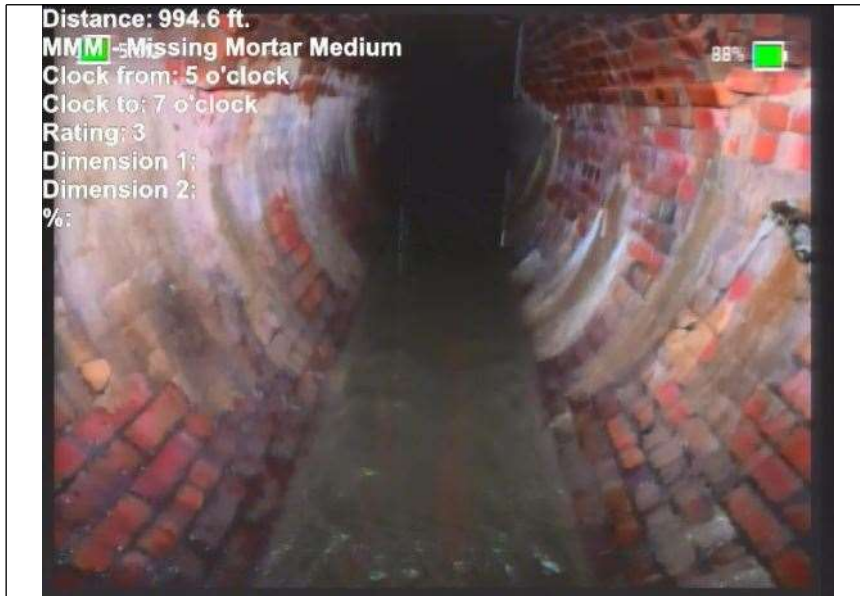
At 994.6 ft. 5/7  
F01: MMM - Missing Mortar Medium  
Rating: 3  
Category: Structural  
Stopped at 995.0 ft. with flow  
on 6/26/2024 2:40:25 PM

At: 994. 5999755859  
MMM - Missing Mortar Medium  
38 ft. 5/7
