PACP Report with Pipe Run and Incident Snapshots

Surveyed by: ANDREW		Certificate number: T-507-4975		Owner:		Customer:		Drainage area:		P/O number:		Sheet number:							
Pipe segment ref.: MH7A_MH7				Start date/time: 20240626 11:54		Street: SILVER ST				City: MARION, OH									
Location details:				Upstream MH No: MH7A				Rim to invert:		Grade to invert:		Rim to grade:							
Pipe use: CB		Direction: D		Flow control:		Downstream MH No: MH7				Rim to invert:		Grade to invert:		Rim to grade:					
Height: 72 in.		Width:		Shape: C		Material: BR		Lining method:		Pipe joint length:		Total length: 149.300 ft.		Length surveyed: 149.300 ft.		Purpose: B		Sewer category:	
Media label:				Pre-cleaning: N		Date cleaned:		Weather: 1		Location code:		Pressure value:							
Project name: ROCK SWALE 72 IN INSPECTION				Additional info:

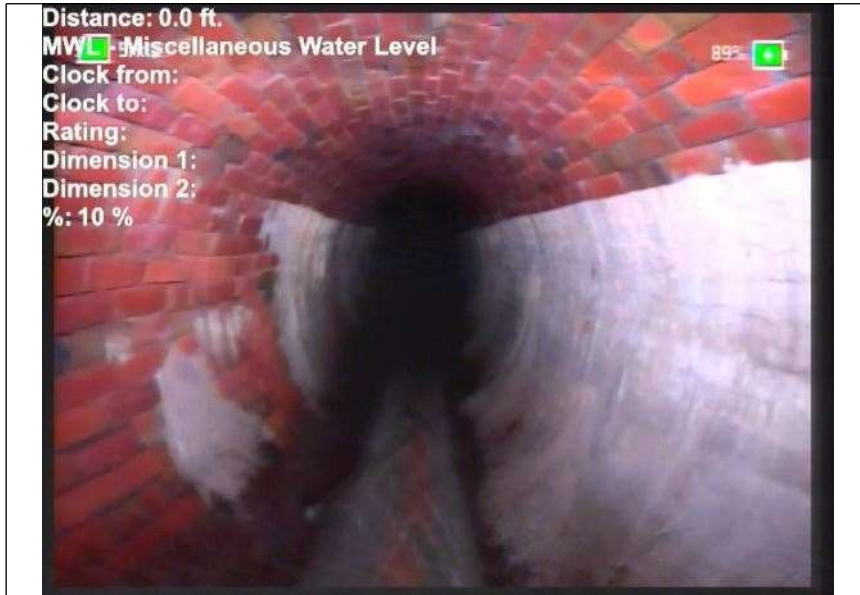
At: 0 ft. MWL - Miscellaneous Water Level
Joint: No 10 %

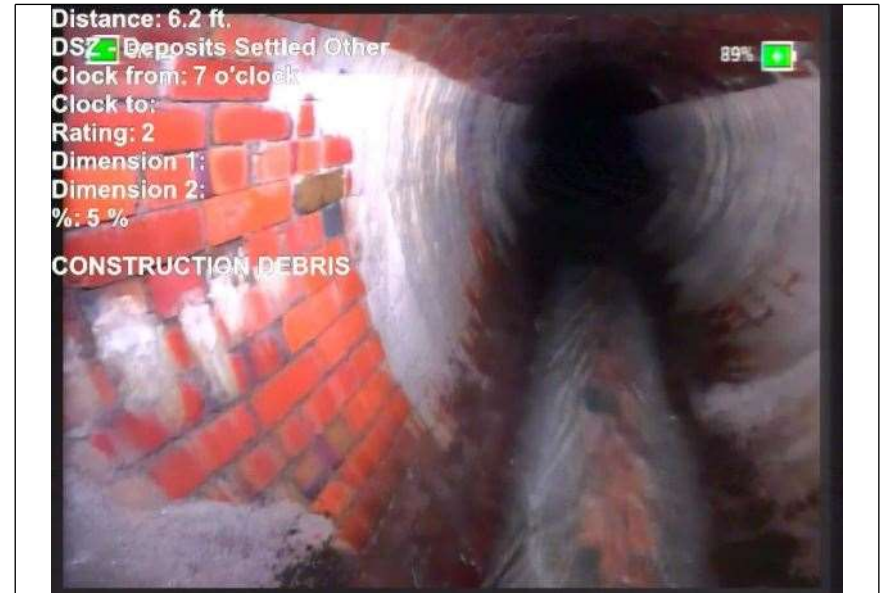
6.2 ft.	00:00:33	DSZ					5	<input type="checkbox"/>	7 /		2	ROCK SWALE 72 IN INSPECTION-AMH 'MH7A'-AMH 'MH7'-DSZ at 6.2 ft.JPG	CONSTRUCTION DEBRIS
11.1 ft.	00:01:16	MGO						<input type="checkbox"/>	/			ROCK SWALE 72 IN INSPECTION-AMH 'MH7A'-AMH 'MH7'-MGO at 11.1 ft.JPG	DAE LESS THAN 5% 2-10 OCLOCK

At: 6. 199998092
6514 ft. 7/. DSZ - Deposits Settled Other
Joint: No 5 % CONSTRUCTION DEBRIS

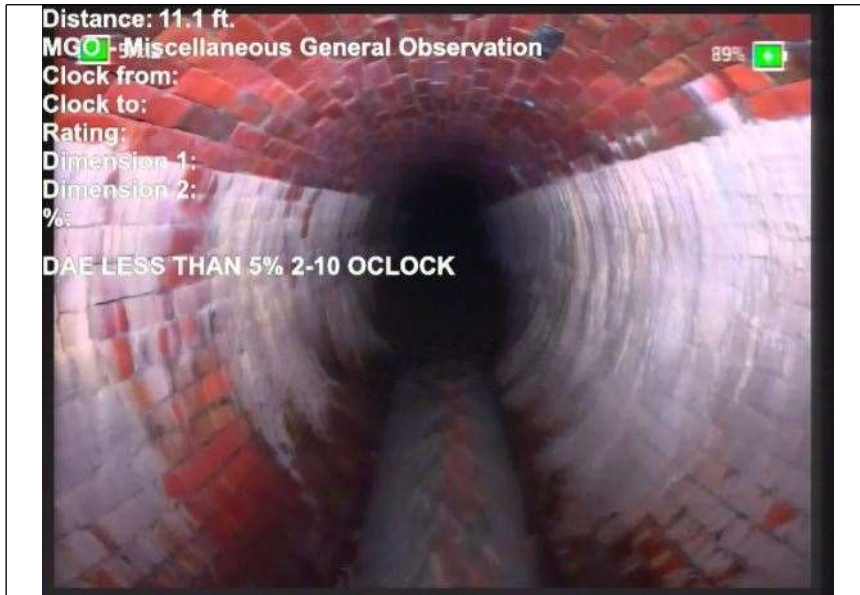
At: 11. MGO - Miscellaneous General Observation
1000003814
697 ft.

Joint: No DAE LESS THAN 5% 2-10 OCLOCK

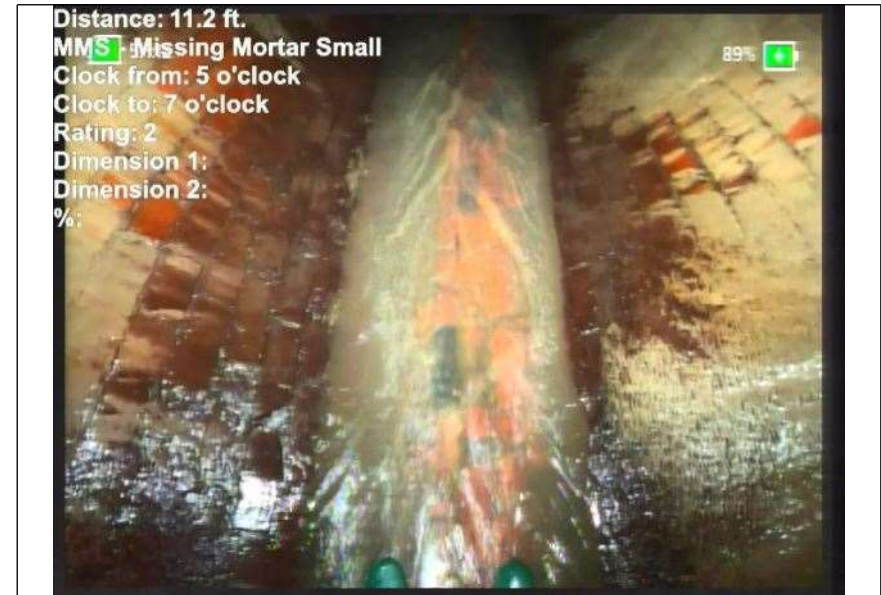
11.2 ft.	00:01:45	MMS	S01	S				<input type="checkbox"/>	5 / 7		2	ROCK SWALE 72 IN INSPECTION-AMH 'MH7A'-AMH 'MH7'-MMS at 11.2 ft.JPG	
20.0 ft.	00:02:04	VC						<input type="checkbox"/>	/		1	ROCK SWALE 72 IN INSPECTION-AMH 'MH7A'-AMH 'MH7'-VC at 20.0 ft.JPG

At: 11. MMS - Missing Mortar Small
1999998092
651 ft. 5/7

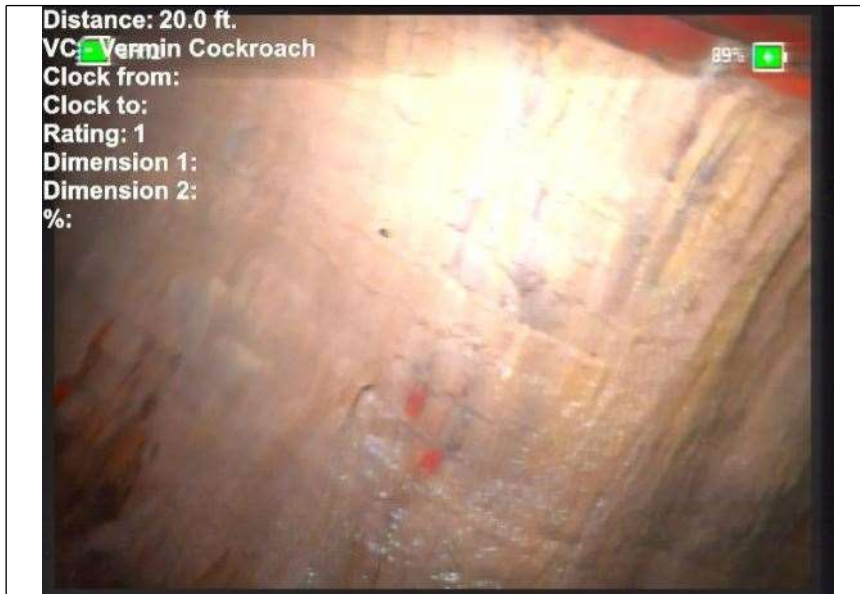
At: 20 ft. VC - Vermin Cockroach

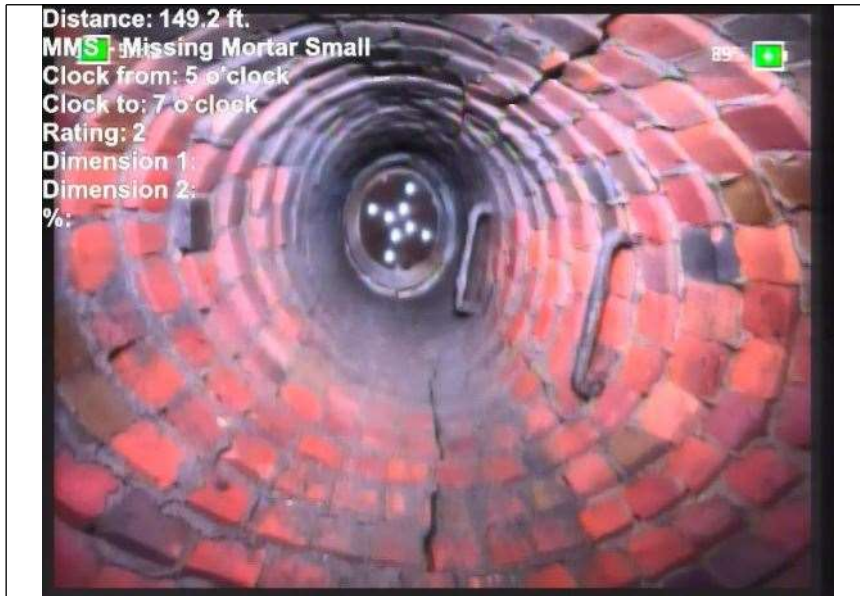
149.2 ft.	00:03:49	MMS	F01	S				<input type="checkbox"/>	5 / 7		2	ROCK SWALE 72 IN INSPECTION-AMH 'MH7A'-AMH 'MH7'-MMS at 149.2 ft.JPG

At: 149. MMS - Missing Mortar Small
1999969482
42 ft. 5/7
