## PACP Report with Pipe Run and Incident Snapshots

Surveyed by: <b>ANDREW</b>	Certificate number: <b>T-507-4975</b>	Owner: <b>CITY OF MARION</b>	Customer:	Drainage area:	P/O number:	Sheet number:
Pipe segment ref.: <b>MH7_MH6</b>	Start date/time: <b>20240626 14:55</b>	Street: <b>1045 HOLLAND RD.</b>	City: <b>MARION, OH</b>			
Location details:		Upstream MH No: <b>MH7</b>	Rim to invert:	Grade to invert:	Rim to grade:	
Pipe use: <b>CB</b>	Direction: <b>U</b>	Flow control:	Downstream MH No: <b>MH6</b>	Rim to invert:	Grade to invert:	Rim to grade:
Height: <b>72 in.</b>	Width:	Shape: <b>C</b>	Material: <b>BR</b>	Lining method:	Pipe joint length:	Total length: <b>1,023.500 ft.</b>
Media label:	Pre-cleaning: <b>N</b>	Date cleaned:	Weather: <b>1</b>	Length surveyed: <b>1,023.500 ft.</b>	Purpose: <b>B</b>	Sewer category:
Project name: <b>ROCK SWALE 72 IN INSPECTION</b>	Additional info:

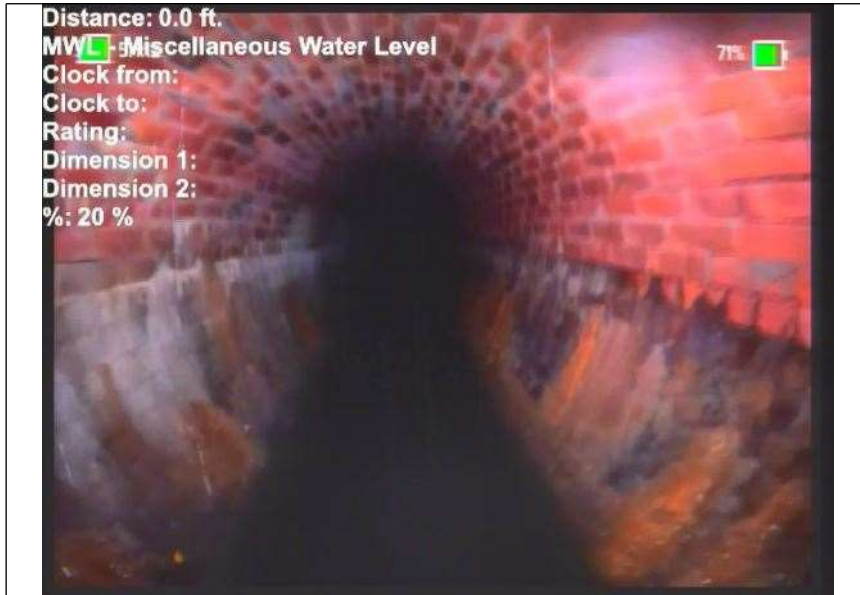
At: 0 ft. MWL - Miscellaneous Water Level  
Joint: No 20 %

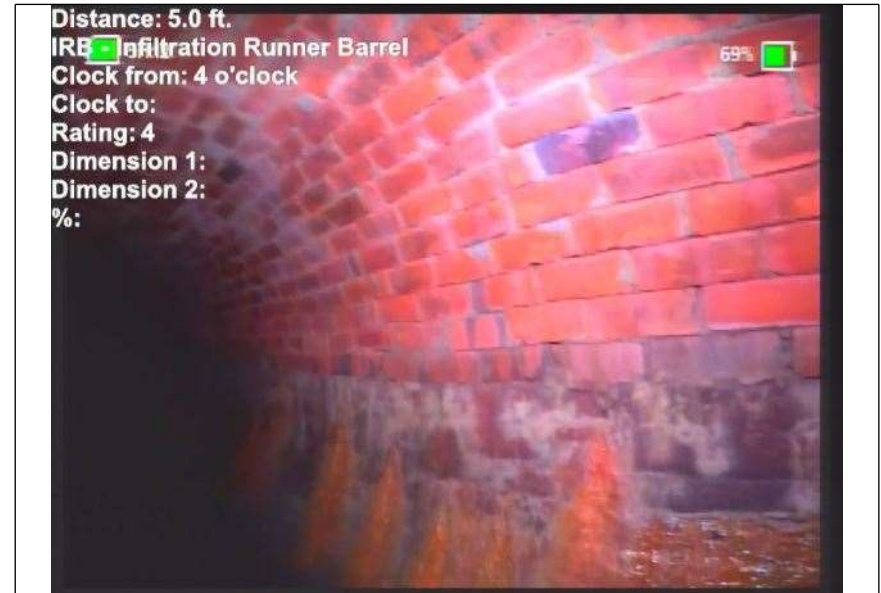
At: 5 ft. 4/. IRB - Infiltration Runner Barrel  
Joint: No

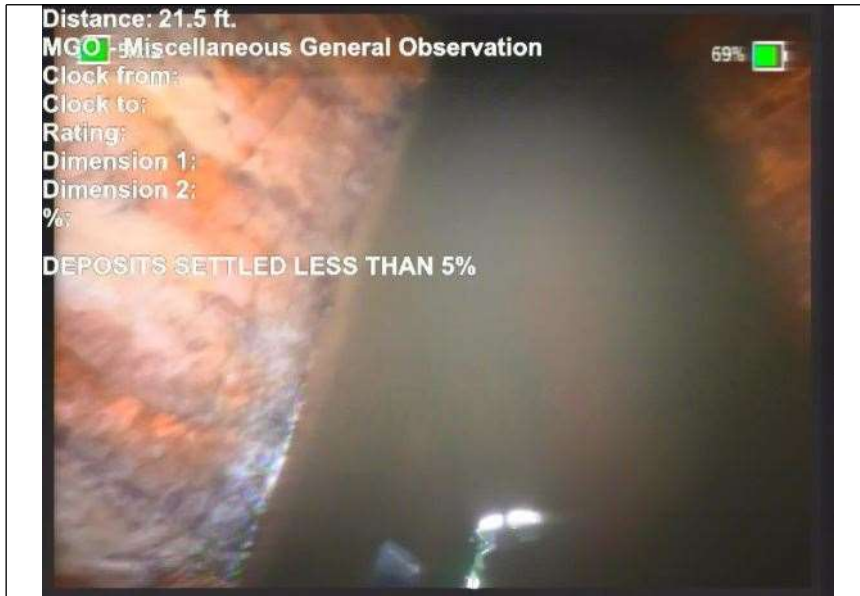
At: 21.5 ft. MGO - Miscellaneous General Observation  
Joint: No DEPOSITS SETTLED LESS THAN 5%

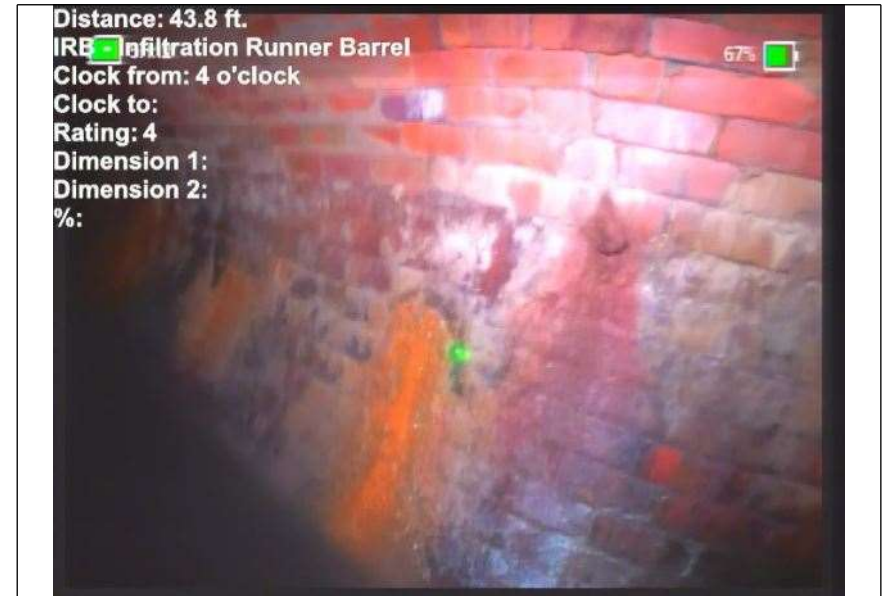
At: 43.8 ft. IRB - Infiltration Runner Barrel  
7999992370  
605 ft. 4/.  
Joint: No

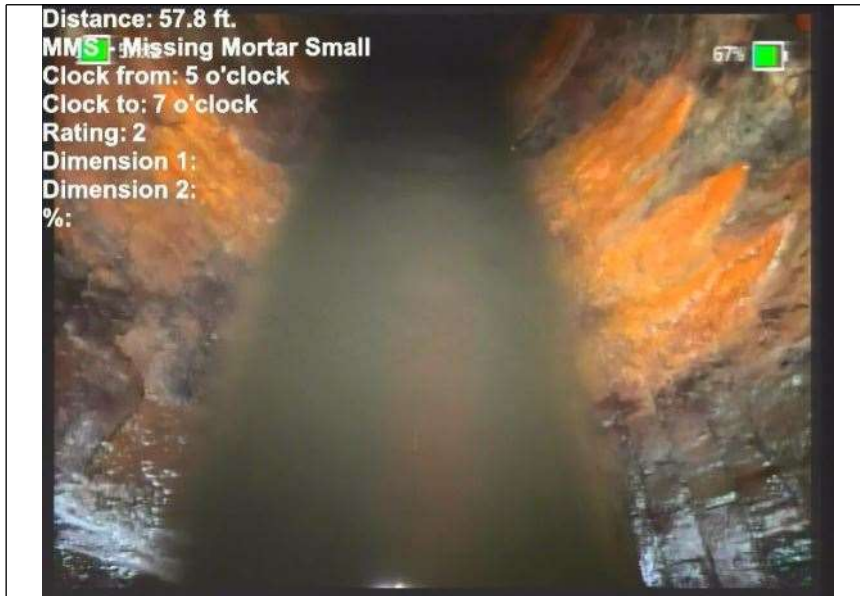
At: 57. MMS - Missing Mortar Small  
7999992370  
605 ft. 5/7

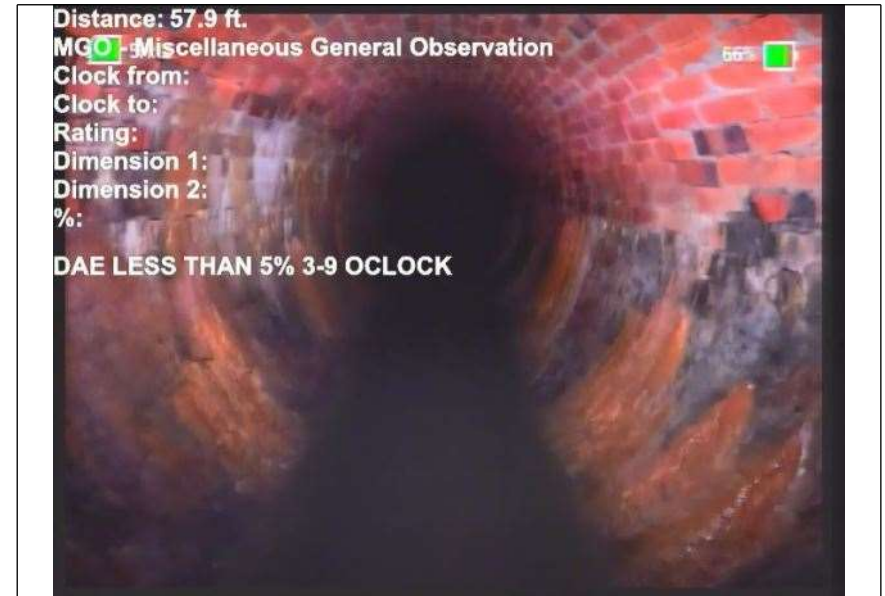
At: 57. MGO - Miscellaneous General Observation  
9000015258  
789 ft.

Joint: No DAE LESS THAN 5% 3-9 OCLOCK

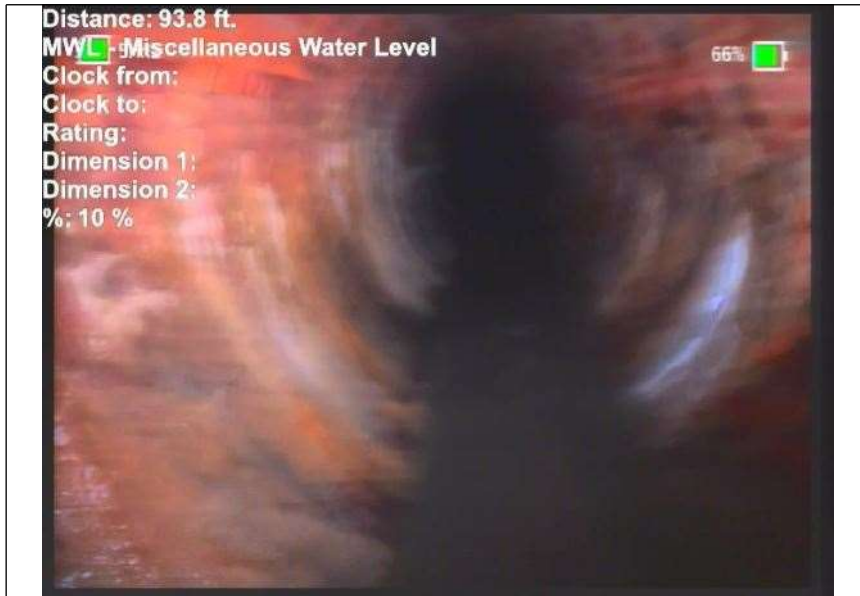
At: 93. MWL - Miscellaneous Water Level  
8000030517  
578 ft.

Joint: No 10 %

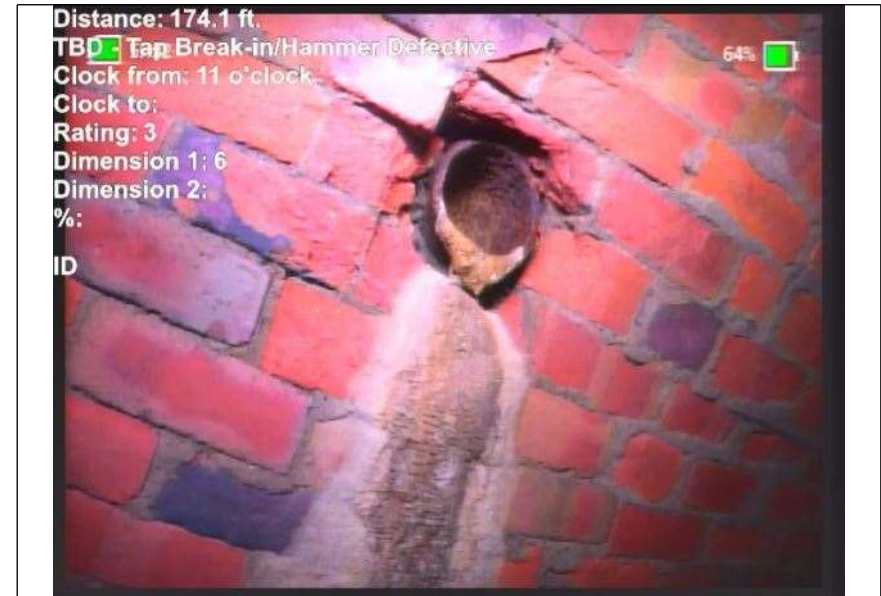
At: 174. TBD - Tap Break-in/Hammer Defective  
1000061035  
16 ft. 11/.

Joint: No ID

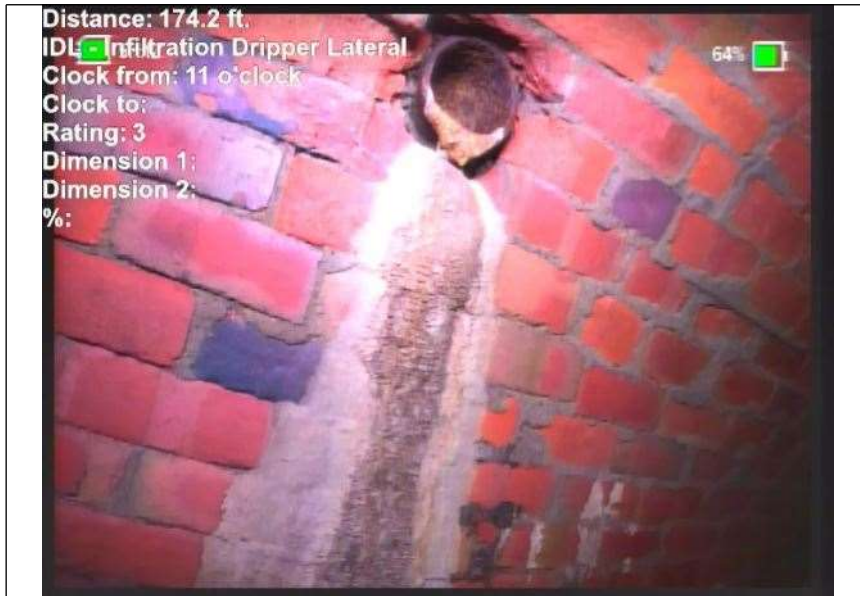
At: 174. IDL - Infiltration Dripper Lateral  
1999969482  
42 ft. 11/.

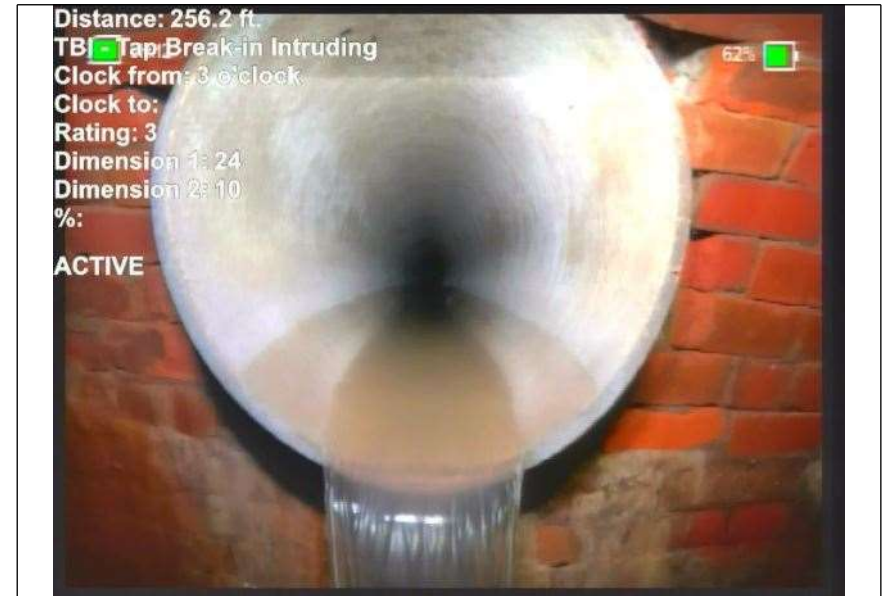
At: 256. TBI - Tap Break-in Intruding  
2000122070  
31 ft. 3/.

Joint: No ACTIVE

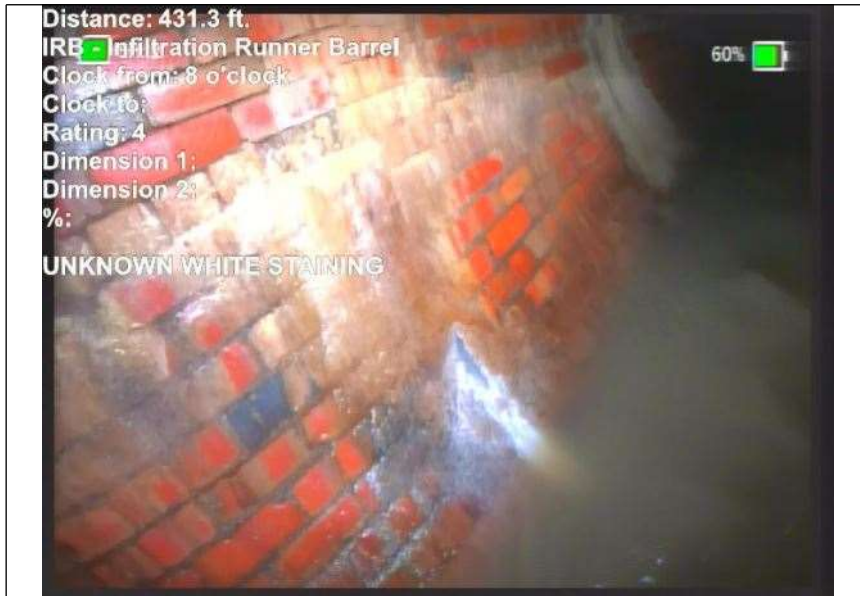
At: 431. IRB - Infiltration Runner Barrel  
2999877929  
69 ft. 8/.

Joint: No UNKNOWN WHITE STAINING

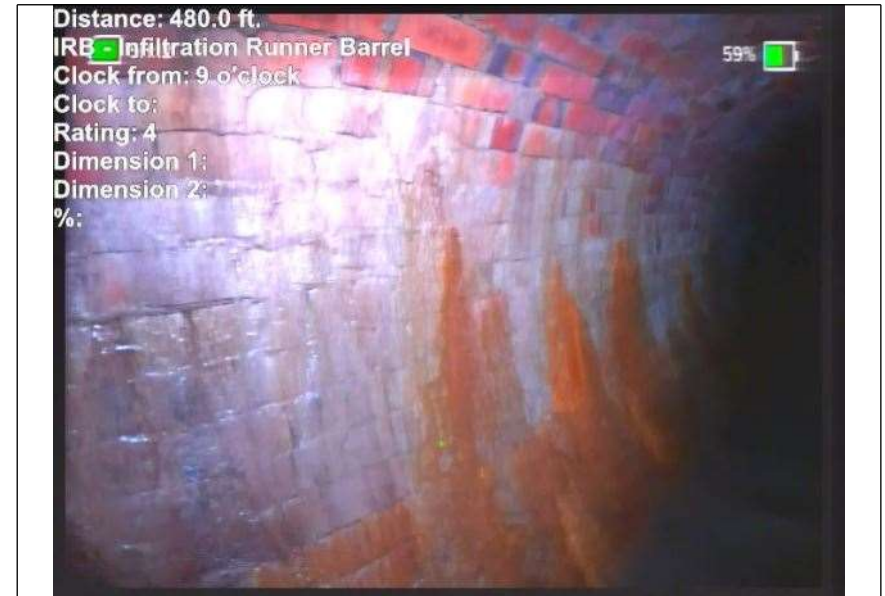
At: 480 ft. 9/. IRB - Infiltration Runner Barrel

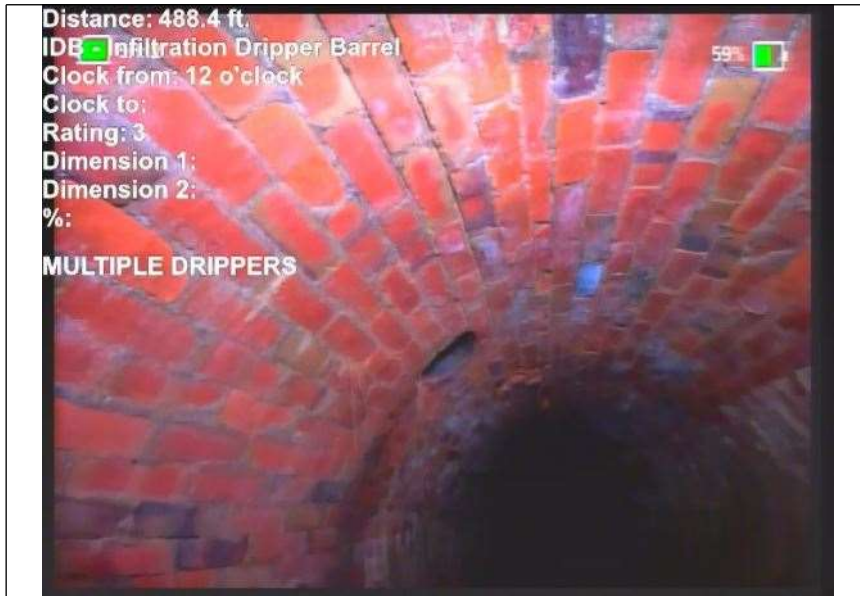
At: 488. IDB - Infiltration Dripper Barrel  
3999938964  
84 ft. 12/.

Joint: No MULTIPLE DRIPPERS

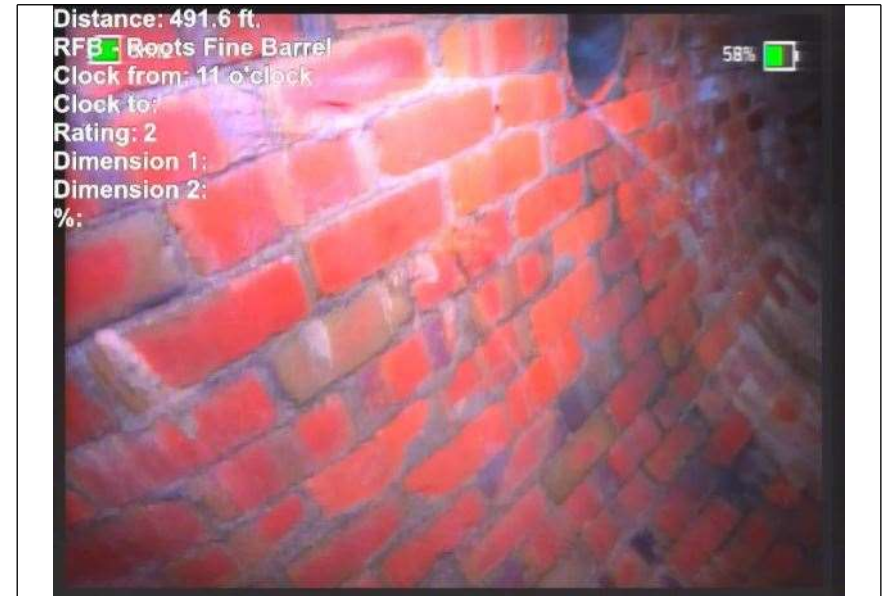
At: 491. RFB - Roots Fine Barrel  
6000061035  
16 ft. 11/.

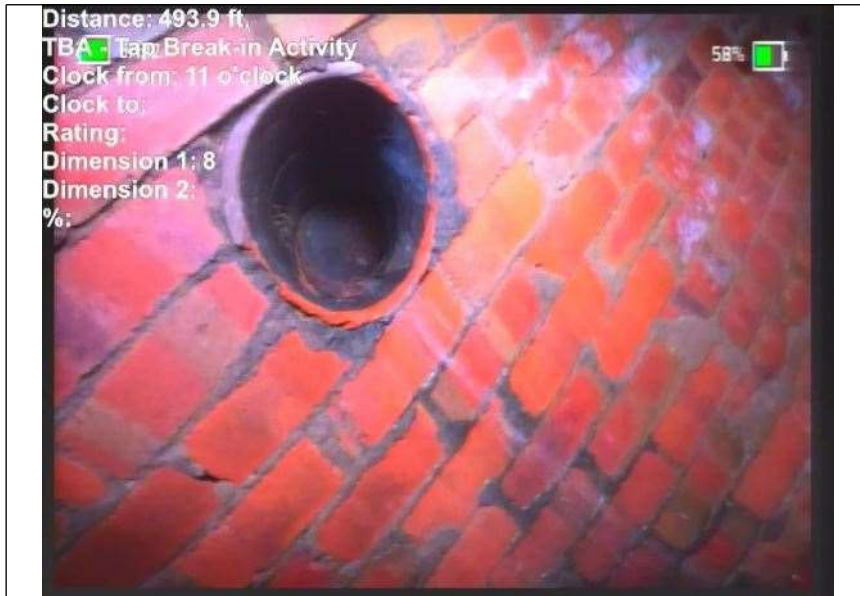
At: 493. TBA - Tap Break-in Activity  
8999938964  
84 ft. 11/.

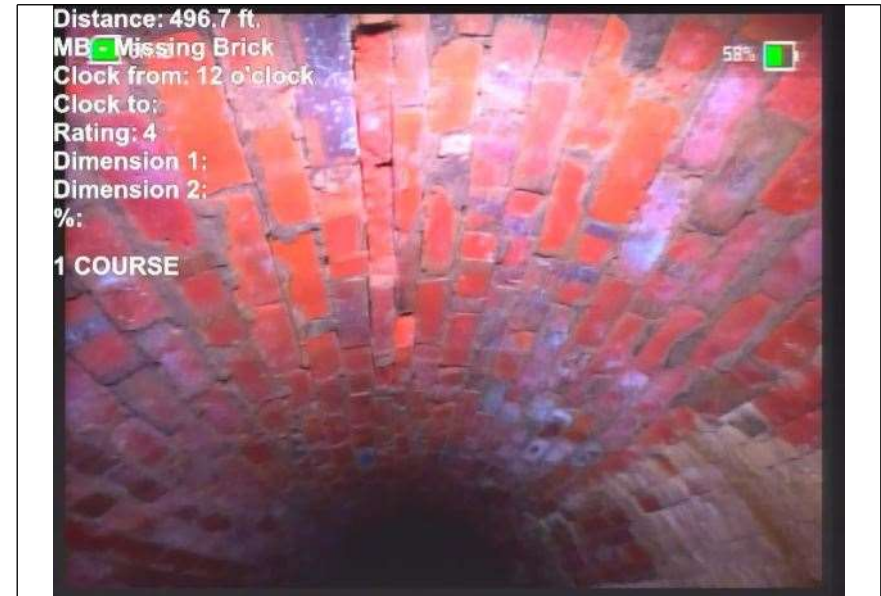
At: 496. MB - Missing Brick  
7000122070  
31 ft. 12/.

Joint: No 1 COURSE

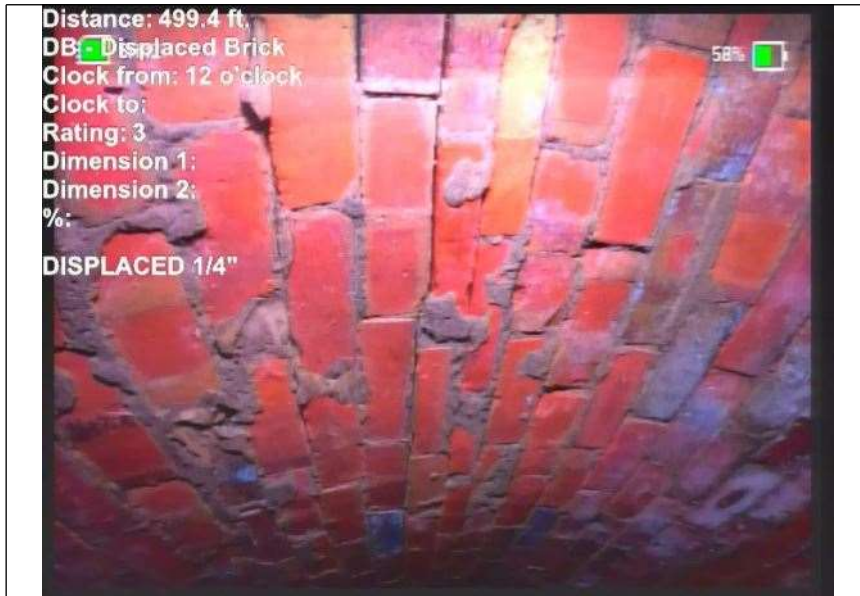
At: 499. DB - Displaced Brick  
3999938964  
84 ft. 12/.

Joint: No **DISPLACED 1/4"**

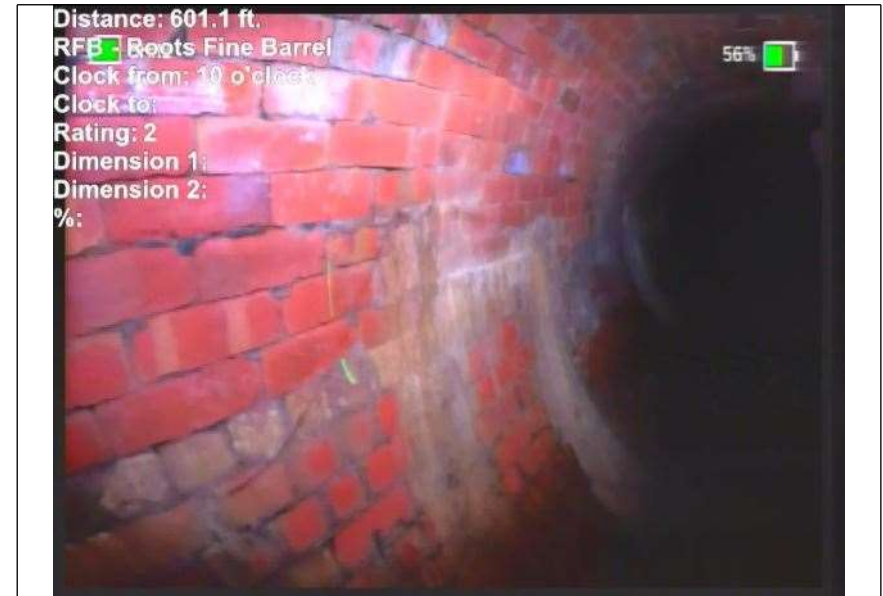
At: 601. RFB - Roots Fine Barrel  
0999755859  
38 ft. 10/.

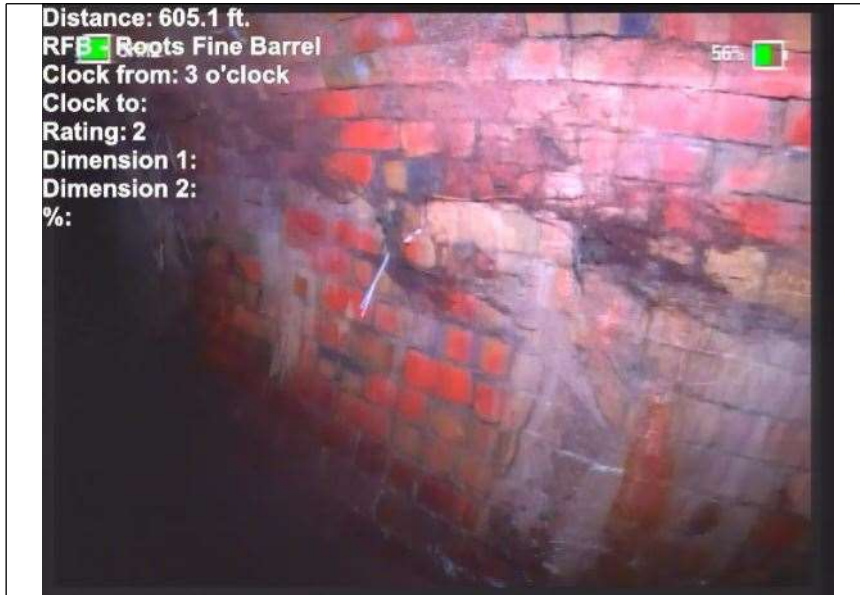
At: 605. RFB - Roots Fine Barrel  
0999755859  
38 ft. 3/.

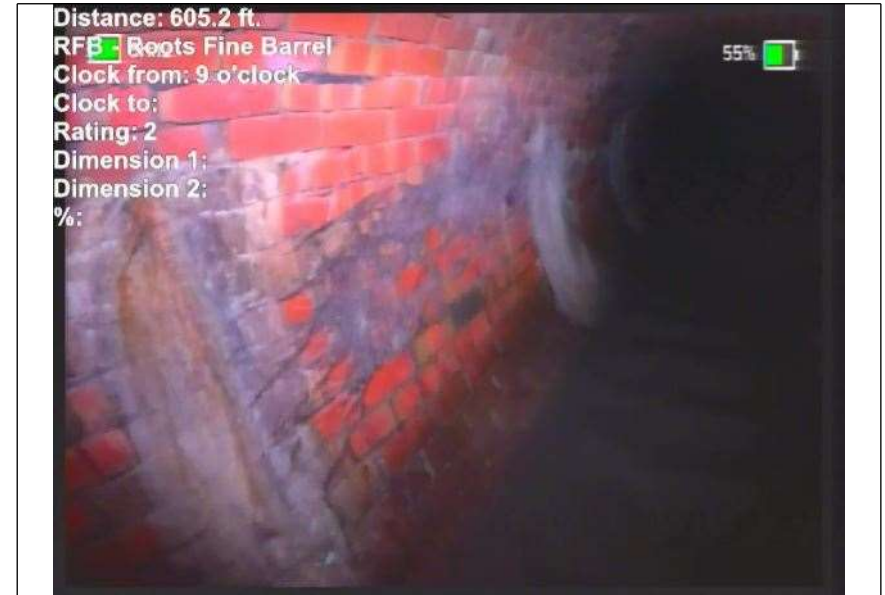
At: 605. RFB - Roots Fine Barrel  
2000122070  
31 ft. 9/.

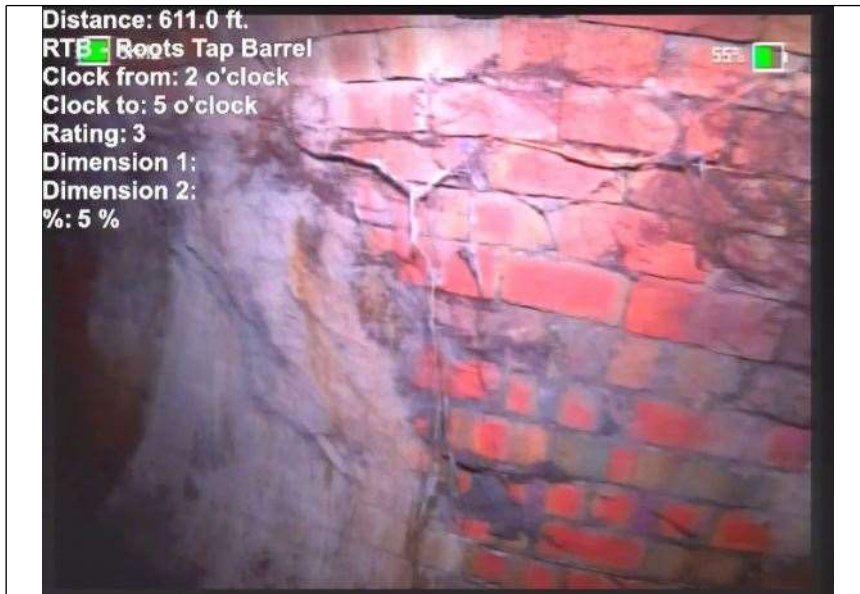
At: 611 ft. 2/5 RTB - Roots Tap Barrel

Joint: No 5 %

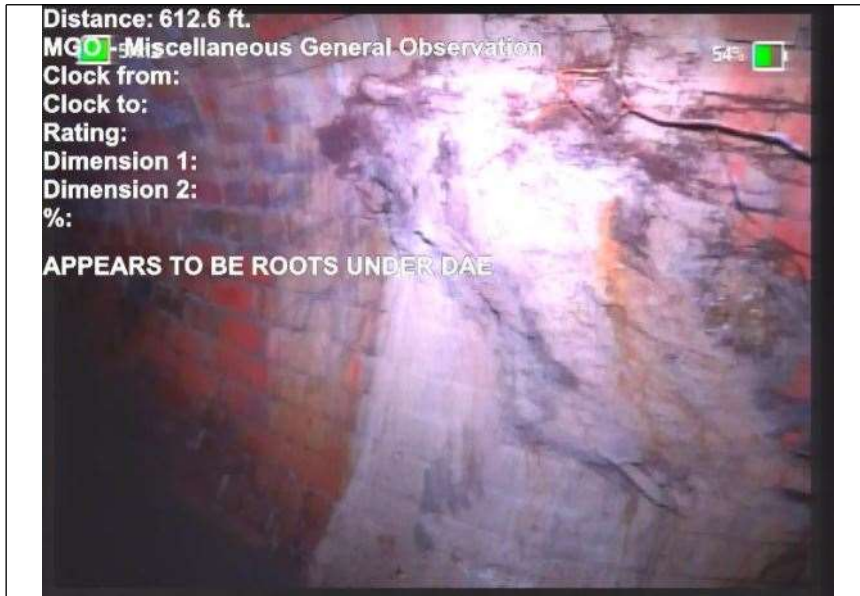
At: 612. MGO - Miscellaneous General Observation  
5999755859  
38 ft.

Joint: No APPEARS TO BE ROOTS UNDER DAE

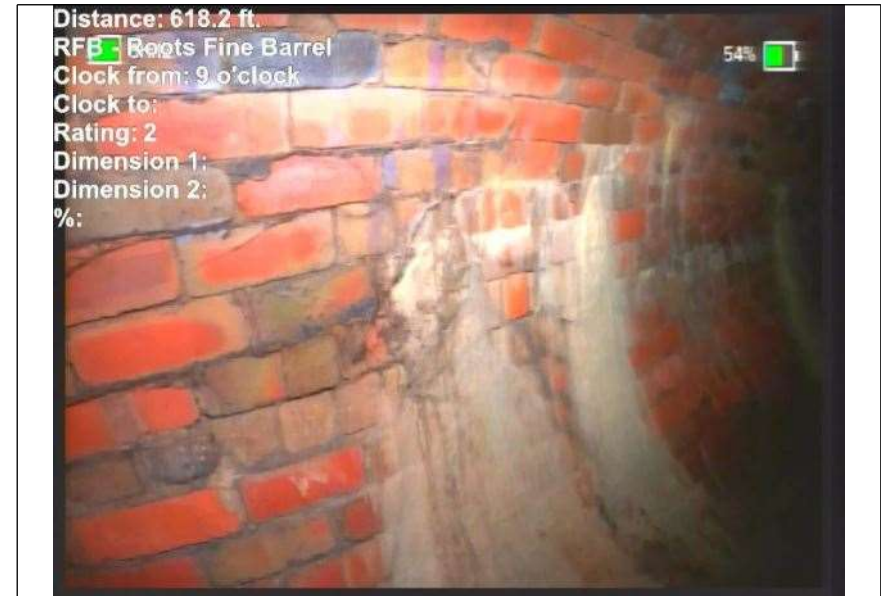
At: 618. RFB - Roots Fine Barrel  
2000122070  
31 ft. 9/.

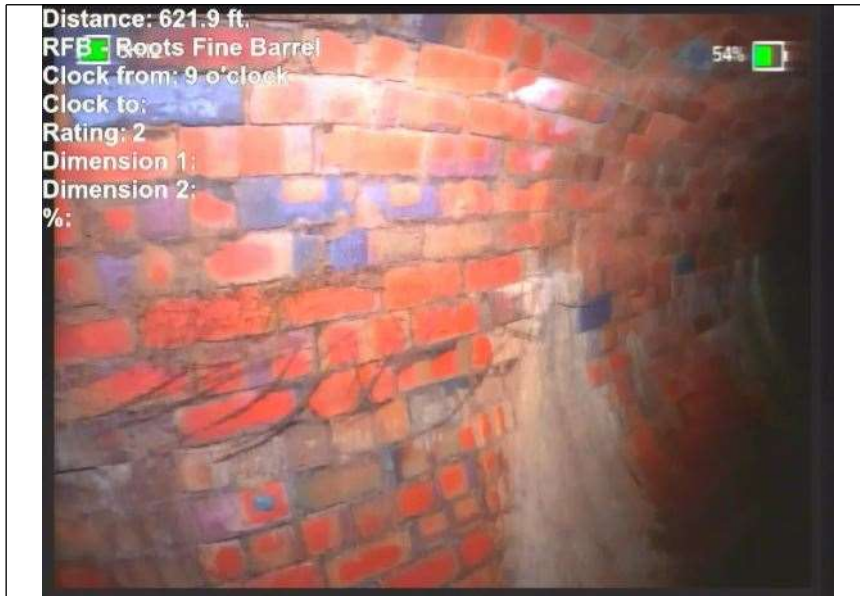
At: 621. 9000244140 RFB - Roots Fine Barrel  
63 ft. 9/.

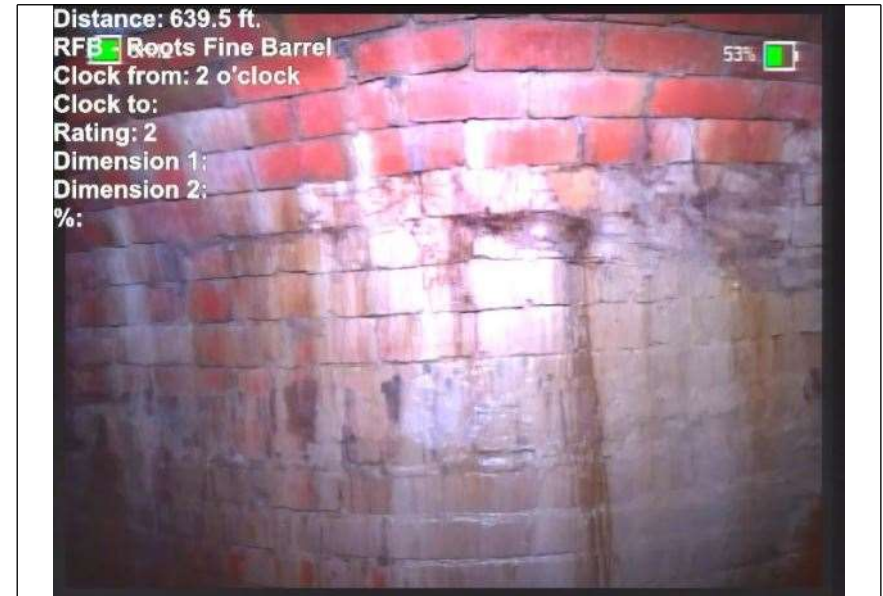
At: 639.5 ft. 2/. RFB - Roots Fine Barrel  
Joint: No

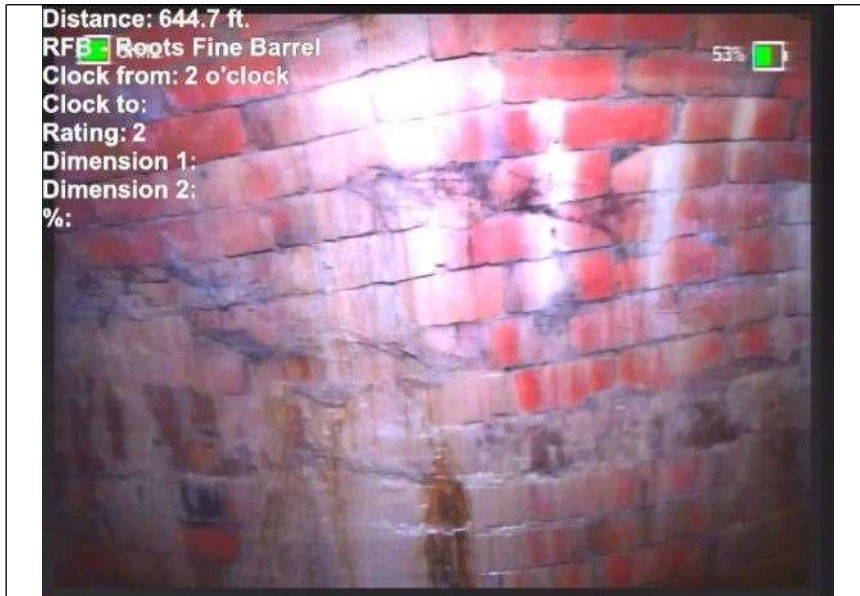
At: 644. RFB - Roots Fine Barrel  
7000122070  
31 ft. 2/.

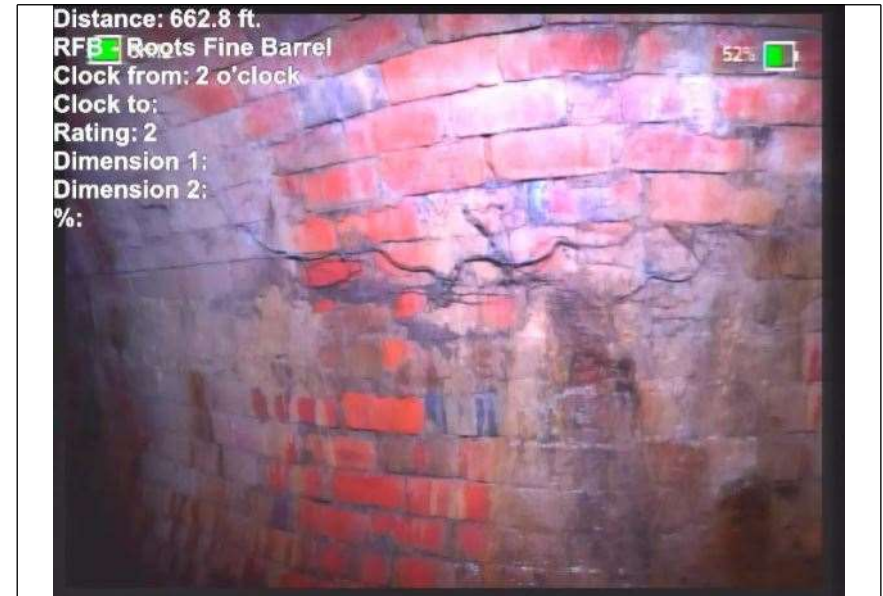
At: 662. RFB - Roots Fine Barrel  
7999877929  
69 ft. 2/.

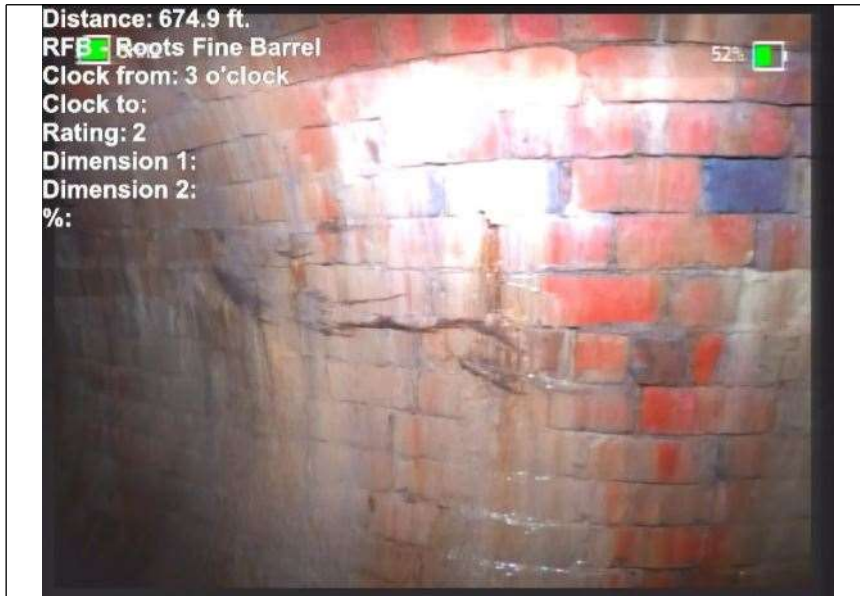
At: 674. RFB - Roots Fine Barrel  
9000244140  
63 ft. 3/.

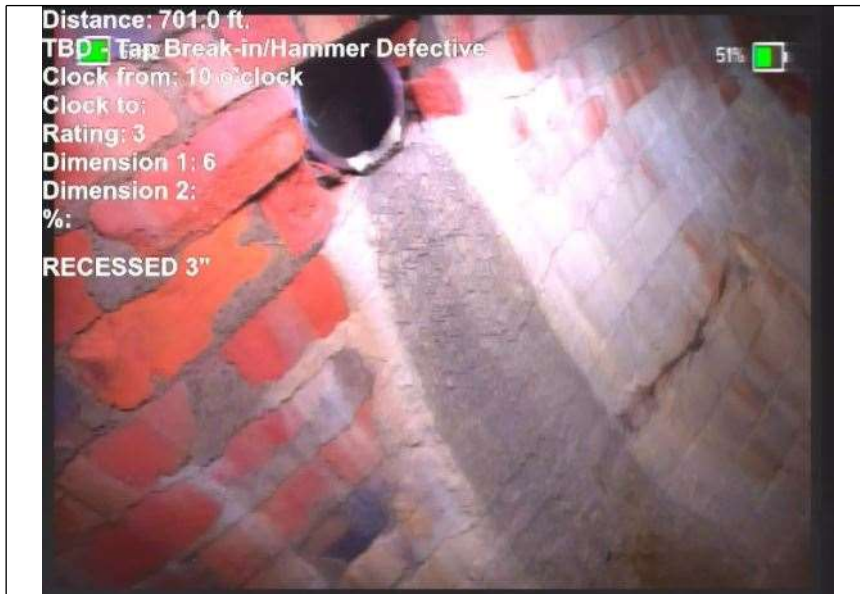
At: 701 ft. 10/. TBD - Tap Break-in/Hammer Defective

Joint: No RECESSED 3"

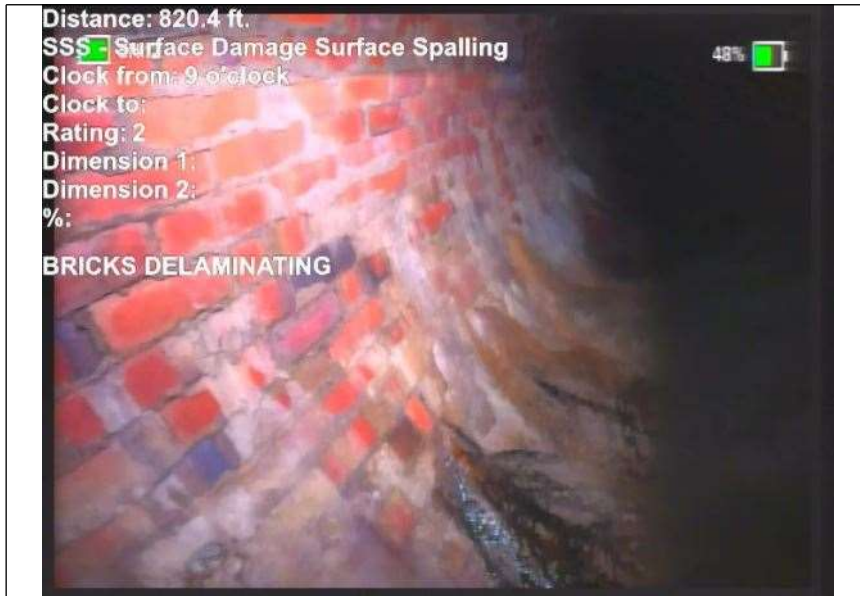
At: 820. 820.4 ft. SSS - Surface Damage Surface Spalling  
4000244140  
63 ft. 9/.

Joint: No BRICKS DELAMINATING

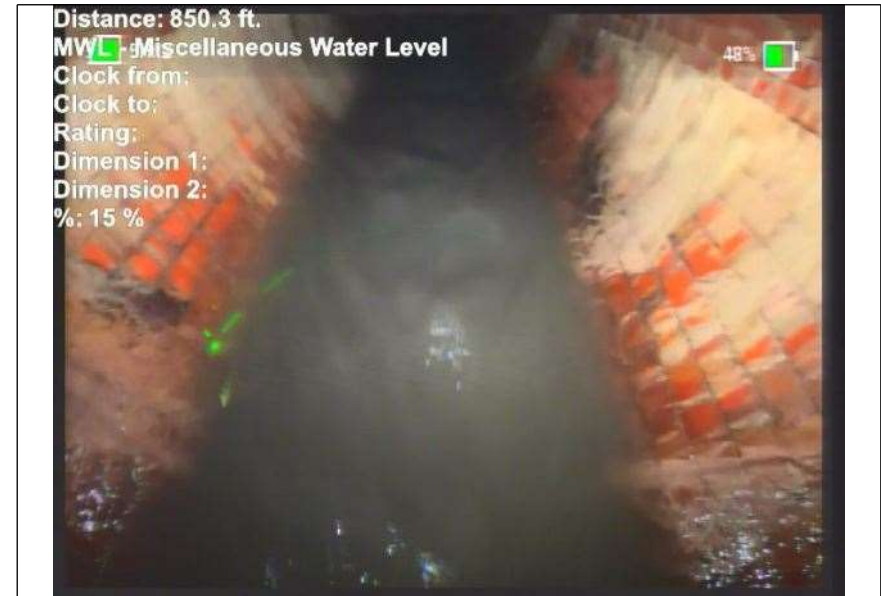
At: 850. 850.3 ft. MWL - Miscellaneous Water Level  
2999877929  
69 ft.

Joint: No 15 %

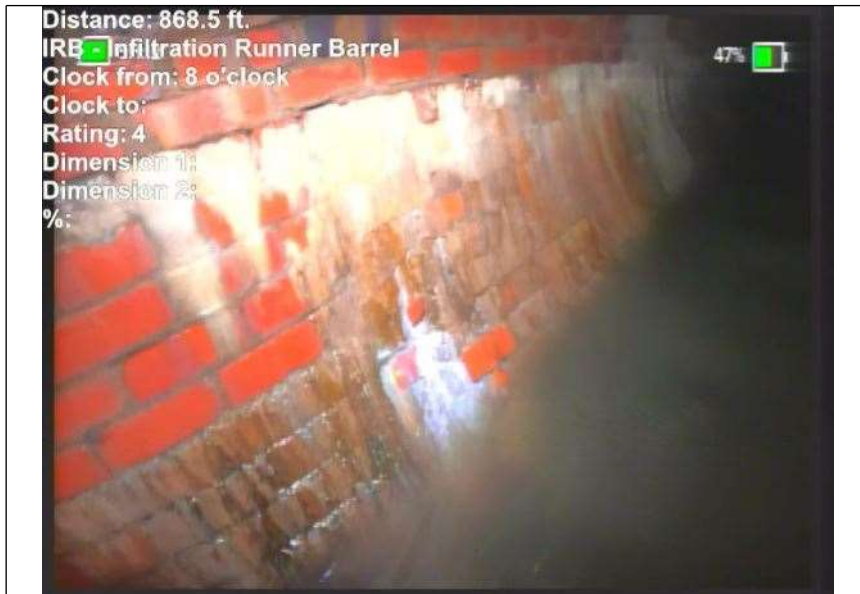
At: 868.5 ft. 8/. IRB - Infiltration Runner Barrel

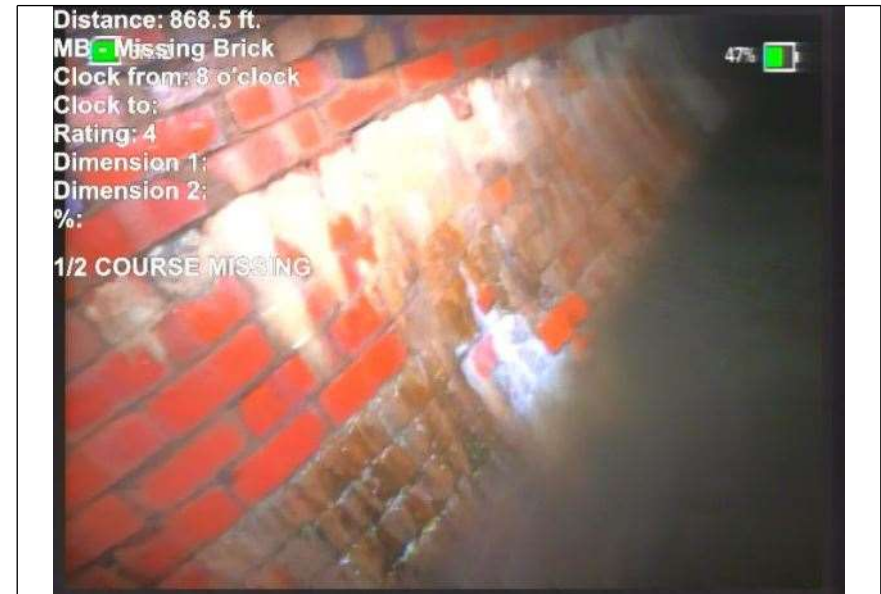
At: 868.5 ft. 8/. MB - Missing Brick

Joint: No 1/2 COURSE MISSING

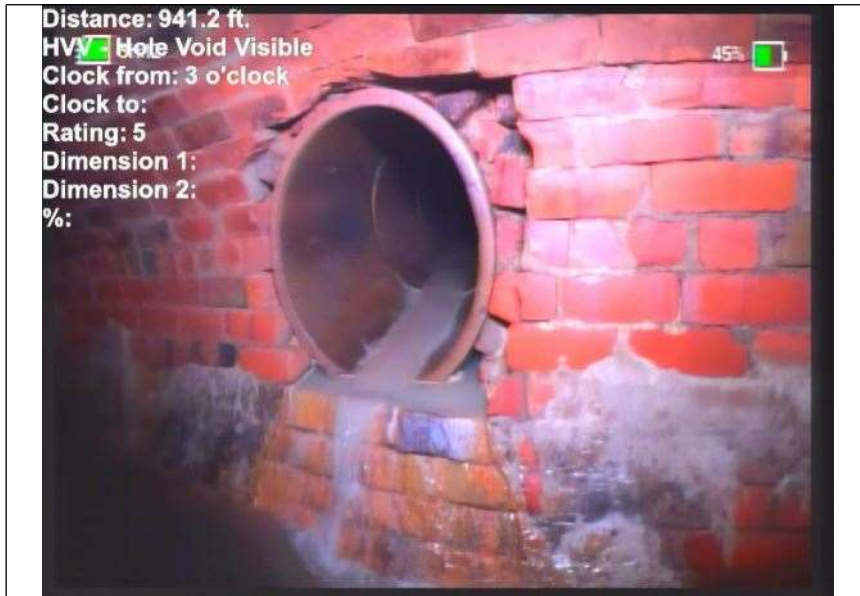
868.5 ft.	00:19:55	MB						<input type="checkbox"/>	8 /		4	ROCK SWALE 72 IN INSPECTION-AMH 'MH7'-AMH 'MH6'-MB at 868.5 ft.JPG	1/2 COURSE MISSING
941.2 ft.	00:21:40	HVV						<input type="checkbox"/>	3 /		5	ROCK SWALE 72 IN INSPECTION-AMH 'MH7'-AMH 'MH6'-HVV at 941.2 ft.JPG

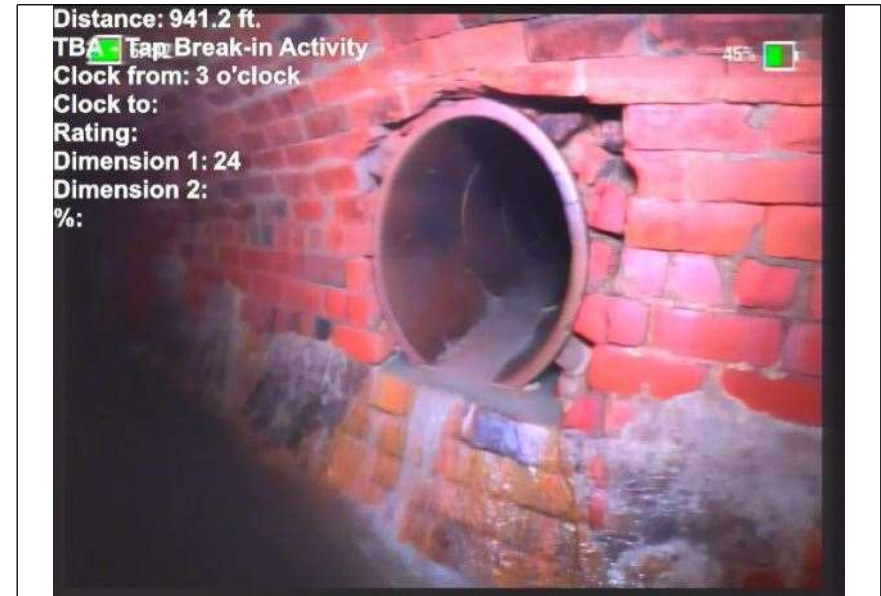
941.2 ft.	00:21:29	TBA			24.000			<input type="checkbox"/>	3 /			ROCK SWALE 72 IN INSPECTION-AMH 'MH7'-AMH 'MH6'-TBA at 941.2 ft.JPG	
1,022.9 ft.	00:23:00	MMS	F01	S				<input type="checkbox"/>	5 / 7		2	ROCK SWALE 72 IN INSPECTION-AMH 'MH7'-AMH 'MH6'-MMS at 1_022.9 ft.JPG

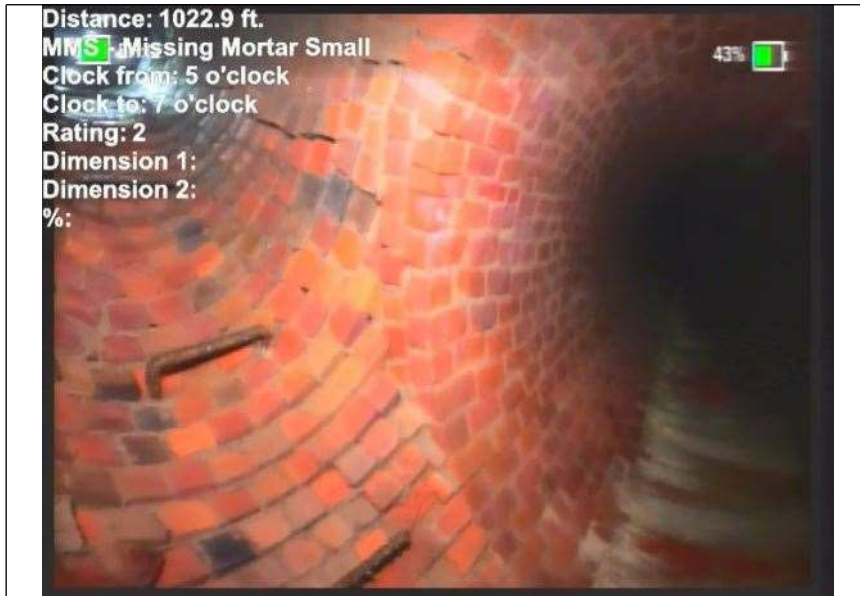
At: 1022. MMS - Missing Mortar Small  
9000244140  
6 ft. 5/7
