PACP Report with Pipe Run and Incident Snapshots

Surveyed by: ANDREW		Certificate number: T-507-4975		Owner: CITY OF MARION		Customer:		Drainage area:		P/O number:		Sheet number:	
Pipe segment ref.: MH8_MH7A				Start date/time: 20240626 11:39		Street: SILVER ST & KENTON AVE.				City: MARION, OH			
Location details:				Upstream MH No: MH8				Rim to invert:		Grade to invert:		Rim to grade:	
Pipe use: CB		Direction: D		Flow control:		Downstream MH No: MH7A				Rim to invert:		Grade to invert:	
Height: 72 in.		Width:		Shape: C		Material: BR		Lining method:		Pipe joint length:		Total length: 207.600 ft.	
Length surveyed: 207.600 ft.		Purpose: B		Sewer category:		Media label:		Pre-cleaning: N		Date cleaned:		Weather: 1	
Project name: ROCK SWALE 72 IN INSPECTION				Additional info:

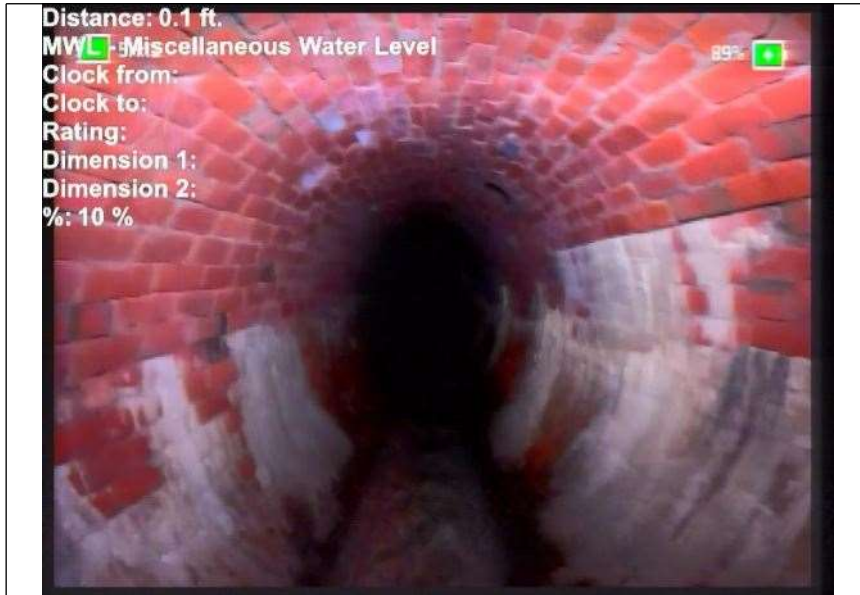
At: 0 ft. MWL - Miscellaneous Water Level
Joint: No 10 %

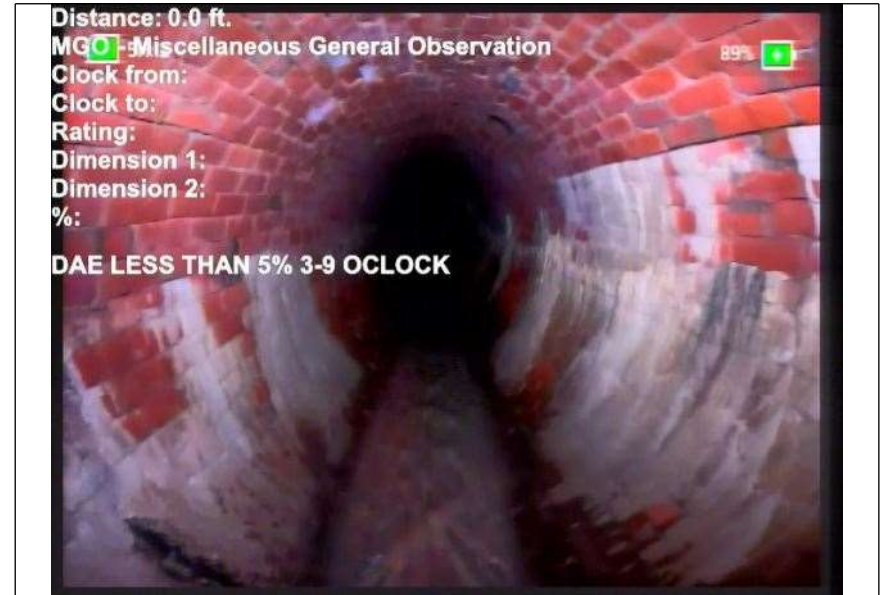
0.0 ft.	00:00:14	MWL					10	<input type="checkbox"/>	/			ROCK SWALE 72 IN INSPECTION-AMH 'MH8'-AMH 'MH7'-MWL at 0.1 ft.JPG	
0.0 ft.	00:00:54	MGO						<input type="checkbox"/>	/			ROCK SWALE 72 IN INSPECTION-AMH 'MH8'-AMH 'MH7'-MGO at 0.0 ft.JPG	DAE LESS THAN 5% 3-9 OCLOCK

At: 0 ft. MGO - Miscellaneous General Observation
Joint: No DAE LESS THAN 5% 3-9 OCLOCK

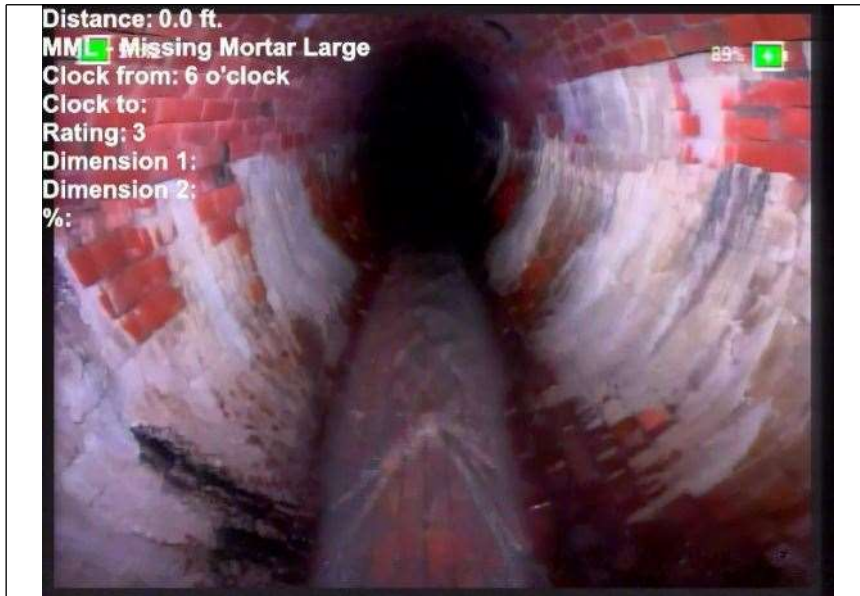
0.0 ft.	00:00:04	AMH						<input type="checkbox"/>	/			ROCK SWALE 72 IN INSPECTION-AMH 'MH8'-AMH 'MH7'-AMH at 0.0 ft.JPG	MH8
0.0 ft.	00:00:35	MML	S01	L				<input type="checkbox"/>	6 /		3	ROCK SWALE 72 IN INSPECTION-AMH 'MH8'-AMH 'MH7'-MML at 0.0 ft.JPG

At: 0 ft. 6/. MML - Missing Mortar Large
Joint: No

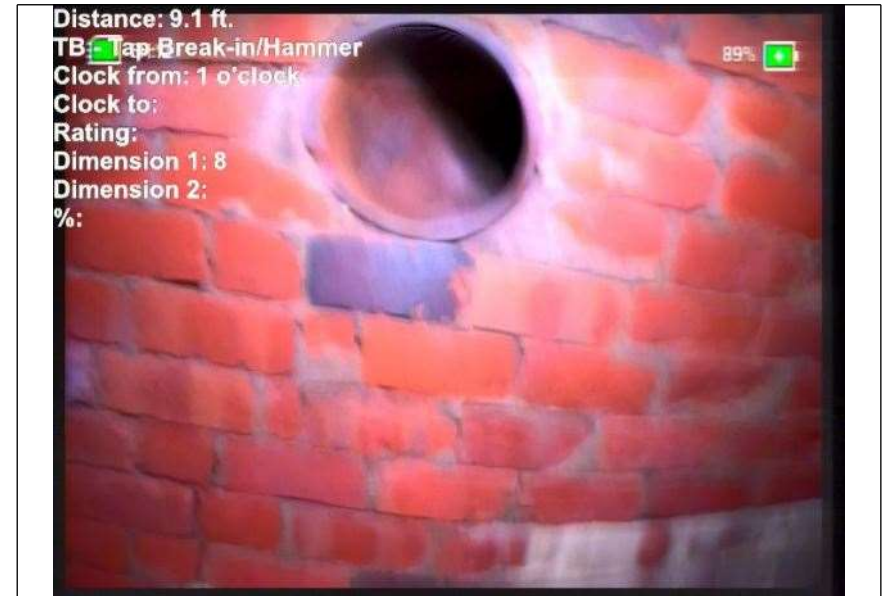
At: 9. TB - Tap Break-in/Hammer
1000003814
6973 ft. 1/.
Joint: No

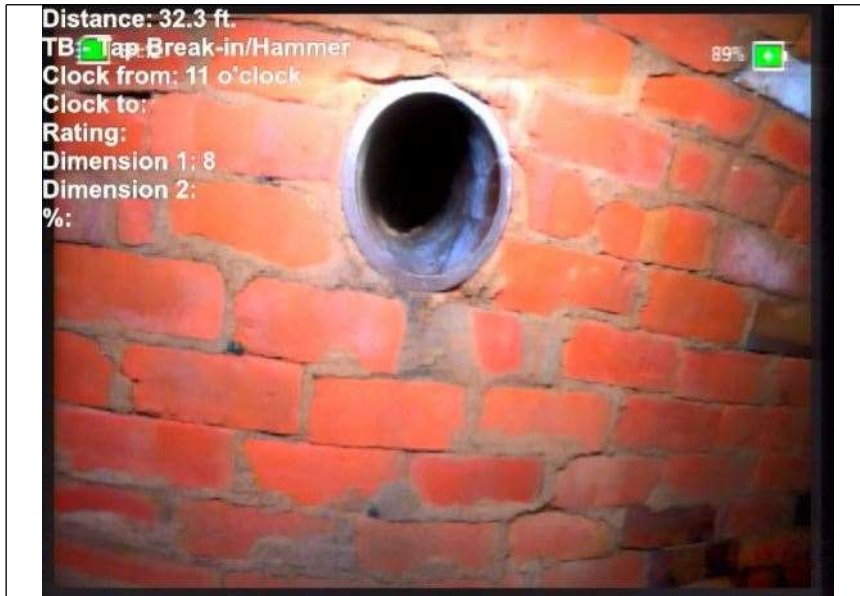
At: 32. TB - Tap Break-in/Hammer
2999992370
605 ft. 11/.
Joint: No

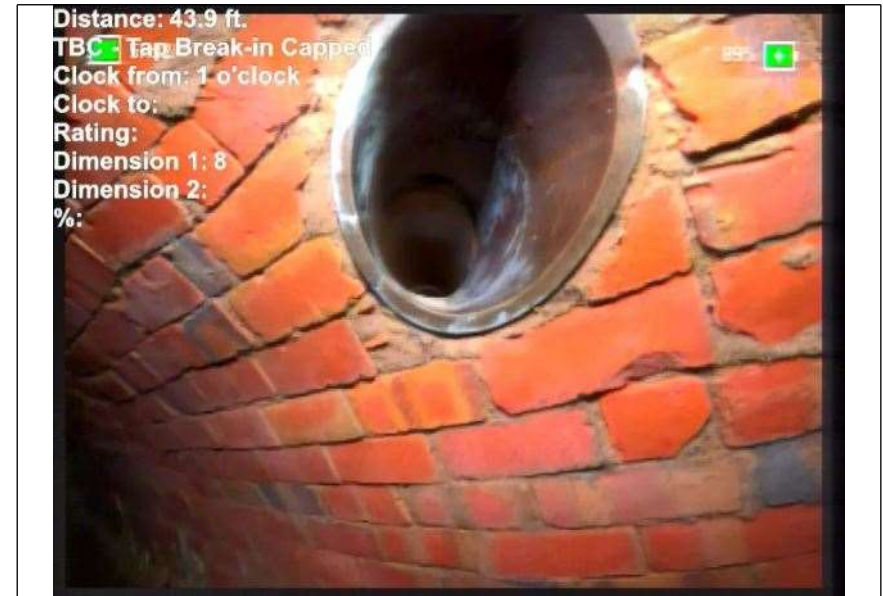
At: 43. TBC - Tap Break-in Capped
9000015258
789 ft. 1/.
Joint: No

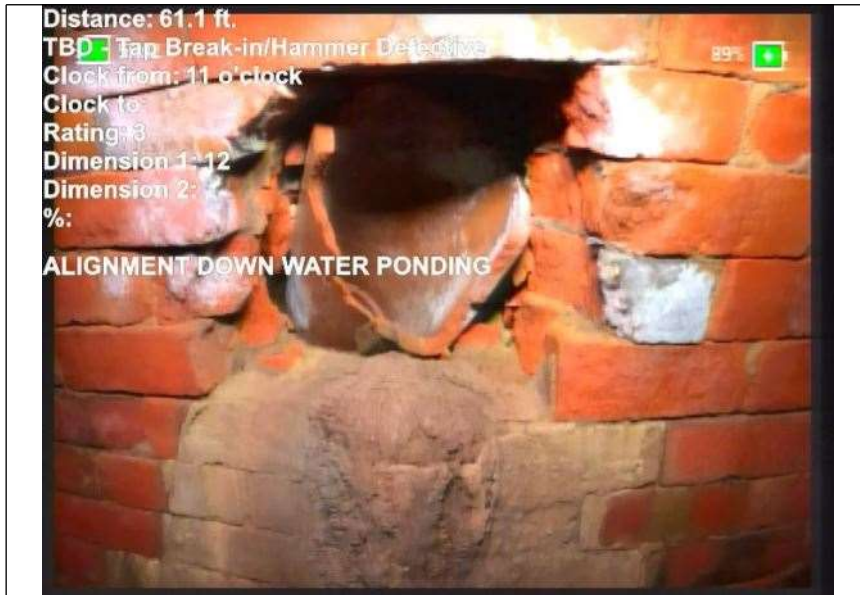
43.9 ft.	00:02:21	TBC				8.000		<input type="checkbox"/>	1 /			ROCK SWALE 72 IN INSPECTION-AMH 'MH8'-AMH 'MH7'-TBC at 43.9 ft.JPG	
61.1 ft.	00:03:02	TBD				12.000		<input type="checkbox"/>	11 /		3	ROCK SWALE 72 IN INSPECTION-AMH 'MH8'-AMH 'MH7'-TBD at 61.1 ft.JPG	ALIGNMENT DOWN WATER PONDING

At: 61. TBD - Tap Break-in/Hammer Defective
0999984741
211 ft. 11/.
Joint: No ALIGNMENT DOWN WATER PONDING

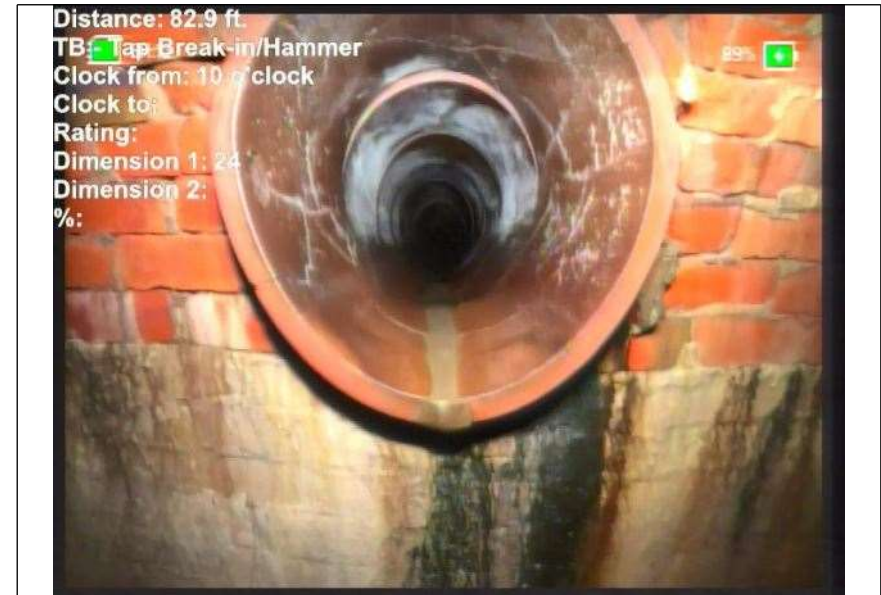
At: 82. TB - Tap Break-in/Hammer
9000015258
789 ft. 10/.
Joint: No

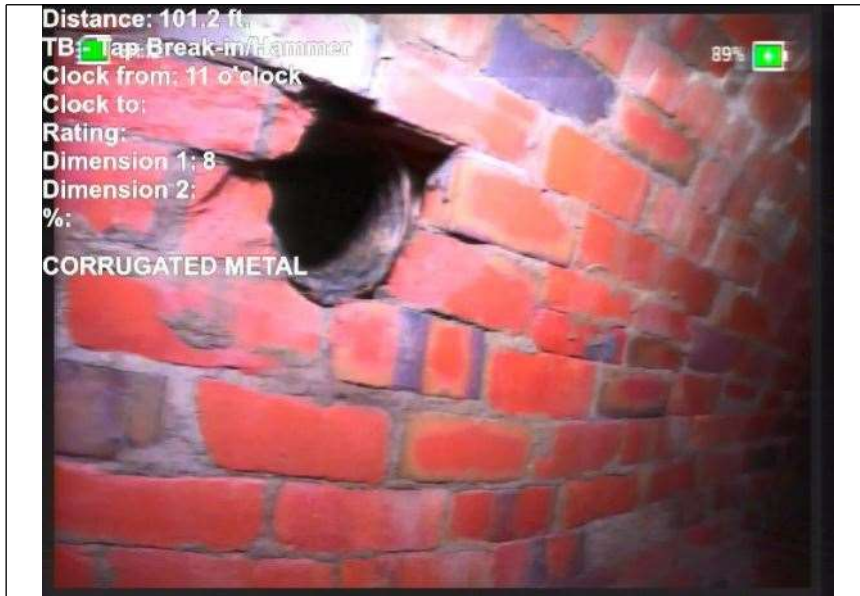
At: 101. 1999969482
42 ft. 11/.

Joint: No CORRUGATED METAL

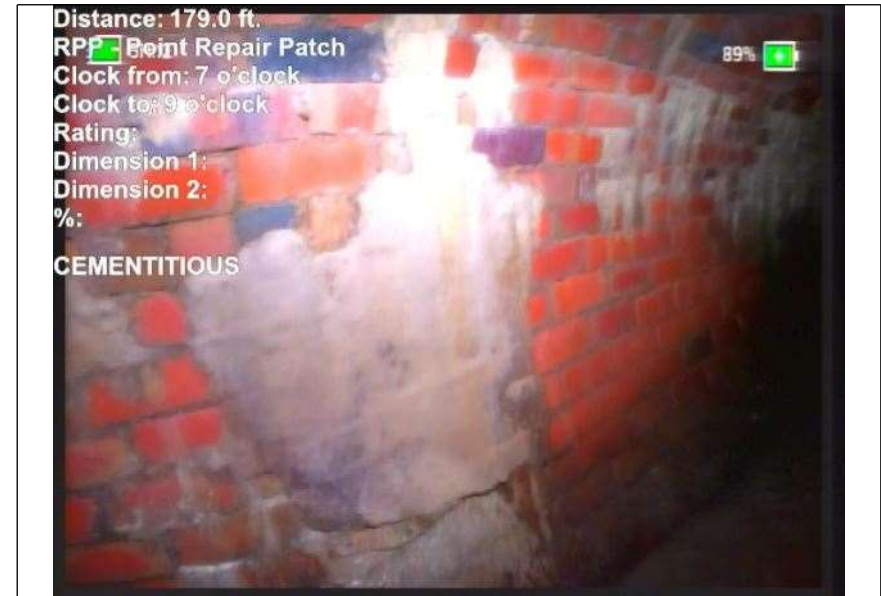
At: 179 ft. 7/9
Joint: No

RPP - Point Repair Patch
CEMENTITIOUS
