PACP Report with Pipe Run and Incident Snapshots

Surveyed by: ANDREW		Certificate number: T-507-4975		Owner: CITY OF MARION		Customer:		Drainage area:		P/O number:		Sheet number:							
Pipe segment ref.: MH10_MH9				Start date/time: 20240626 08:39		Street: 876 SILVER ST.				City: MARION, OH									
Location details:				Upstream MH No: MH10				Rim to invert:		Grade to invert:		Rim to grade:							
Pipe use: CB		Direction: U		Flow control:		Downstream MH No: MH9				Rim to invert:		Grade to invert:		Rim to grade:					
Height: 66 in.		Width:		Shape: C		Material: BR		Lining method:		Pipe joint length:		Total length: 785.200 ft.		Length surveyed: 785.200 ft.		Purpose: B		Sewer category:	
Media label:				Pre-cleaning: N		Date cleaned:		Weather: 1		Location code: C		Pressure value:							
Project name: ROCK SWALE 72 IN INSPECTION				Additional info:

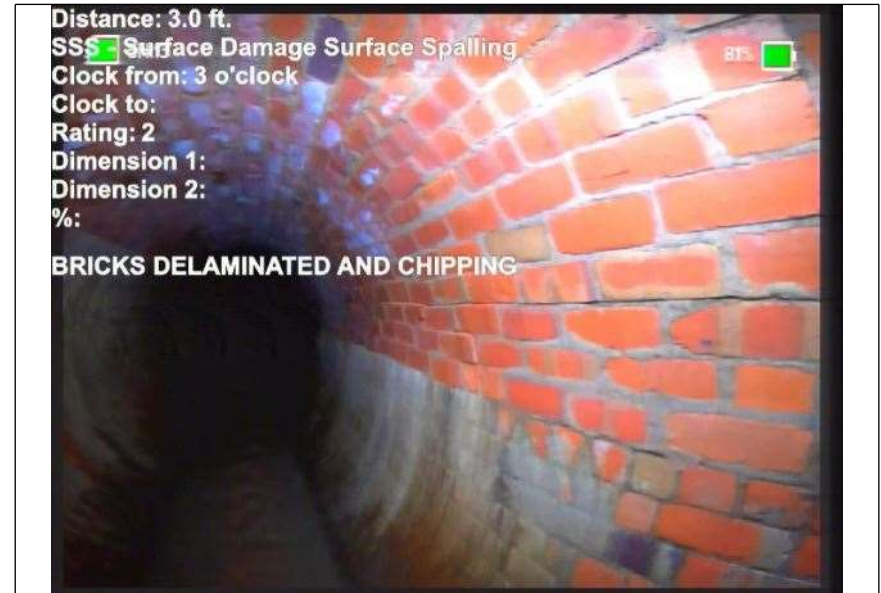
3.0 ft.	00:03:01	SSS						<input type="checkbox"/>	3 /	2		ROCK SWALE 72 IN INSPECTION-AMH 'MH10'-AMH 'MH9'-SSS at 3.0 ft.JPG	BRICKS DELAMINATED AND CHIPPING

Distance: 3.0 ft.
SSS - Surface Damage Surface Spalling
Clock from: 3 o'clock
Clock to:
Rating: 2
Dimension 1:
Dimension 2:
%:
BRICKS DELAMINATED AND CHIPPING

At: 3 ft. 3/. SSS - Surface Damage Surface Spalling
Joint: No BRICKS DELAMINATED AND CHIPPING

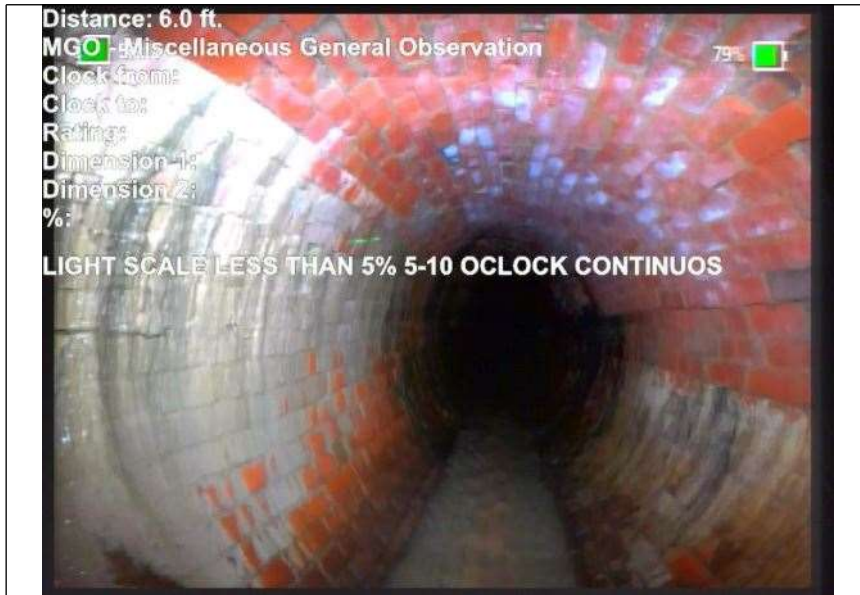
6.0 ft.	00:04:50	MGO						<input type="checkbox"/>	/			ROCK SWALE 72 IN INSPECTION-AMH 'MH10'-AMH 'MH9'-MGO at 6.0 ft.JPG	LIGHT SCALE LESS THAN 5% 5-10 OCLOCK CONTINUOUS

At: 6 ft. MGO - Miscellaneous General Observation
Joint: No LIGHT SCALE LESS THAN 5% 5-10 OCLOCK CONTINUOUS

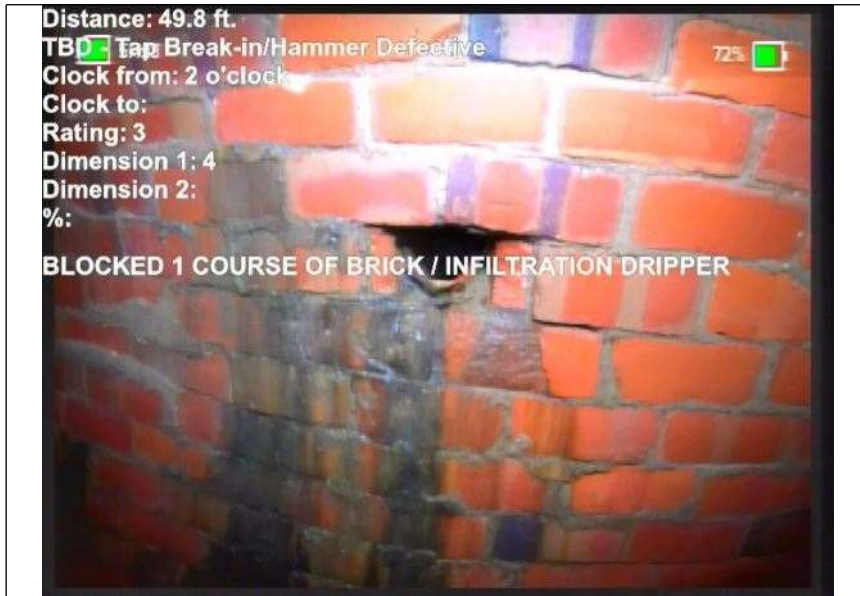
49.8 ft.	00:11:05	TBD			4.000			<input type="checkbox"/>	2 /		3	ROCK SWALE 72 IN INSPECTION-AMH 'MH10'-AMH 'MH9'-TBD at 49.8 ft.JPG	BLOCKED 1 COURSE OF BRICK / INFILTRATION DRIPPER

At: 49. 7999992370 TBD - Tap Break-in/Hammer Defective
605 ft. 2/.
Joint: No **BLOCKED 1 COURSE OF BRICK / INFILTRATION DRIPPER**

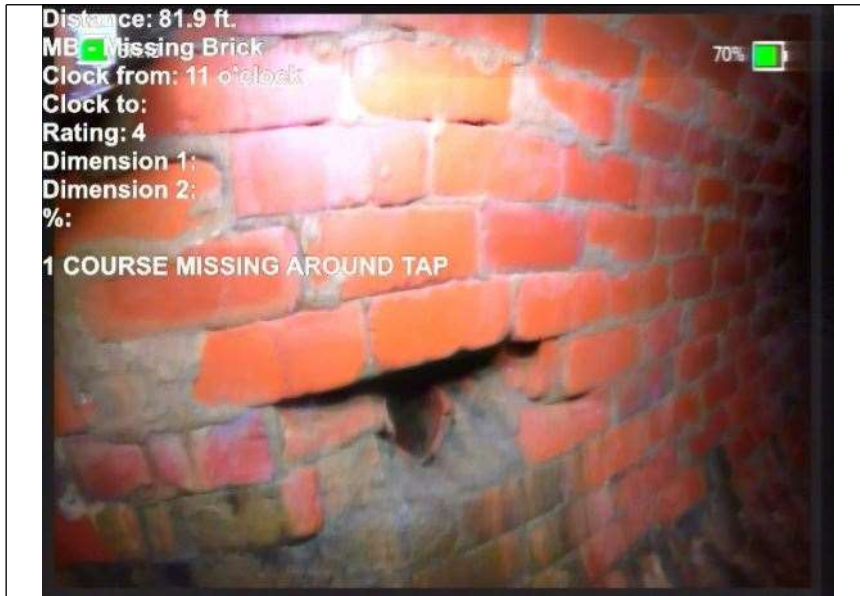
At: 81. 9000015258 MB - Missing Brick
789 ft. 11/.
Joint: No 1 COURSE MISSING AROUND TAP

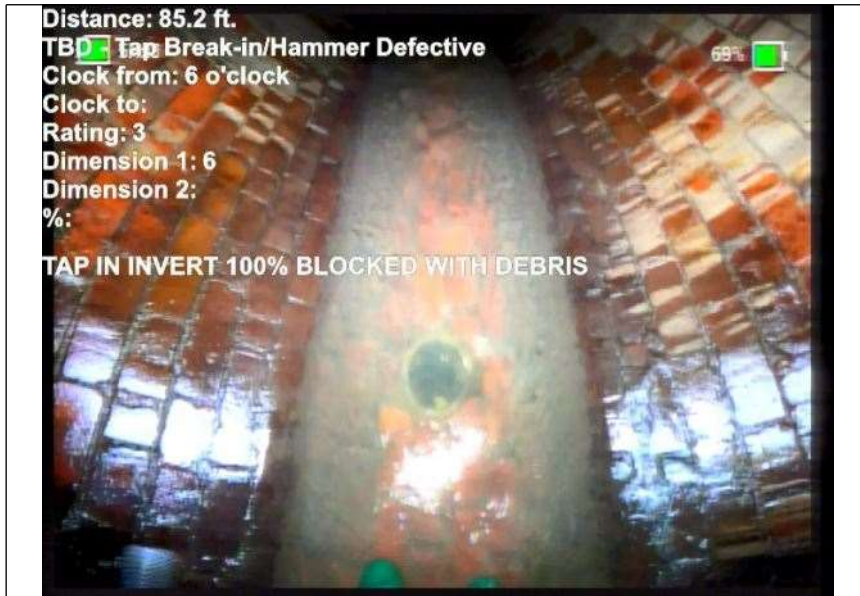
At: 85. TBD - Tap Break-in/Hammer Defective
1999969482
422 ft. 6/.

Joint: No TAP IN INVERT 100% BLOCKED WITH DEBRIS

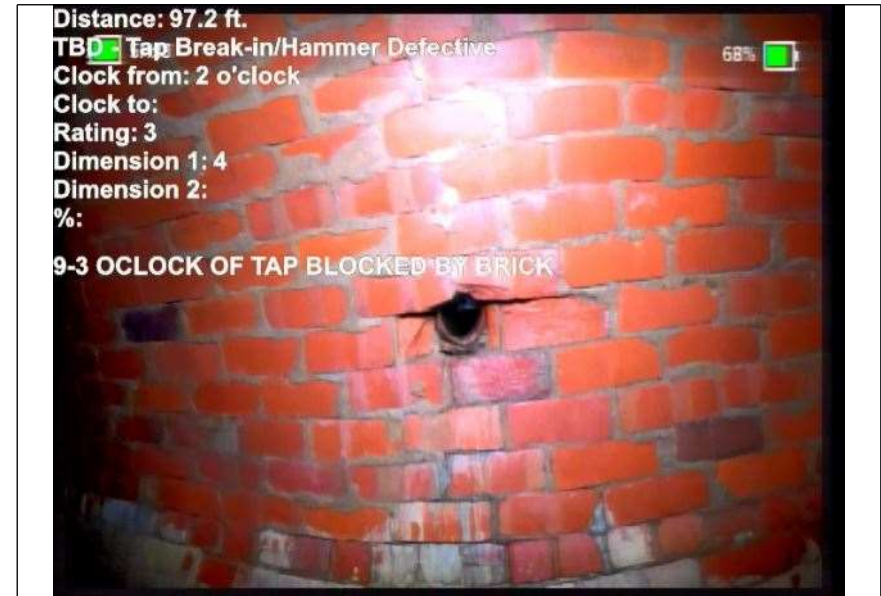
97.2 ft.	00:15:51	TBD			4.000			<input type="checkbox"/>	2 /		3	ROCK SWALE 72 IN INSPECTION-AMH 'MH10'-AMH 'MH9'-TBD at 97.2 ft.JPG	9-3 OCLOCK OF TAP BLOCKED BY BRICK

At: 97. TBD - Tap Break-in/Hammer Defective
1999969482
422 ft. 2/.

Joint: No 9-3 OCLOCK OF TAP BLOCKED BY BRICK

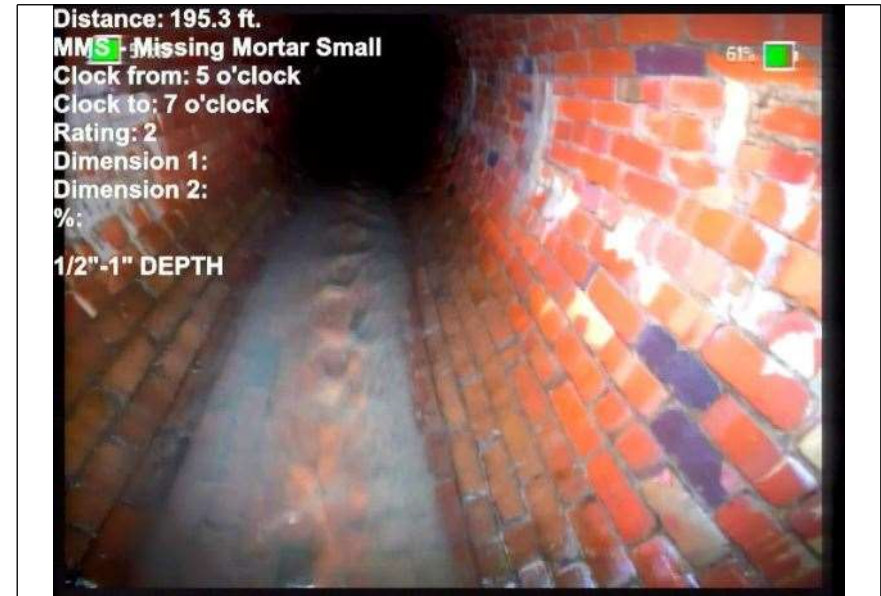
At: 195. MMS - Missing Mortar Small
3000030517
58 ft. 5/7

Joint: No 1/2"-1" DEPTH

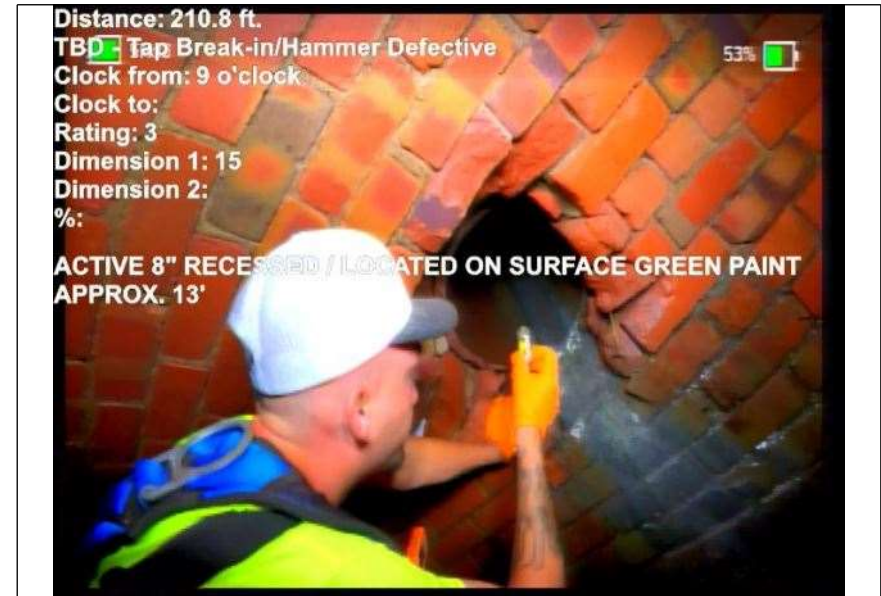
At: 210. TBD - Tap Break-in/Hammer Defective
8000030517
58 ft. 9/.

Joint: No ACTIVE 8" RECESSED / LOCATED ON SURFACE GREEN PAINT APPROX. 13'

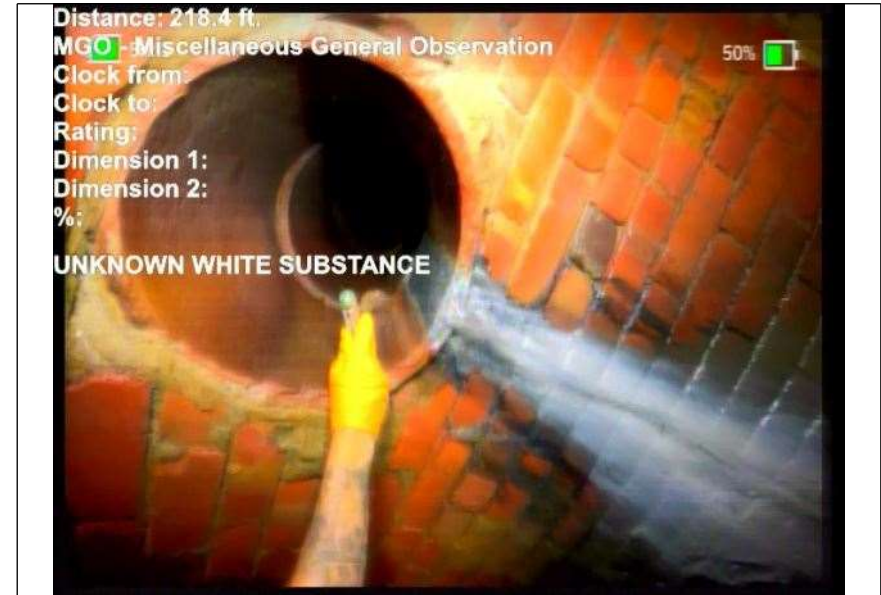
At: 218. MGO - Miscellaneous General Observation
3999938964
84 ft.

Joint: No UNKNOWN WHITE SUBSTANCE

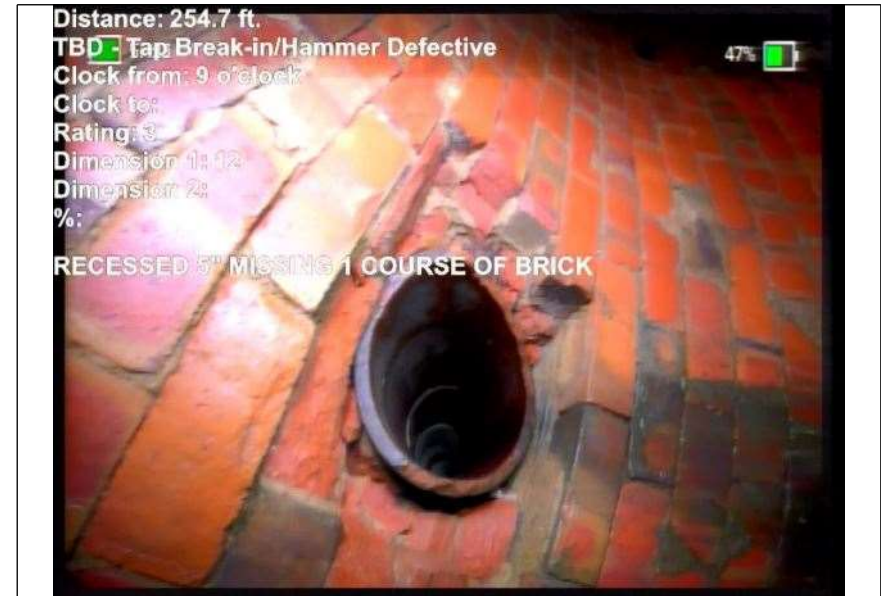
254.7 ft.	00:30:18	TBD			12.000			<input type="checkbox"/>	9 /	3		ROCK SWALE 72 IN INSPECTION-AMH 'MH10'-AMH 'MH9'-TBD at 254.7 ft_1.JPG	RECESSED 5" MISSING 1 COURSE OF BRICK

At: 254. TBD - Tap Break-in/Hammer Defective
6999969482
42 ft. 9/.

Joint: No RECESSED 5" MISSING 1 COURSE OF BRICK

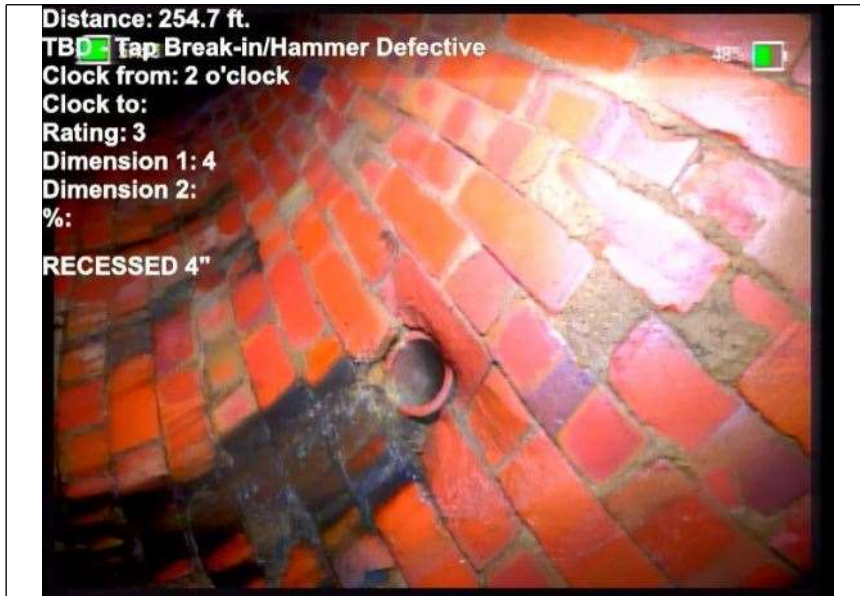
At: 254. TBD - Tap Break-in/Hammer Defective
6999969482
42 ft. 2/.

Joint: No RECESSED 4"

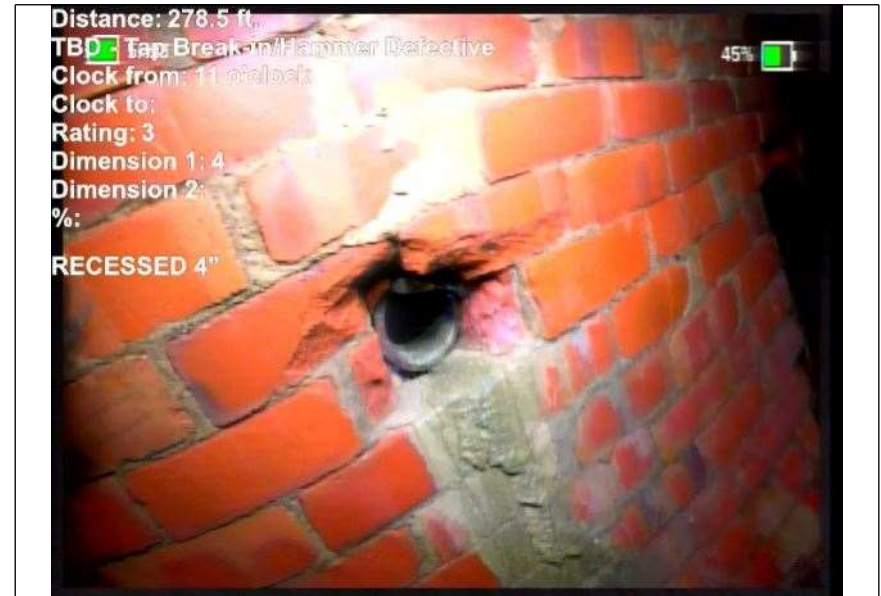
278.5 ft.	00:32:22	TBD			4.000			<input type="checkbox"/>	11 /	3		ROCK SWALE 72 IN INSPECTION-AMH 'MH10'-AMH 'MH9'-TBD at 278.5 ft.JPG	RECESSED 4"

At: 278.5 ft. 11/. TBD - Tap Break-in/Hammer Defective
Joint: No RECESSED 4"

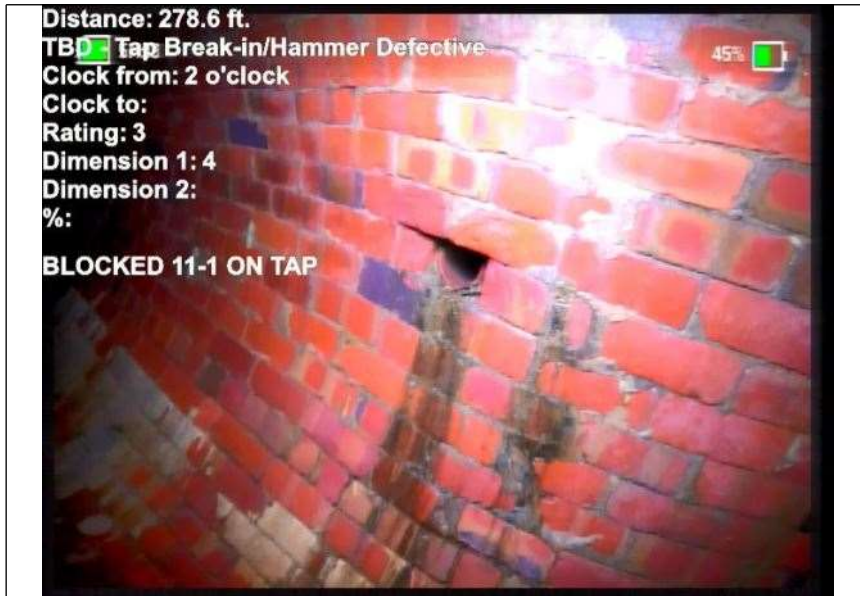
278.6 ft.	00:32:51	TBD			4.000			<input type="checkbox"/>	2 /		3	ROCK SWALE 72 IN INSPECTION-AMH 'MH10'-AMH 'MH9'-TBD at 278.6 ft.JPG	BLOCKED 11-1 ON TAP

At: 278. TBD - Tap Break-in/Hammer Defective
6000061035
16 ft. 2/.

Joint: No BLOCKED 11-1 ON TAP

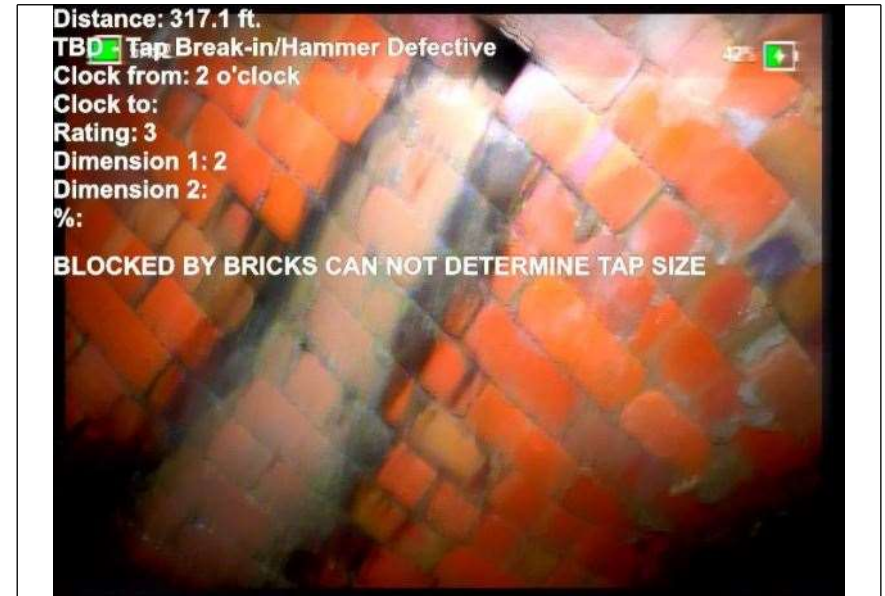
317.1 ft.	00:36:43	TBD			2.000			<input type="checkbox"/>	2 /		3	ROCK SWALE 72 IN INSPECTION-AMH 'MH10'-AMH 'MH9'-TBD at 317.1 ft.JPG	BLOCKED BY BRICKS CAN NOT DETERMINE TAP SIZE

At: 317. TBD - Tap Break-in/Hammer Defective
1000061035
16 ft. 2/.

Joint: No BLOCKED BY BRICKS CAN NOT DETERMINE TAP SIZE

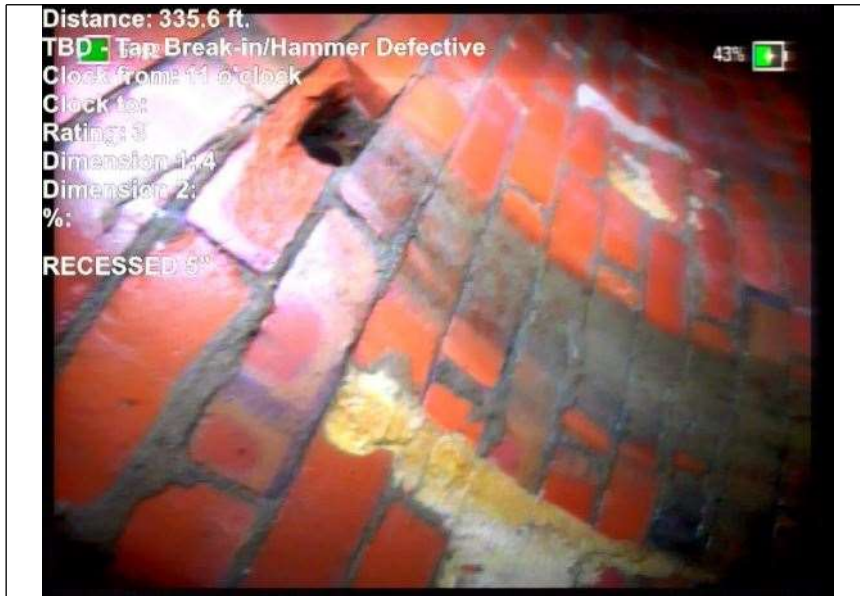
At: 335. TBD - Tap Break-in/Hammer Defective
6000061035
16 ft. 11/.

Joint: No RECESSED 5"

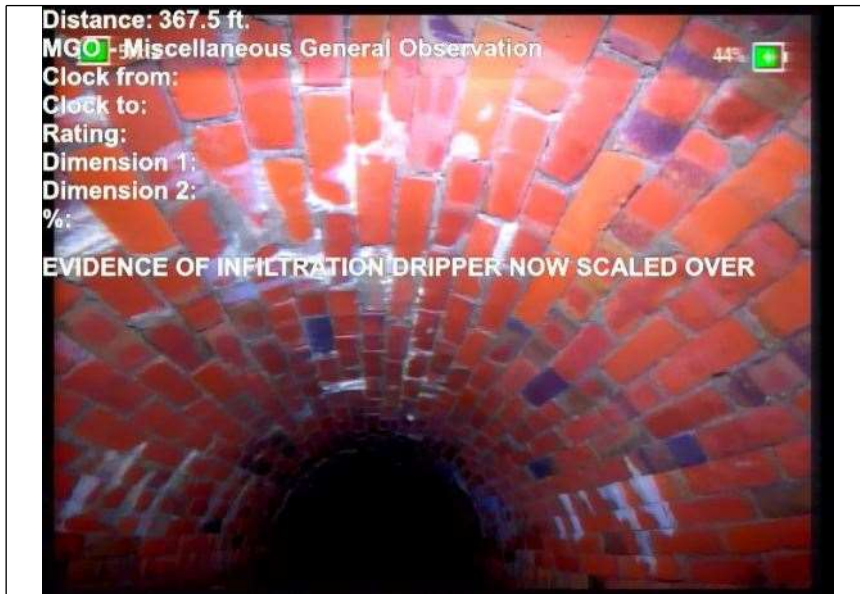
367.5 ft.	00:39:44	MGO						<input type="checkbox"/>	/			ROCK SWALE 72 IN INSPECTION-AMH 'MH10'-AMH 'MH9'-MGO at 367.5 ft.JPG	EVIDENCE OF INFILTRATION DRIPPER NOW SCALED OVER

At: 367.5 ft. MGO - Miscellaneous General Observation
Joint: No EVIDENCE OF INFILTRATION DRIPPER NOW SCALED OVER

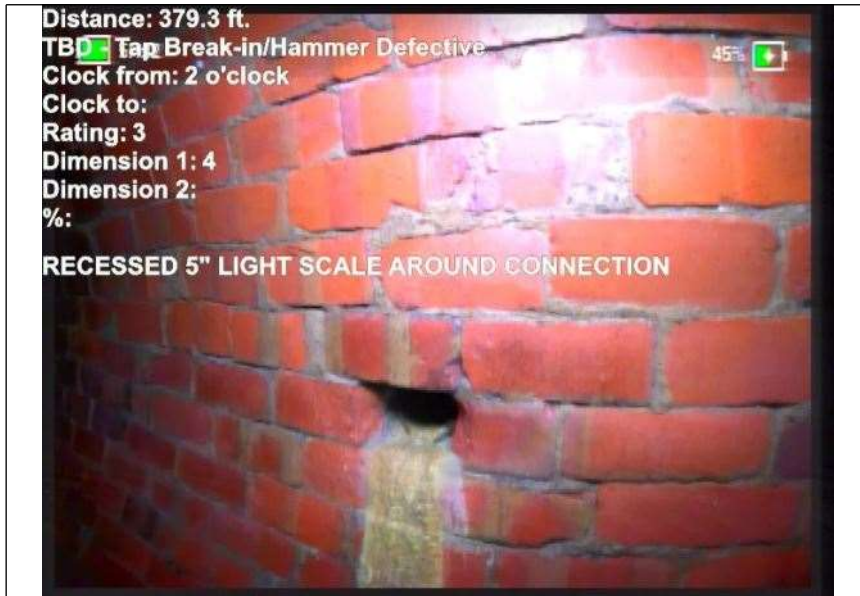
379.3 ft.	00:40:48	TBD			4.000			<input type="checkbox"/>	2 /		3	ROCK SWALE 72 IN INSPECTION-AMH 'MH10'-AMH 'MH9'-TBD at 379.3 ft.JPG	RECESSED 5" LIGHT SCALE AROUND CONNECTION

At: 379. 379.3 ft. TBD - Tap Break-in/Hammer Defective
2999877929
69 ft. 2/.

Joint: No RECESSED 5" LIGHT SCALE AROUND CONNECTION

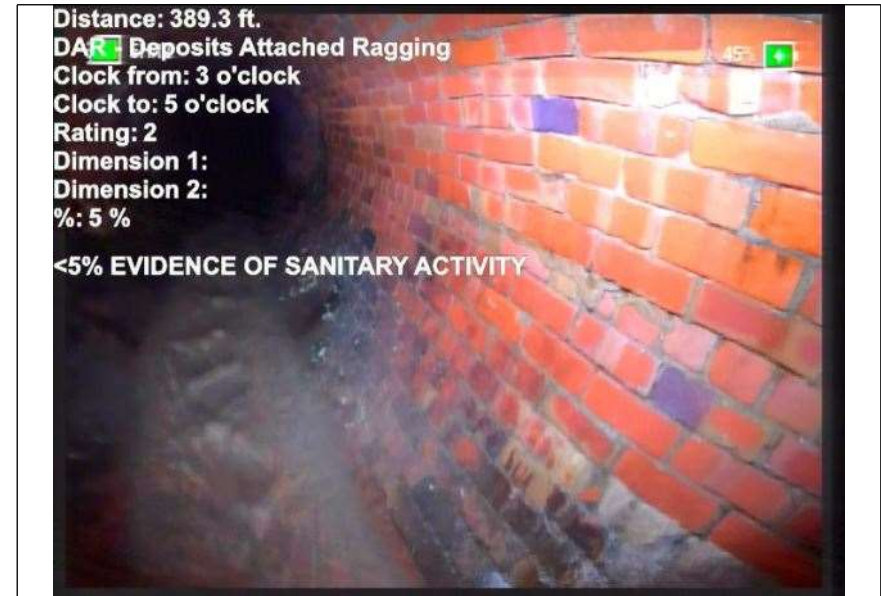
389.3 ft.	00:41:34	DAR					5	<input type="checkbox"/>	3 / 5		2	ROCK SWALE 72 IN INSPECTION-AMH 'MH10'-AMH 'MH9'-DAR at 389.3 ft.JPG	<5% EVIDENCE OF SANITARY ACTIVITY

At: 389. 389.3 ft. DAR - Deposits Attached Ragging
2999877929
69 ft. 3/5

Joint: No 5 % <5% EVIDENCE OF SANITARY ACTIVITY

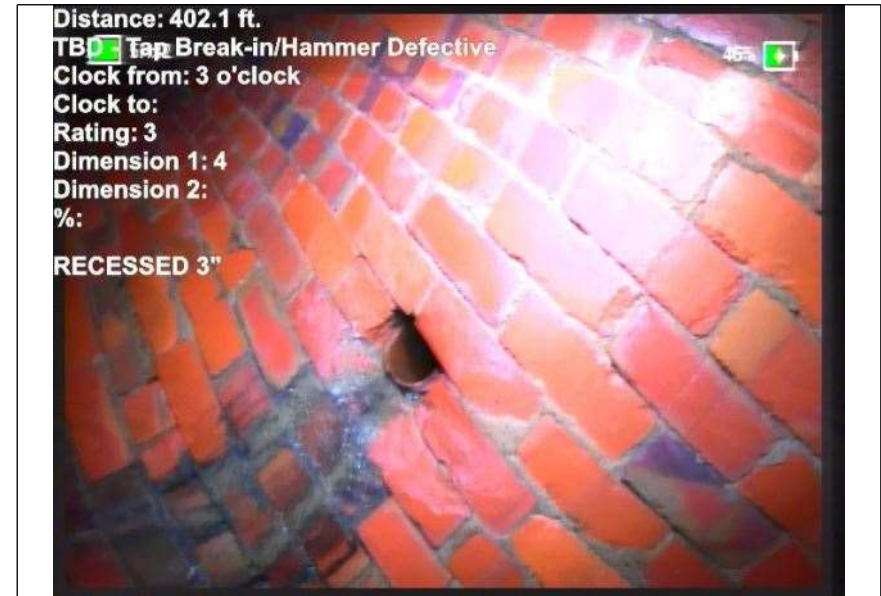
At: 402. TBD - Tap Break-in/Hammer Defective
1000061035
16 ft. 3/.

Joint: No RECESSED 3"

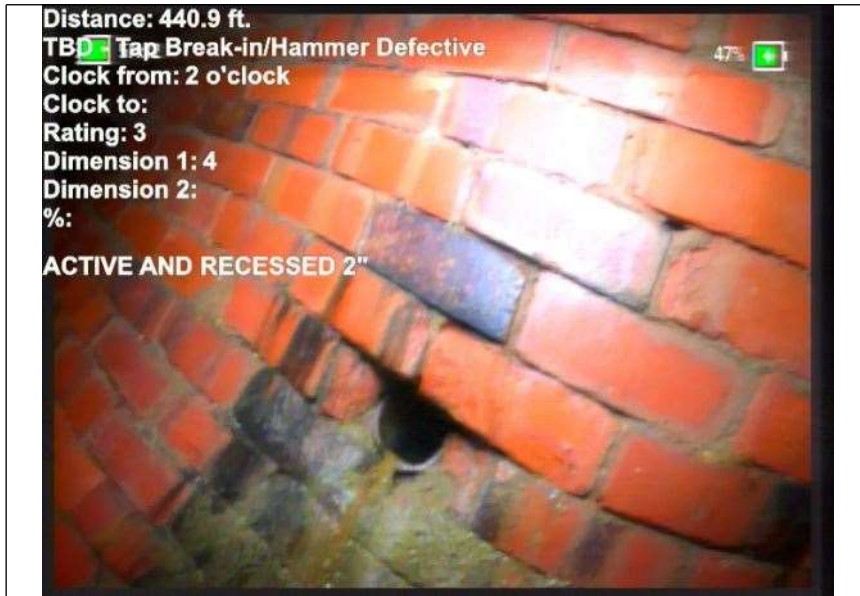
At: 440. TBD - Tap Break-in/Hammer Defective
8999938964
84 ft. 2/.

Joint: No ACTIVE AND RECESSED 2"

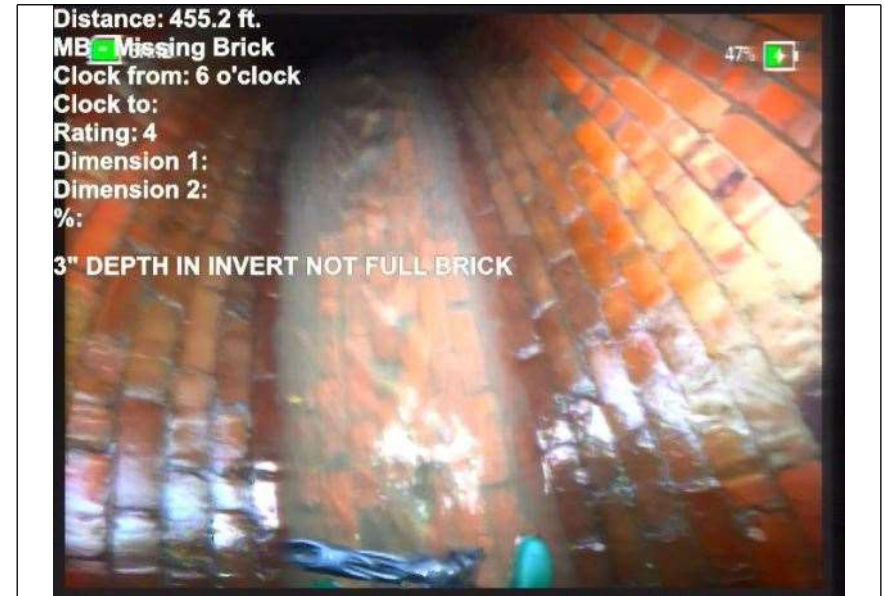
455.2 ft.	00:45:09	MB						<input type="checkbox"/>	6 /		4	ROCK SWALE 72 IN INSPECTION-AMH 'MH10'-AMH 'MH9'-MB at 455.2 ft.JPG	3" DEPTH IN INVERT NOT FULL BRICK

At: 455. MB - Missing Brick
2000122070
31 ft. 6/.

Joint: No 3" DEPTH IN INVERT NOT FULL BRICK

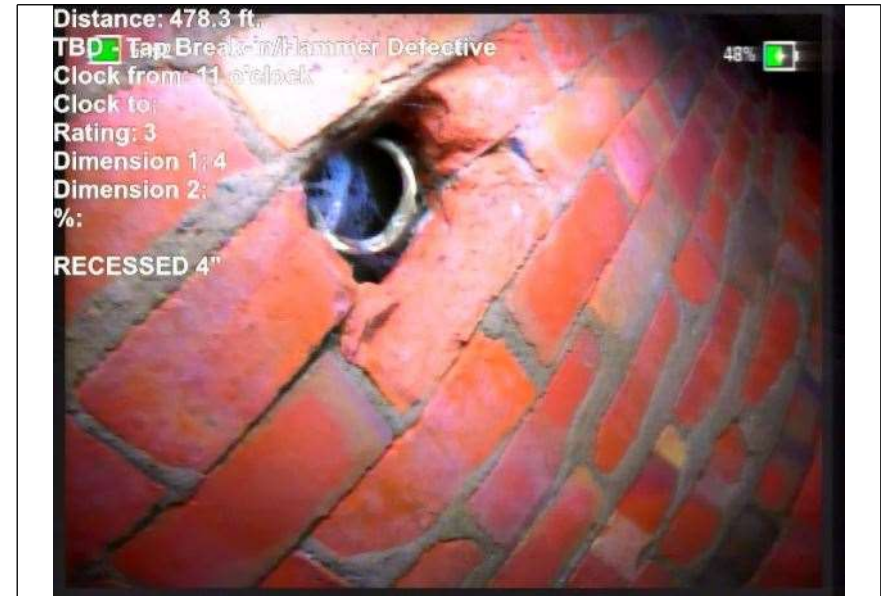
At: 478. TBD - Tap Break-in/Hammer Defective
2999877929
69 ft. 11/.

Joint: No RECESSED 4"

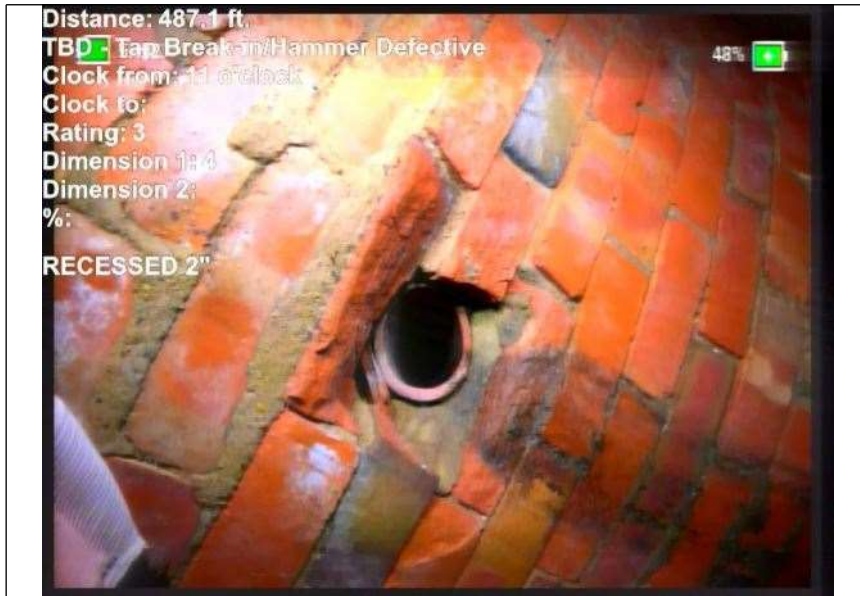
At: 487. TBD - Tap Break-in/Hammer Defective
1000061035
16 ft. 11/.

Joint: No RECESSED 2"

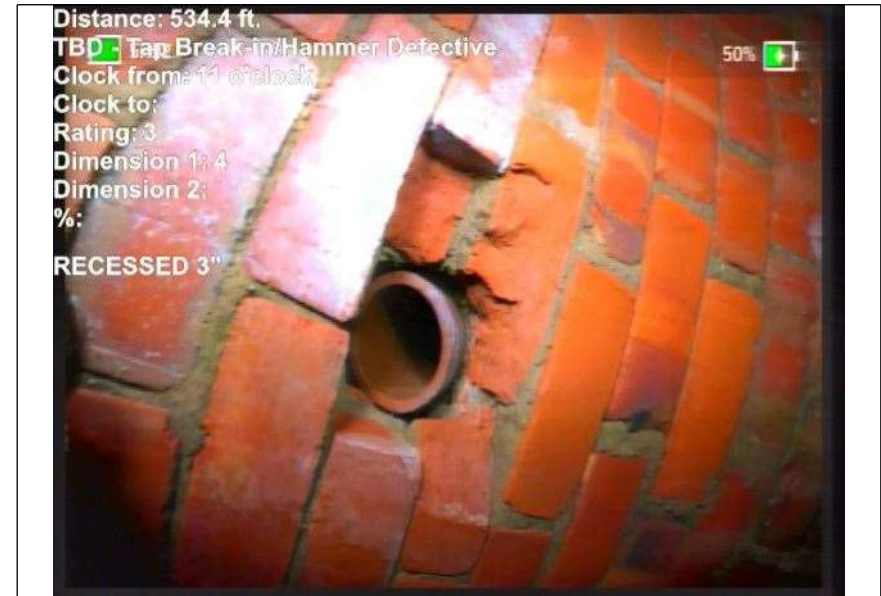
534.4 ft.	00:49:29	TBD			4.000			<input type="checkbox"/>	11 /		3	ROCK SWALE 72 IN INSPECTION-AMH 'MH10'-AMH 'MH9'-TBD at 534.4 ft.JPG	RECESSED 3"

At: 534. TBD - Tap Break-in/Hammer Defective
400244140
63 ft. 11/.

Joint: No RECESSED 3"

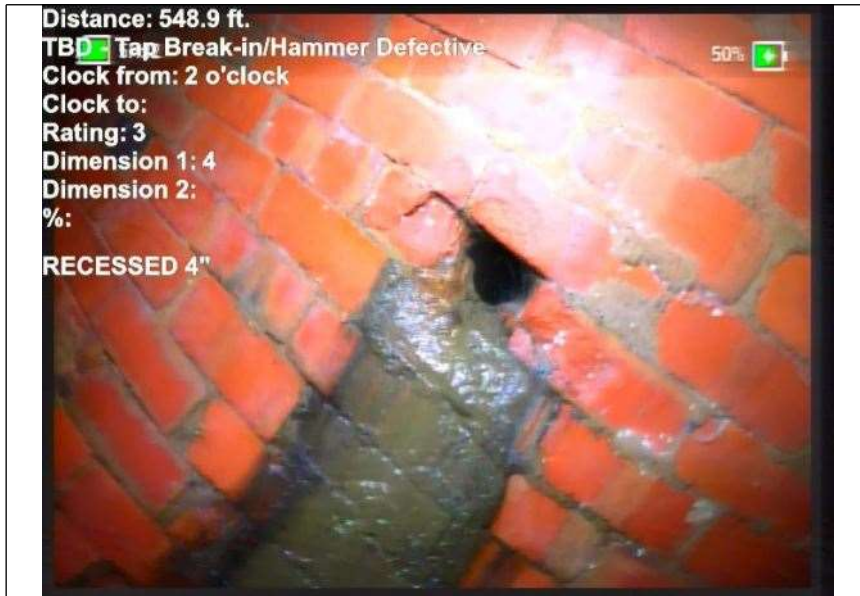
At: 548. TBD - Tap Break-in/Hammer Defective
9000244140
63 ft. 2/.

Joint: No RECESSED 4"

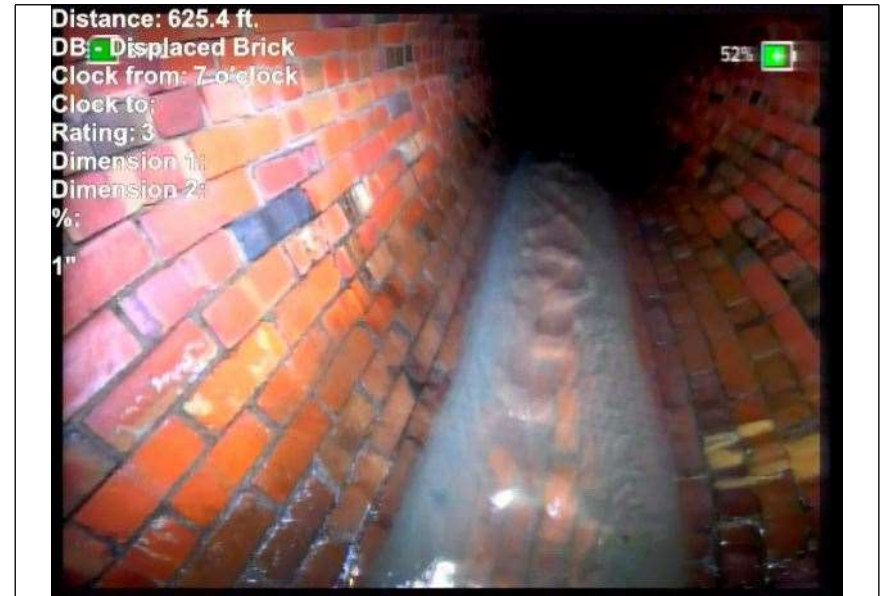
At: 625. DB - Displaced Brick
4000244140
63 ft. 7/.

Joint: No 1"

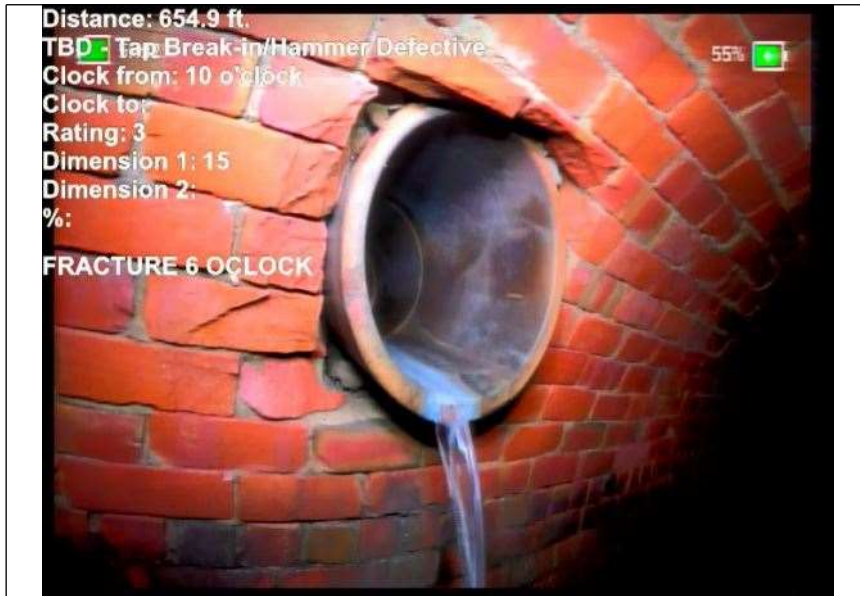
654.9 ft.	00:56:26	TBD			15.000			<input type="checkbox"/>	10 /		3	ROCK SWALE 72 IN INSPECTION-AMH 'MH10'-AMH 'MH9'-TBD at 654.9 ft.JPG	FRACTURE 6 OCLOCK ACTIVE

At: 654. TBD - Tap Break-in/Hammer Defective
9000244140
63 ft. 10/.

Joint: No FRACTURE 6 OCLOCK ACTIVE

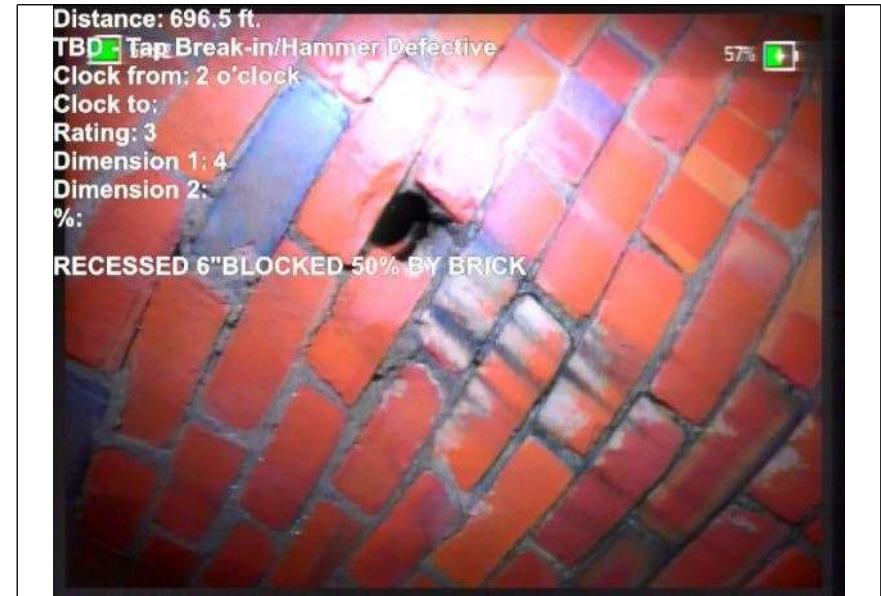
696.5 ft.	01:00:10	TBD			4.000			<input type="checkbox"/>	2 /		3	ROCK SWALE 72 IN INSPECTION-AMH 'MH10'-AMH 'MH9'-TBD at 696.5 ft.JPG	RECESSED 6" BLOCKED 50% BY BRICK

At: 696.5 ft. 2/. TBD - Tap Break-in/Hammer Defective
Joint: No RECESSED 6"BLOCKED 50% BY BRICK

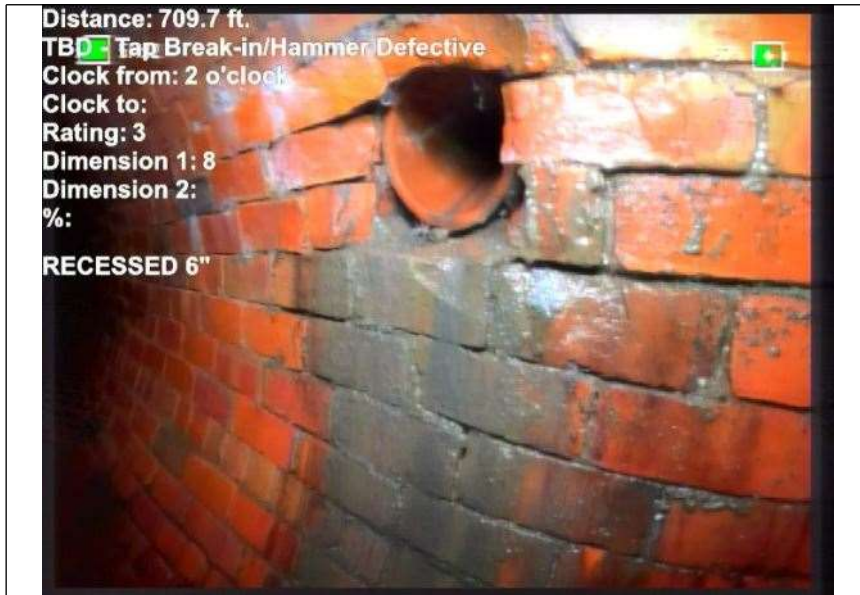
At: 709. 700122070
TBD - Tap Break-in/Hammer Defective
31 ft. 2/.

Joint: No RECESSED 6"

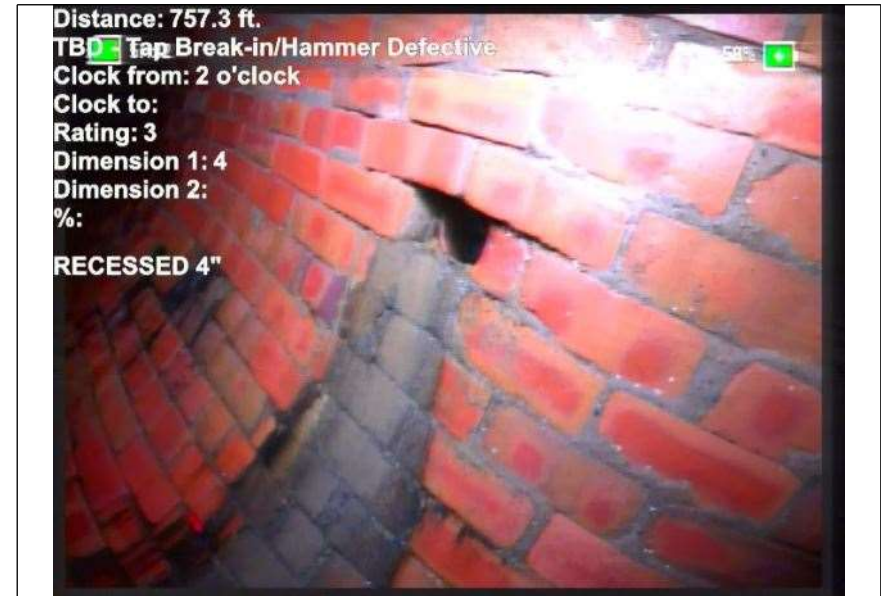
At: 757. TBD - Tap Break-in/Hammer Defective
2999877929
69 ft. 2/.

Joint: No RECESSED 4"
