PACP Report with Pipe Run and Incident Snapshots

Surveyed by: ANDREW		Certificate number: T-507-4975		Owner: CITY OF MARION		Customer:		Drainage area:		P/O number:		Sheet number:							
Pipe segment ref.: MH12A_MH12				Start date/time: 20240626 10:30		Street: SILVER ST. & NILES ST				City: MARION, OH									
Location details:				Upstream MH No: MH12A				Rim to invert:		Grade to invert:		Rim to grade:							
Pipe use: CB		Direction: U		Flow control:		Downstream MH No: MH12				Rim to invert:		Grade to invert:		Rim to grade:					
Height: 66 in.		Width:		Shape: C		Material: BR		Lining method:		Pipe joint length:		Total length: 32.800 ft.		Length surveyed: 32.800 ft.		Purpose: B		Sewer category:	
Media label:				Pre-cleaning: N		Date cleaned:		Weather: 1		Location code: C		Pressure value:							
Project name: ROCK SWALE 72 IN INSPECTION				Additional info:

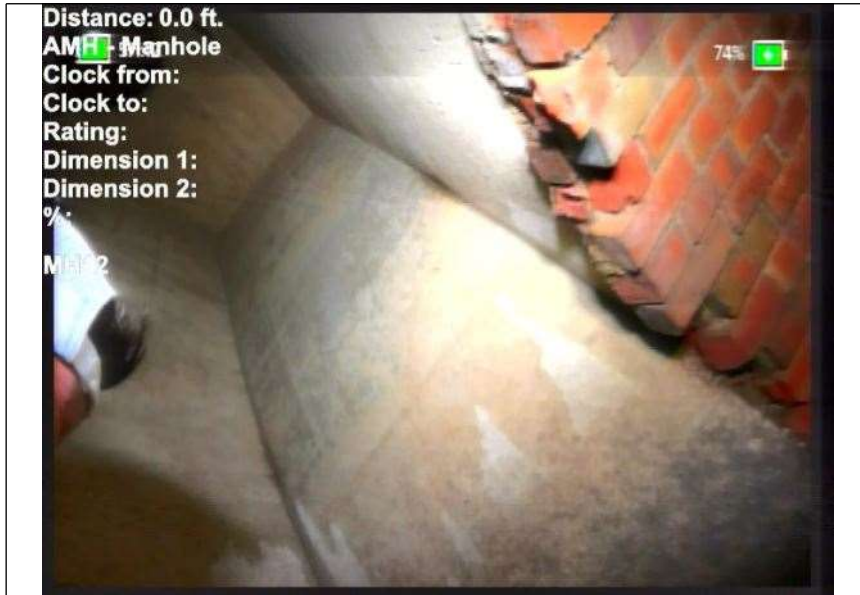
At: 0 ft. AMH - Manhole
Joint: No MH12

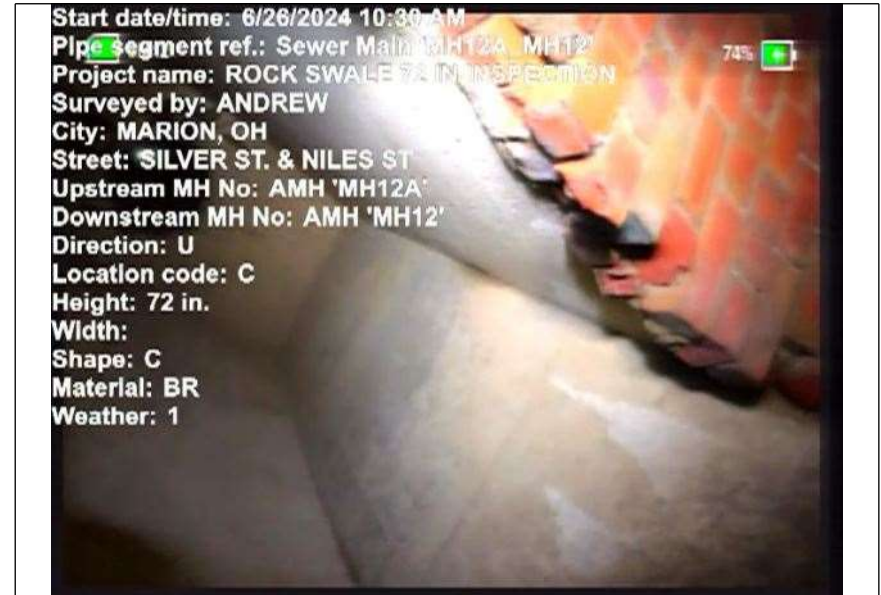
At: 0 ft. AMH - Manhole
Joint: No MH12

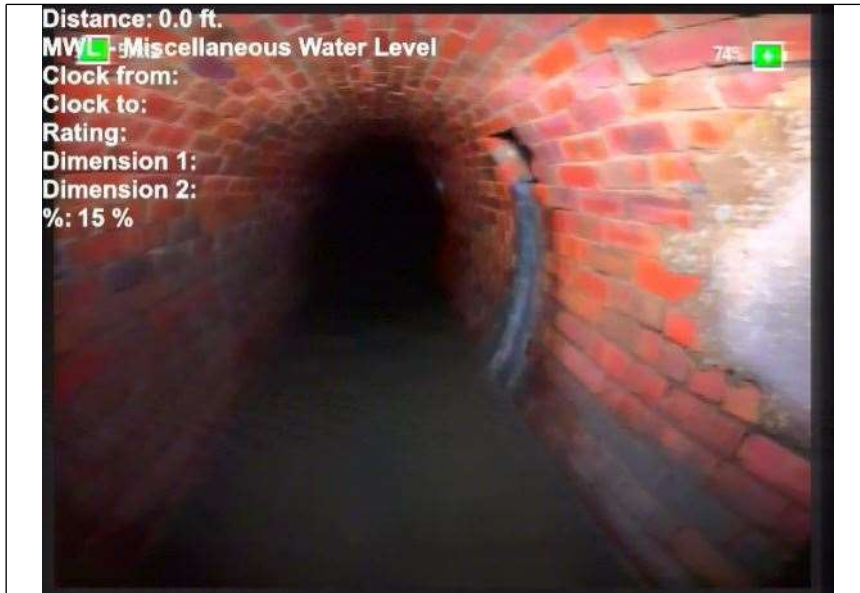
At: 0 ft. MWL - Miscellaneous Water Level
Joint: No 15 %

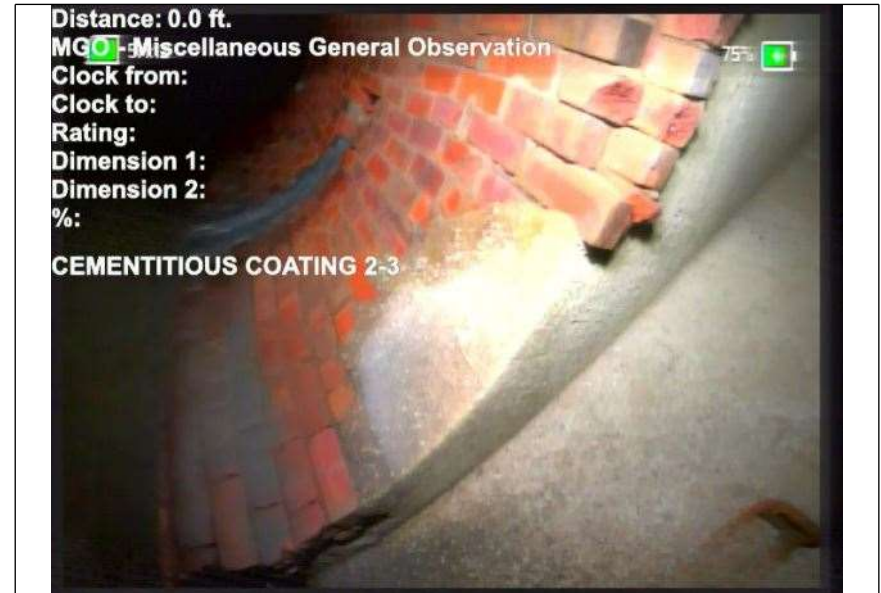
At: 0 ft. MGO - Miscellaneous General Observation
Joint: No CEMENTITIOUS COATING 2-3

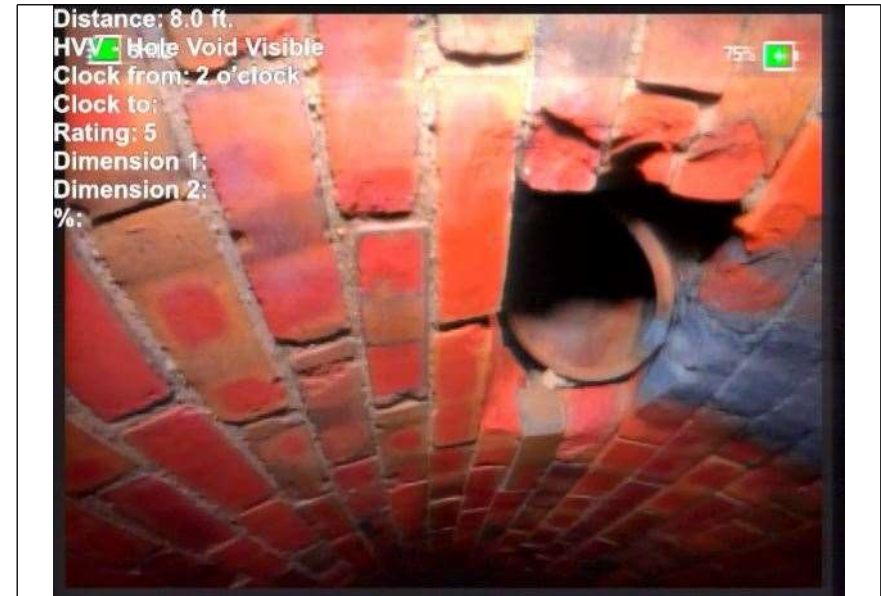
At: 8 ft. 2/. HVV - Hole Void Visible
Joint: No

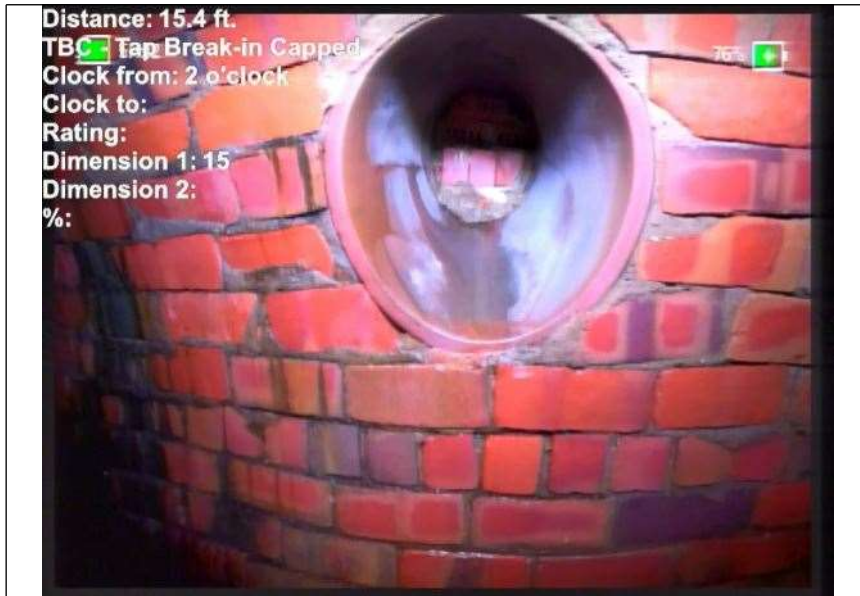
At: 15. TBC - Tap Break-in Capped
3999996185
303 ft. 2/.
Joint: No

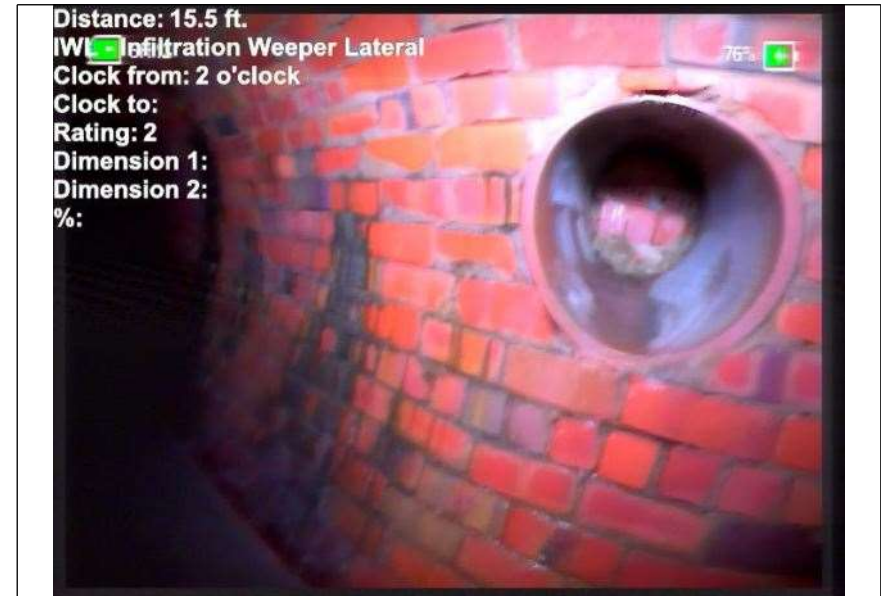
At: 15.5 ft. 2/. IWL - Infiltration Weeper Lateral
Joint: No

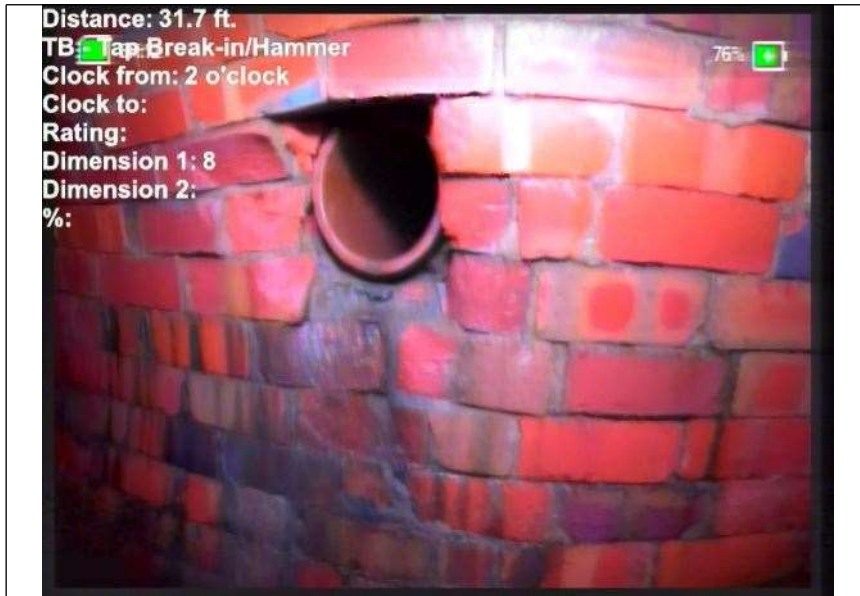
At: 31. TB - Tap Break-in/Hammer
7000007629
395 ft. 2/.

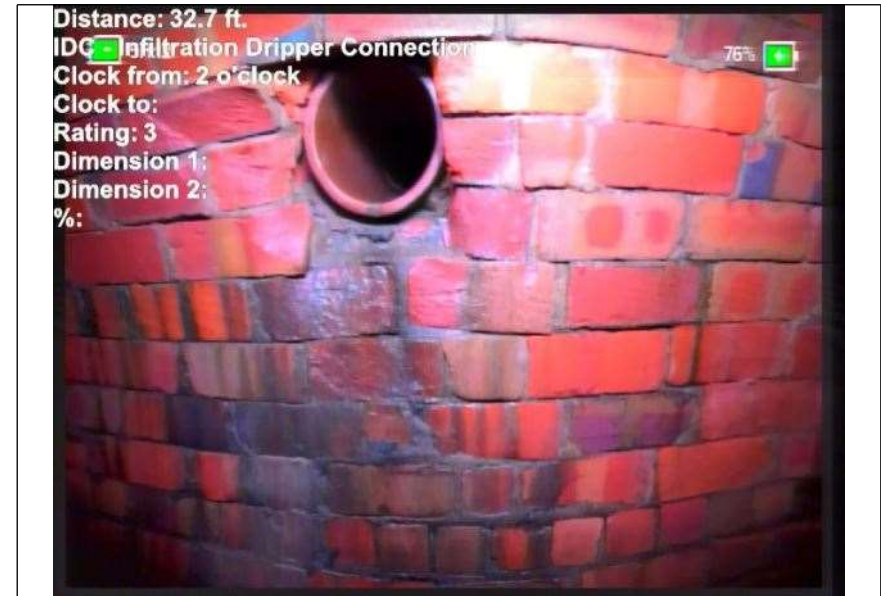
At: 32. IDC - Infiltration Dripper Connection
7000007629
395 ft. 2/.

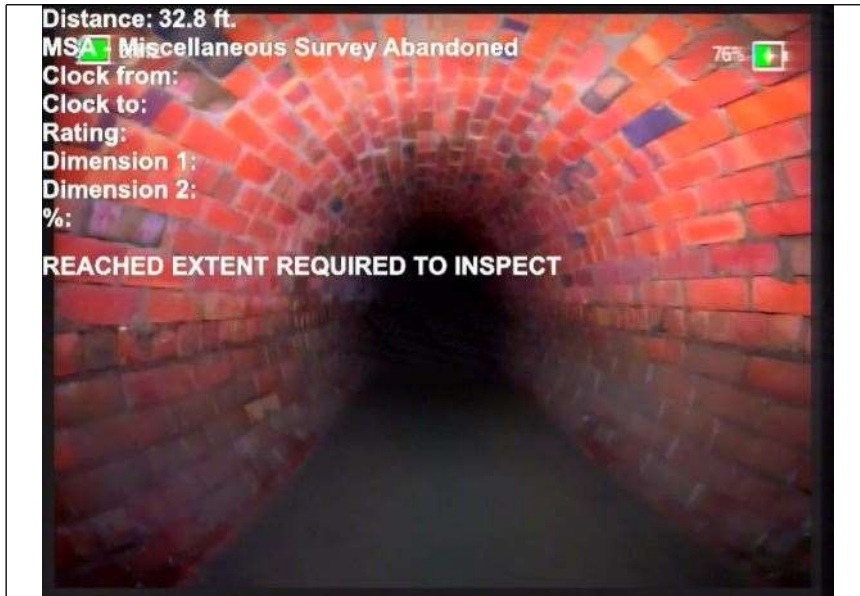
At: 32. MSA - Miscellaneous Survey Abandoned
7999992370
605 ft.

Joint: No REACHED EXTENT REQUIRED TO INSPECT
