Project:		Date/Time:	June 28 2024 -
Street and City:	1350 Holland Rd. - Marion	Weather:	Unknown Weather
Owner:		P.O. #	
Customer:		Inspection Status:	Remote Inspection
Surveyor Name and Certificate:	Dan Shrodes U-716-07004752	Inspection Level:	2
Reviewer Name and Certificate:	chad pauls P0036127-022022	MH:	DC1

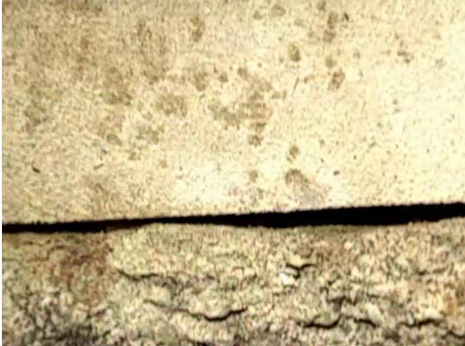
2.7	SSC - component:CMI Continuous: F01 Clock from 12 to 12 Grade = 2	000006

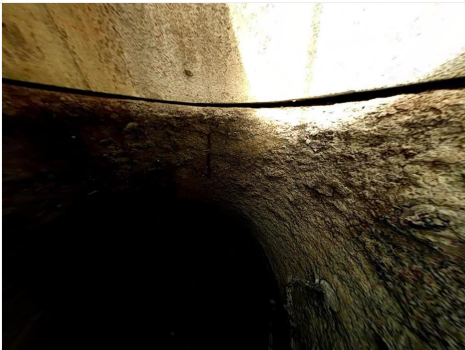
2.8	SSC - component:COI Continuous: S02 Clock from 12 to 12 Grade = 2	000007

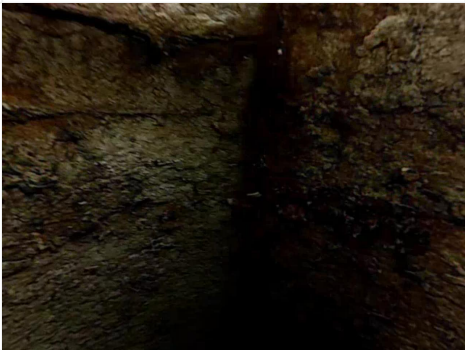
3.2	SRC - component:COI Clock from 1 to 5 Grade = 5	000007

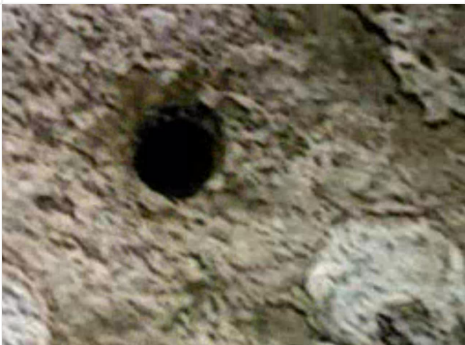
4.5	MGO - component:COI Remark = LIFT POINT	000008

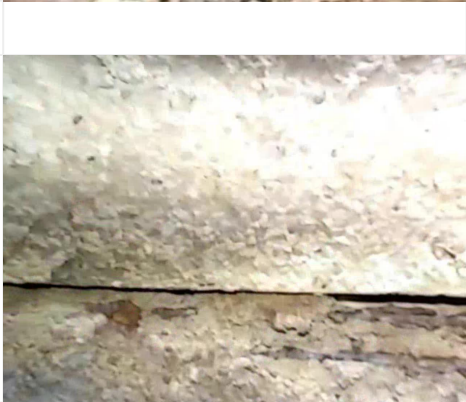
6.6	SSC - component:COI Continuous: F02 Clock from 12 to 12 Grade = 2	000010

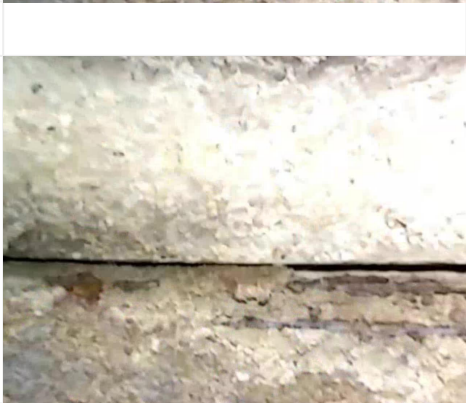
6.7	SSC - component:WI Continuous: S03 Clock from 12 to 12 Grade = 2	000011

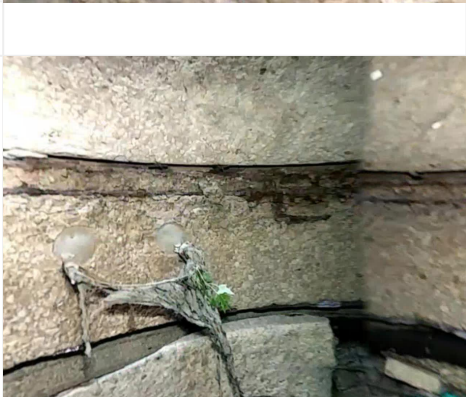
7.1	SRP - component:WI Clock from 7 to 12 Grade = 5	000011

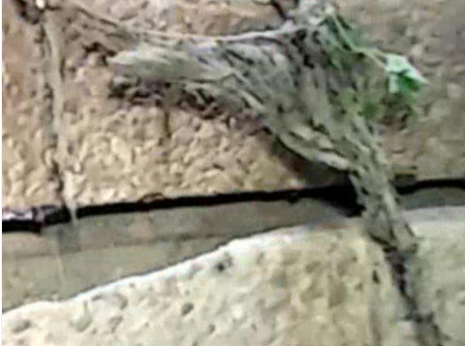
7.7	DAZ - component:WI Percent: 5 Clock At 9 Remark = DEBRIS Grade = 1	000012

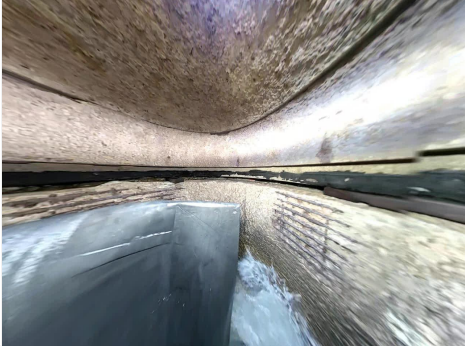
8.1	ISZ - component:WI Percent: 5 Clock from 12 to 12 Remark = URETHANE Grade = 1	000012

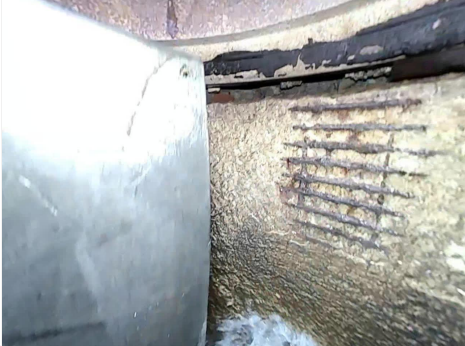
8.9	SRP - component:WI Continuous: S04 Clock from 12 to 7 Grade = 5	000013

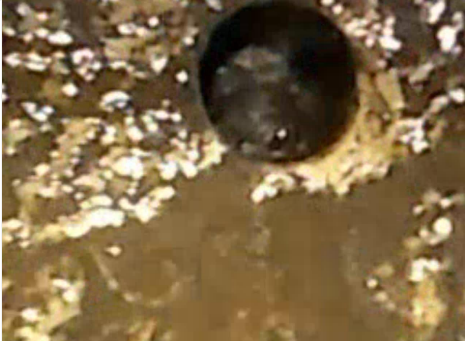
11.6	RPP - component:WI Clock At 6 Remark = MORTAR	000017

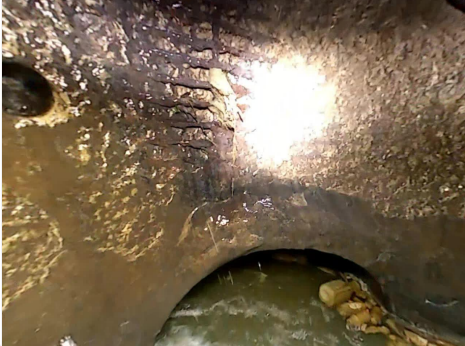
11.6	SRP - component:WI Continuous: F04 Clock from 12 to 7 Grade = 5	000017

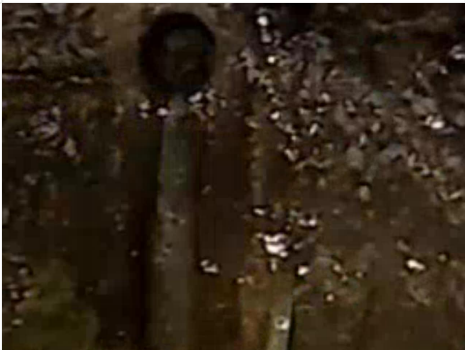
11.6	RPPD - component:WI Clock At 12 Remark = MORTAR/ISB Grade = 4	000017

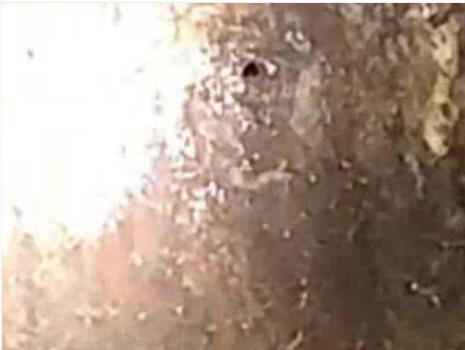
11.6	H - component:WI Clock At 8 Grade = 2	000023

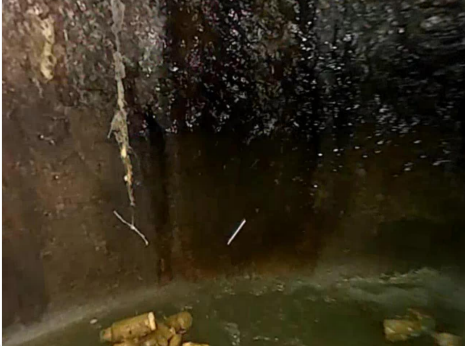
13.2	SSC - component:WI Continuous: F03 Clock from 12 to 12 Grade = 2	000023

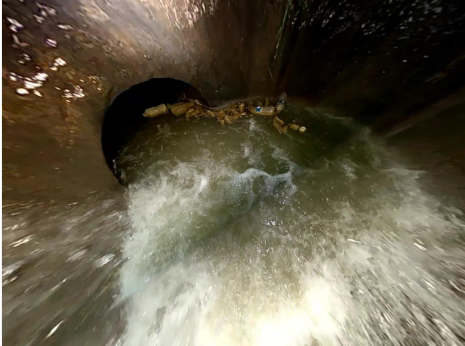
13.3	DSZ - component:B Percent: 5 Clock from 12 to 12 Remark = DEBRIS Grade = 1	000019

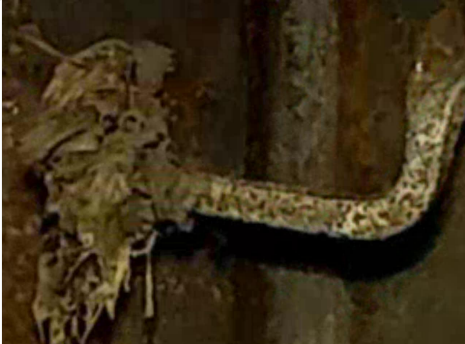
13.9	DAZ - component:WI Percent: 5 Clock At 9 Remark = DEBRIS Grade = 1	000049

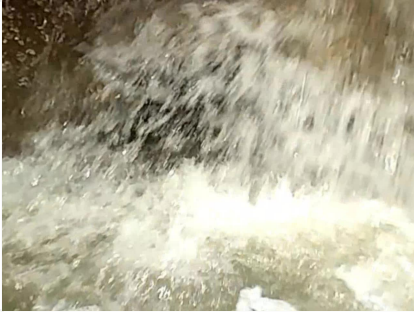
4	Incoming Connection Shape = Circle Height = 21 Pipe Condition = S Pipe Seal Condition = S Pipe type = GR	14	1

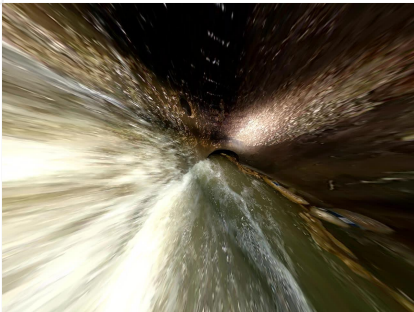
1	Outgoing Connection Shape = Circle Height = 30 Pipe Condition = D Pipe Seal Condition = S Pipe type = GR Comments = DSZ	14.1	6

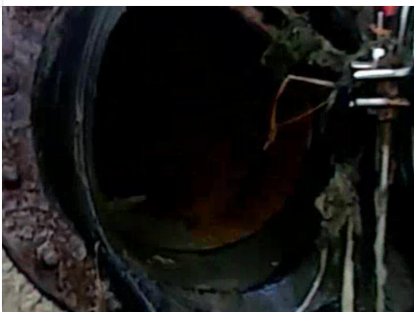
2	Incoming Connection Shape = Circle Height = 18 Pipe Condition = D Pipe Seal Condition = S Pipe type = GR Comments = DAZ	9.6	9

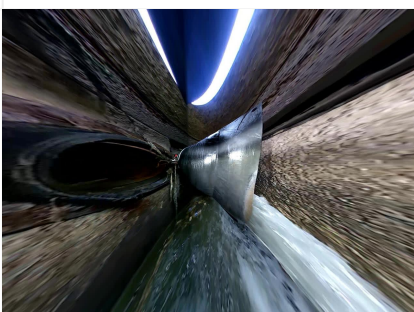
3	Incoming Connection Shape = Circle Height = 18 Pipe Condition = S Pipe Seal Condition = S Pipe type = GR	9.6	11
