Project:		Date/Time:	June 28 2024 -
Street and City:	1350 Holland Rd. - Marion	Weather:	Unknown Weather
Owner:		P.O. #	
Customer:		Inspection Status:	Remote Inspection
Surveyor Name and Certificate:	Dan Shrodes U-716-07004752	Inspection Level:	2
Reviewer Name and Certificate:	chad pauls P0036127-022022	MH:	DC2

Asset Details and Measurements

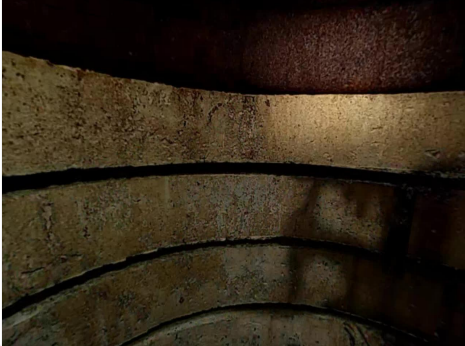
0.6	SRI - component:CMI Continuous: S01 Clock from 12 to 12 Grade = 1	000003

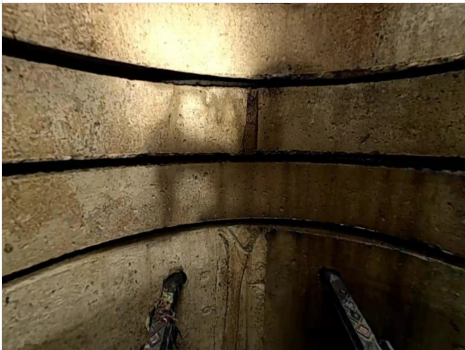
1	IWJ - component:CMI Joint: True Clock from 4 to 5 Grade = 2	000003

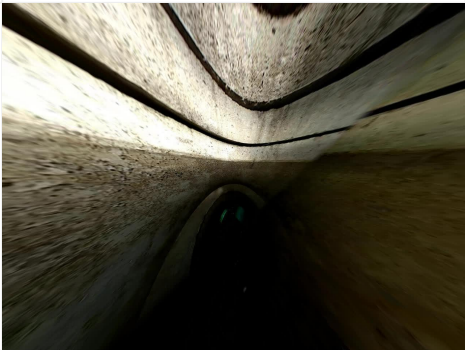
1.9	SRI - component:CMI Continuous: F01 Clock from 12 to 12 Grade = 1	000004

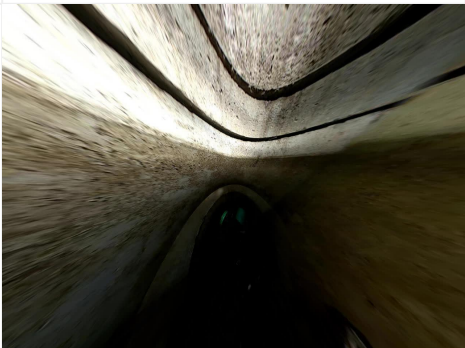
2	SRI - component:COI Continuous: S02 Clock from 12 to 12 Grade = 1	000004

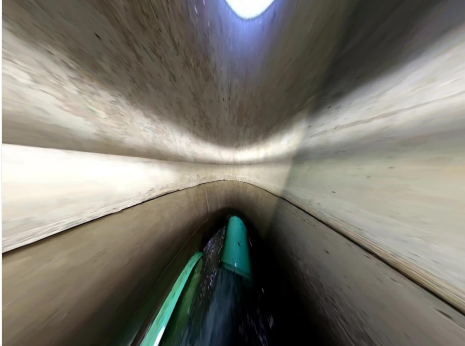
4.3	SRI - component:COI Continuous: F02 Clock from 12 to 12 Grade = 1	000006

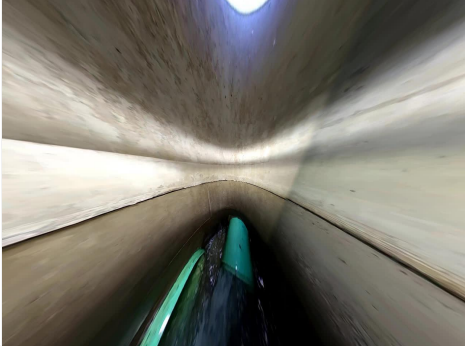
4.4	SRI - component:WI Continuous: S03 Clock from 12 to 12 Grade = 1	000006

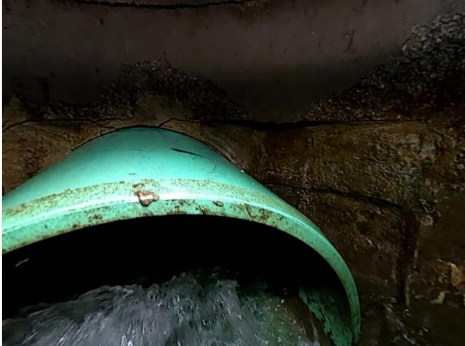
9	RPP - component:WI Clock At 10 Remark = MISC MATERIAL	000014

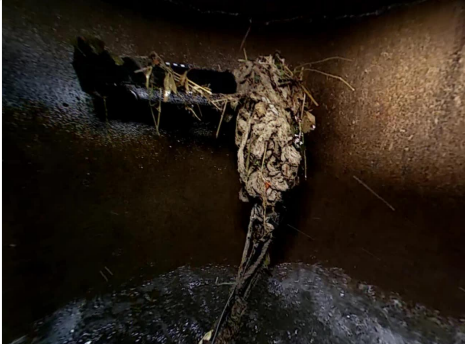
9	DAZ - component:WI Percent: 5 Clock At 2 Remark = DEBRIS Grade = 1	000014

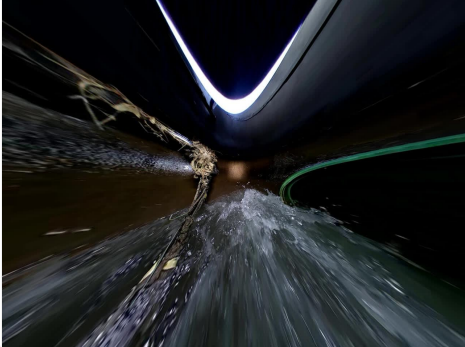
9.8	SRI - component:WI Continuous: F03 Clock from 12 to 12 Grade = 1	000015

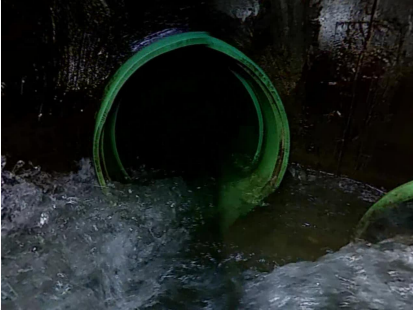
1	Outgoing Connection Shape = Circle Height = 18 Pipe Condition = S Pipe Seal Condition = S Pipe type = GR	10.2	6

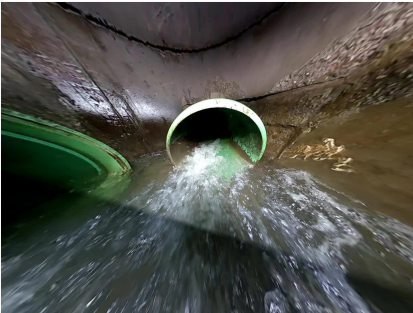
2	Incoming Connection Shape = Circle Height = 18 Pipe Condition = S Pipe Seal Condition = S Pipe type = GR	10.1	9
