Project:		Date/Time:	June 28 2024 -
Street and City:	1350 Holland Rd. - Marion	Weather:	Unknown Weather
Owner:		P.O. #	
Customer:		Inspection Status:	Remote Inspection
Surveyor Name and Certificate:	Dan Shrodes U-716-07004752	Inspection Level:	2
Reviewer Name and Certificate:	Jessy Vargas-Bloom P0034044-102021	MH:	HB

Asset Details and Measurements

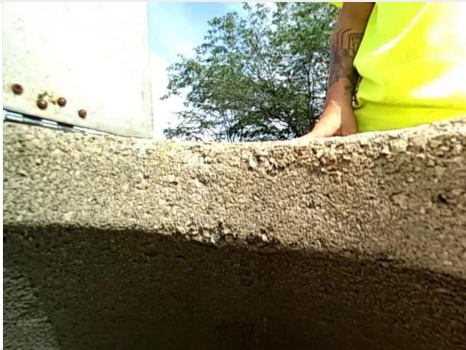
0.3	SAV - component:CMI Clock from 12 to 12 Grade = 2	000002

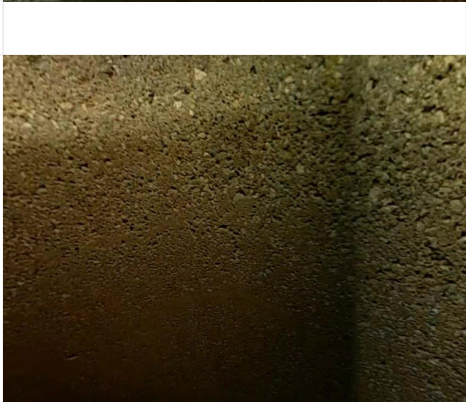
0.6	SAV - component:COI Continuous: S01 Clock from 12 to 12 Grade = 2	000002

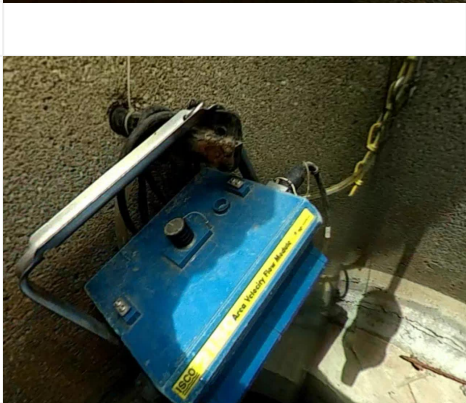
0.6	MGO - component:COI Remark = FLOW MONITOR	000002

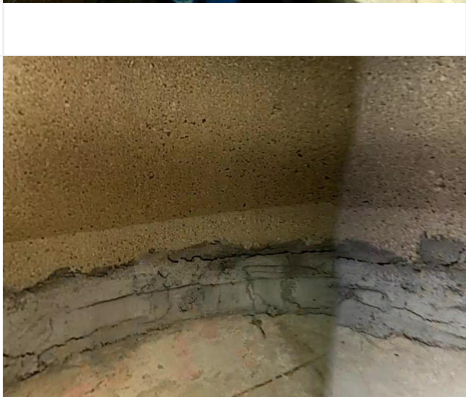
2.1	SAV - component:COI Continuous: F01 Clock from 12 to 12 Grade = 2	000004

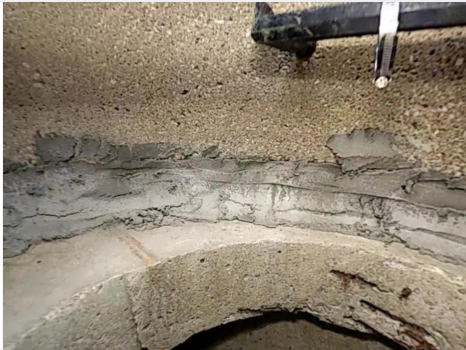
2.2	SAV - component:WI Continuous: S02 Clock from 12 to 12 Grade = 2	000004

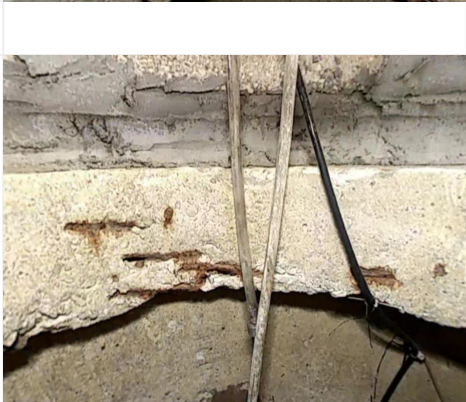
2.9	MSC - component:WI Measurement 1: 23	000005

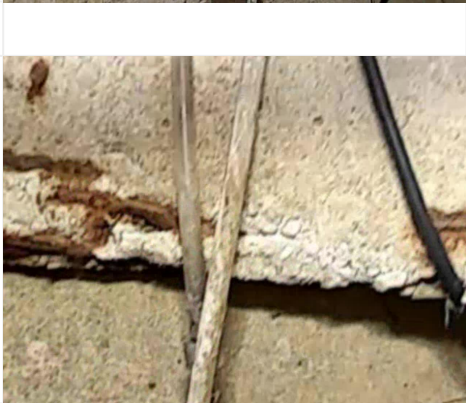
3.4	SRC - component:WI Clock from 9 to 5 Grade = 5	000006

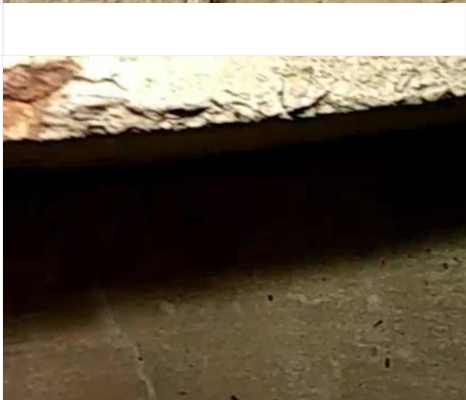
3.6	MSC - component:WI Measurement 1: 46	000006

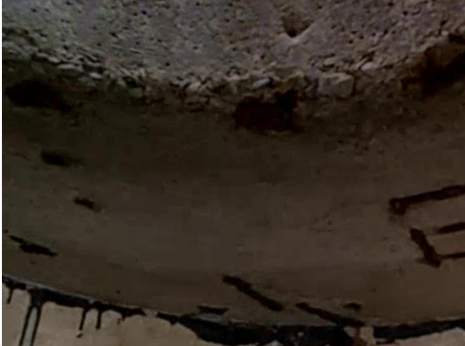
3.6	SRC - component:WI Clock from 12 to 12 Grade = 5	000007

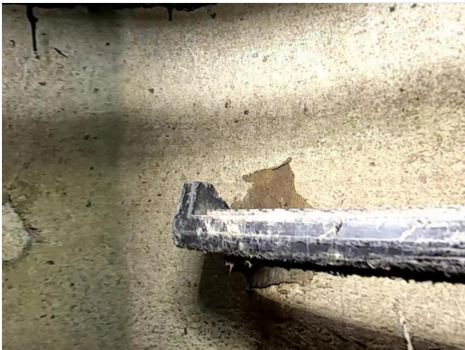
4.3	SAV - component:WI Continuous: F02 Clock from 12 to 12 Grade = 2	000007

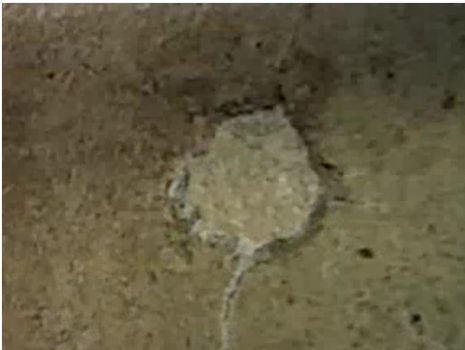
4.4	CL - component:WI Clock At 11 Grade = 2	000007

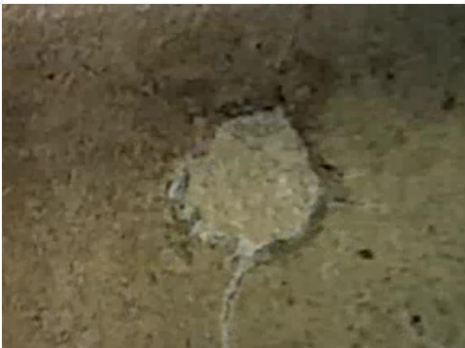
4.4	MGO - component:WI Remark = APPEARS TO BE FILLED IN LIFT HOLE	000007

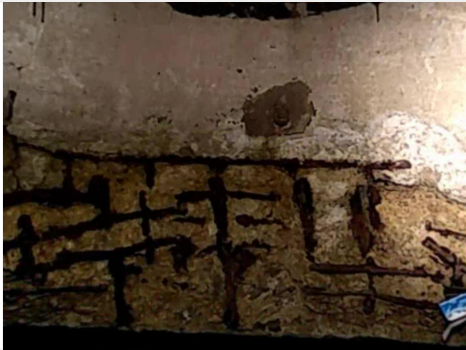
4.6	SRC - component:WI Clock from 5 to 11 Grade = 5	000008

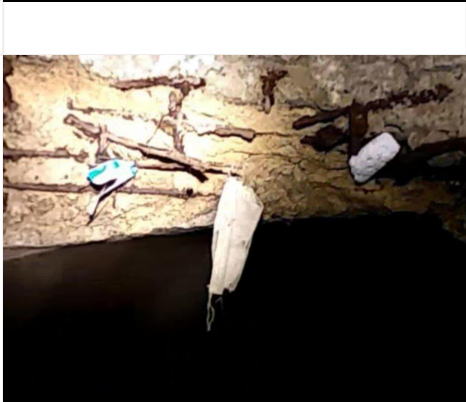
5.6	DAR - component:WI Percent: 5 Clock from 9 to 10 Grade = 1	000011

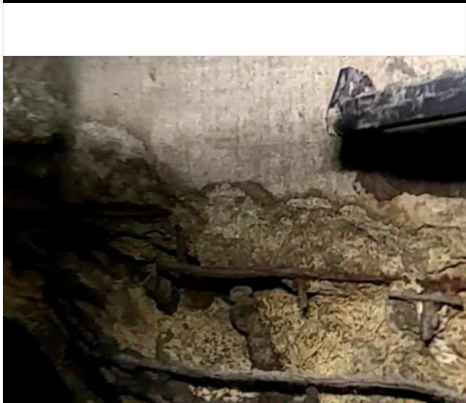
6	SRC - component:WI Clock from 12 to 12 Grade = 5	000012

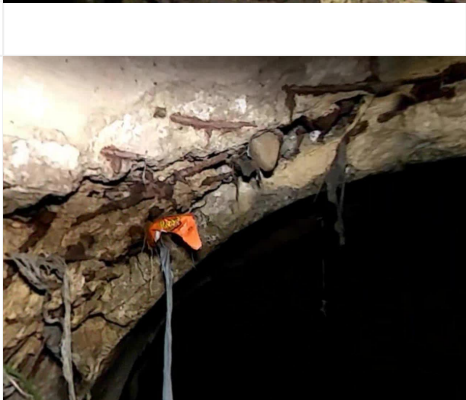
6.3	DAR - component:WI Percent: 5 Clock At 5 Grade = 1	000012

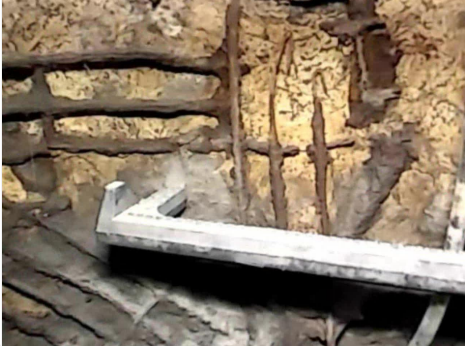
6.6	SRC - component:WI Clock from 1 to 5 Grade = 5	000013

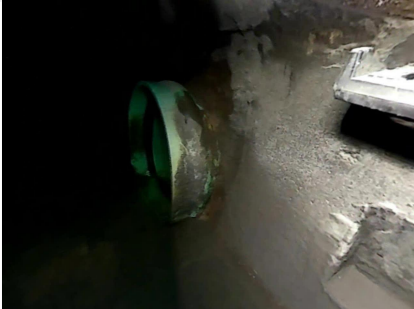
3	Incoming Connection Shape = Circle Height = 18 Pipe Condition = S Pipe Seal Condition = S Pipe type = GR	9.7	1

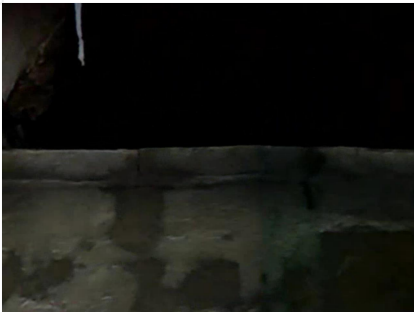
1	Outgoing Connection Shape = Circle Height = 65 Pipe Condition = S Pipe Seal Condition = S Pipe type = GR	11	6

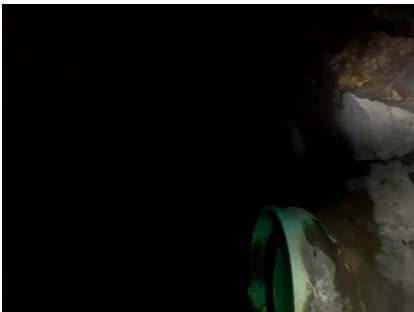
2	Incoming Connection Shape = Circle Height = 65 Pipe Condition = D Pipe Seal Condition = S Pipe type = GR Comments = FL	10.9	12
