Project:		Date/Time:	June 27 2024 -
Street and City:	161 Silver St. - Marion	Weather:	Unknown Weather
Owner:		P.O. #	
Customer:		Inspection Status:	Remote Inspection
Surveyor Name and Certificate:	Dan Shrodes U-716-07004752	Inspection Level:	2
Reviewer Name and Certificate:	Jessy Vargas-Bloom P0034044-102021	MH:	MH10

Asset Details and Measurements

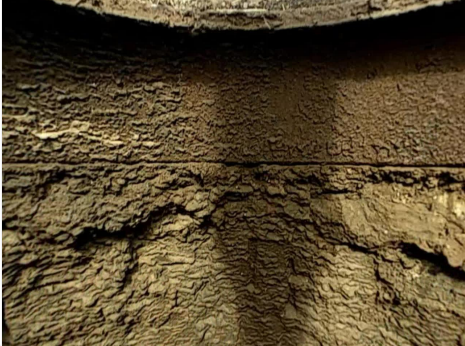
0.7	DAZ - component:CMI Continuous: S01 Percent: 10 Clock from 12 to 12 Remark = APPEARS TO BE DIRT Grade = 1	000005

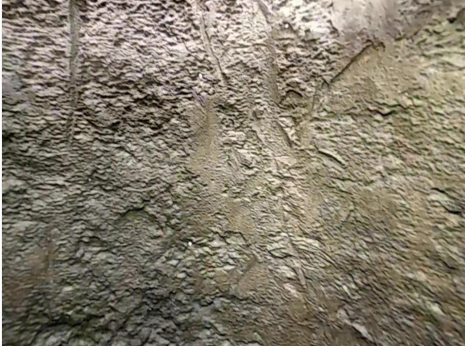
3.1	DAZ - component:CMI Continuous: F01 Percent: 10 Clock from 12 to 12 Remark = APPEARS TO BE DIRT Grade = 1	000008

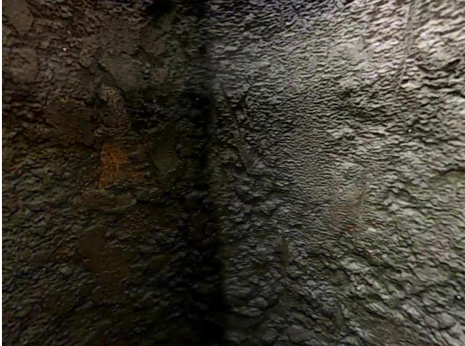
3.2	DAZ - component:COI Continuous: S02 Percent: 5 Clock from 12 to 12 Remark = APPEARS TO BE DIRT Grade = 1	000008

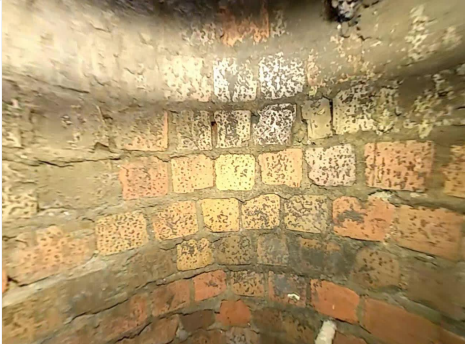
6.6	MMS - component:COI Continuous: S03 Clock from 12 to 12 Grade = 2	000037

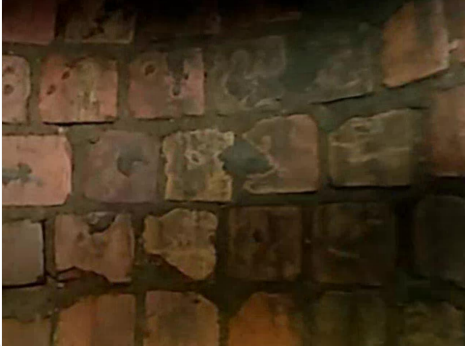
10.1	DAZ - component:COI Continuous: F02 Percent: 5 Clock from 12 to 12 Remark = APPEARS TO BE DIRT Grade = 1	000042

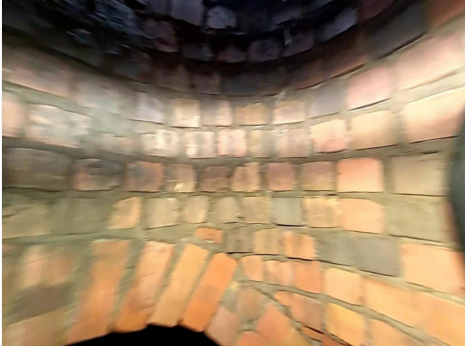
10.2	MMS - component:COI Continuous: F03 Clock from 12 to 12 Grade = 2	000044

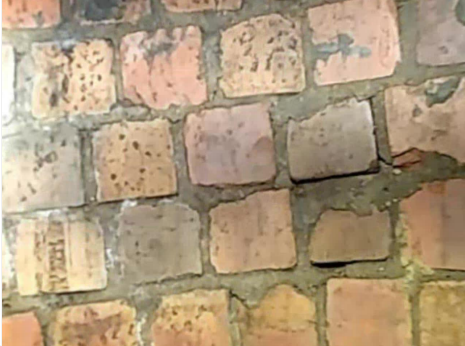
10.3	MMS - component:WI Continuous: S04 Clock from 12 to 12 Grade = 2	000048

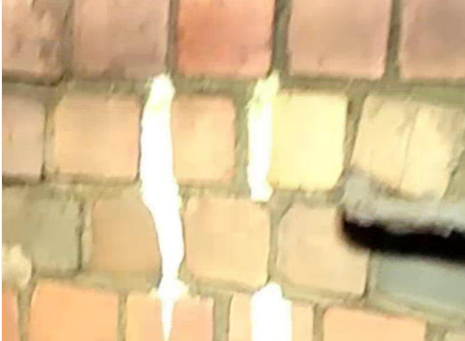
11.9	DAE - component:WI Percent: 5 Clock from 7 to 8 Grade = 1	000052

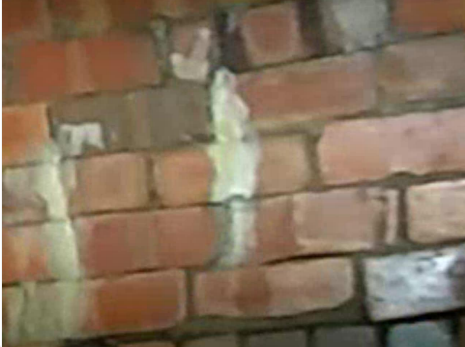
14.1	DAE - component:C Percent: 5 Clock from 2 to 3 Grade = 1	000057

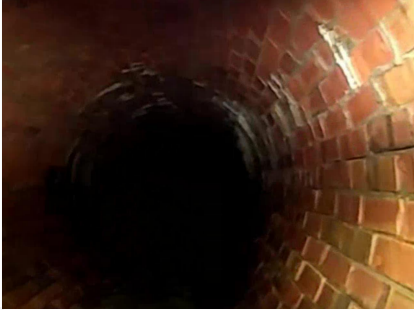
1	Incoming Connection Shape = Circle Height = 70 Pipe Condition = D Pipe Seal Condition = S Pipe type = GR Comments = H2S	16.9	6

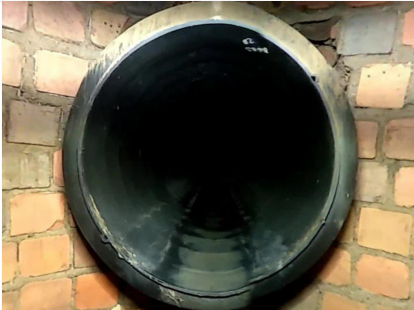
2	Incoming Connection Shape = Circle Height = 18 Pipe Condition = S Pipe Seal Condition = S Pipe type = GR	10.76	9

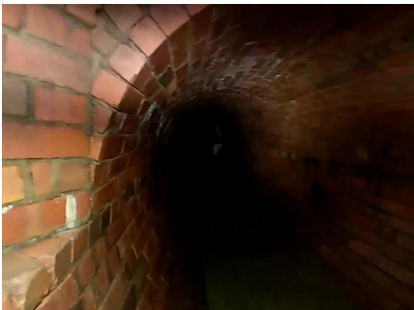
3	Incoming Connection Shape = Circle Height = 70 Pipe Condition = D Pipe Seal Condition = S Pipe type = GR Comments = H2S	16.8	12
