Project:		Date/Time:	June 28 2024 -
Street and City:	Silver St. & Miles - Marion	Weather:	Unknown Weather
Owner:		P.O. #	
Customer:		Inspection Status:	Remote Inspection
Surveyor Name and Certificate:	Dan Shrodes U-716-07004752	Inspection Level:	2
Reviewer Name and Certificate:	chad pauls P0036127-022022	MH:	MH12

Asset Details and Measurements

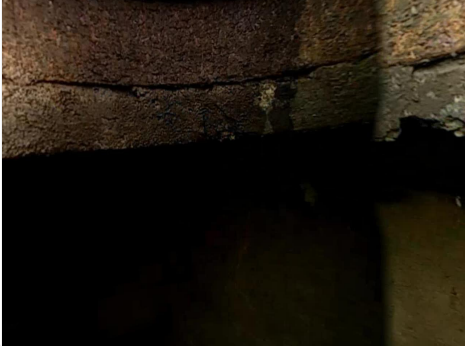
0.8	SSC - component:CMI Clock from 12 to 12 Grade = 2	000004

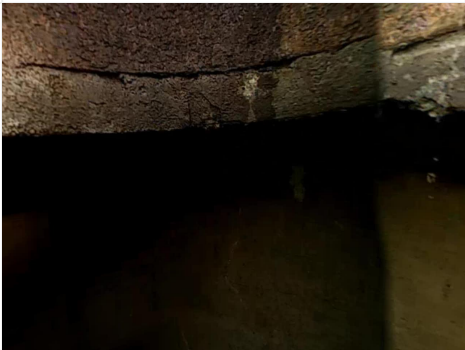
1	SSC - component:COI Clock from 12 to 12 Grade = 2	000004

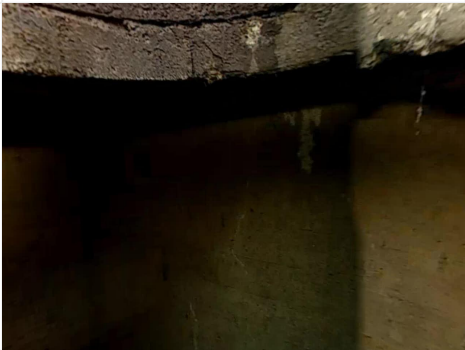
1.1	SSC - component:WI Continuous: S01 Clock from 12 to 12 Grade = 2	000005

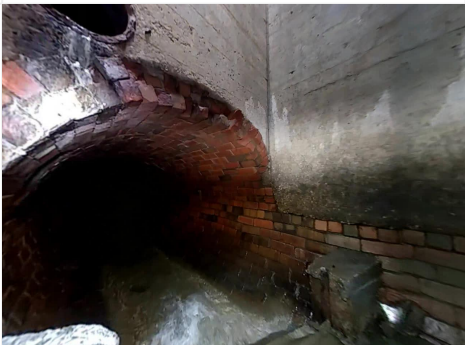
13.1	SSC - component:WI Continuous: F01 Clock from 12 to 12 Grade = 2	000018

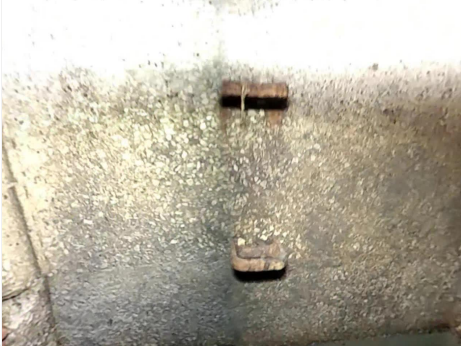
13.4	SSC - component:WI Continuous: S02 Clock At 2 Grade = 2	000018

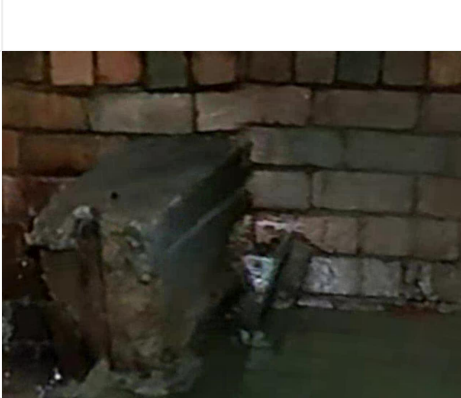
13.4	OBB - component:WI Continuous: S03 Percent: 5 Clock At 8 Grade = 1	000018

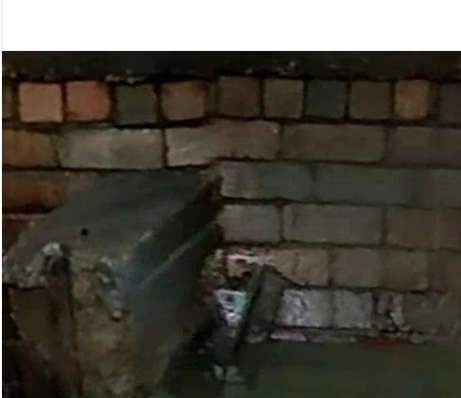
16	OBB - component:WI Continuous: F03 Percent: 5 Clock At 8 Grade = 1	000018

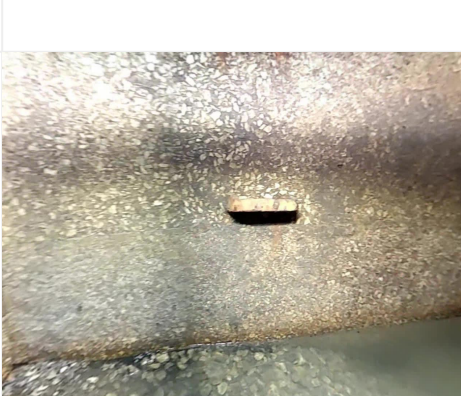
16	SSC - component:WI Continuous: F02 Clock At 2 Grade = 2	000022

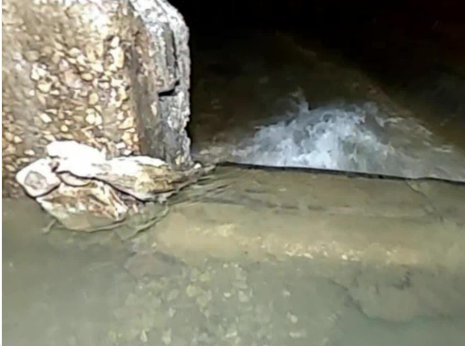
16.1	DSZ - component:B Percent: 5 Clock At 6 Remark = DEBRIS Grade = 1	000021

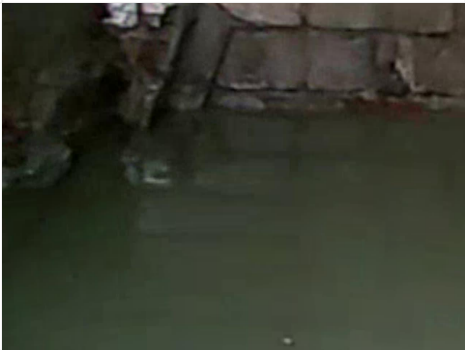
16.1	OBB - component:C Percent: 5 Clock At 8 Grade = 2	000021

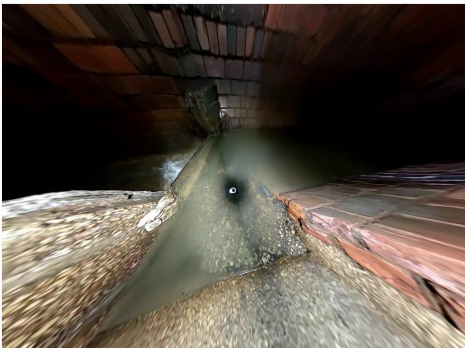
16.3	DSGV - component:C Percent: 10 Clock from 12 to 12 Grade = 1	000021

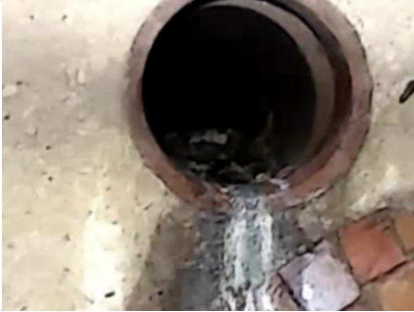
3	Incoming Connection Shape = Circle Height = 12 Pipe Condition = D Pipe Seal Condition = S Pipe type = GR Comments = DSZ	10.5	5
