Project:		Date/Time:	June 28 2024 -
Street and City:	Holland Rd. & Route 96 - Marion	Weather:	Dry - No precipitation during survey
Owner:		P.O. #	
Customer:		Inspection Status:	Remote Inspection
Surveyor Name and Certificate:	Dan Shrodes U-716-07004752	Inspection Level:	2
Reviewer Name and Certificate:	Kyle King P0047679-042024	MH:	MH3

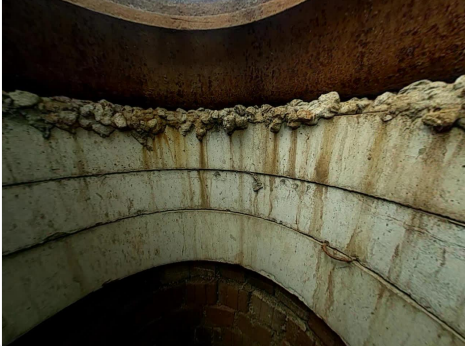
0.7	ISJ - component:CMI Joint: True Clock from 12 to 12 Grade = 1	000009

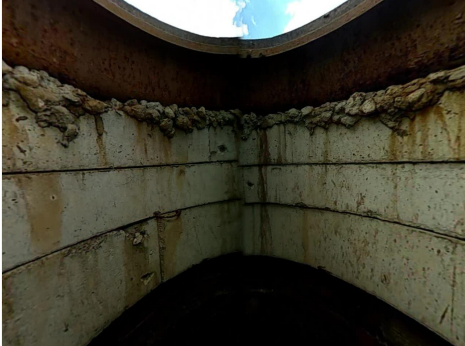
0.7	SRI - component:CMI Continuous: S01 Joint: True Clock from 12 to 12 Grade = 1	000010

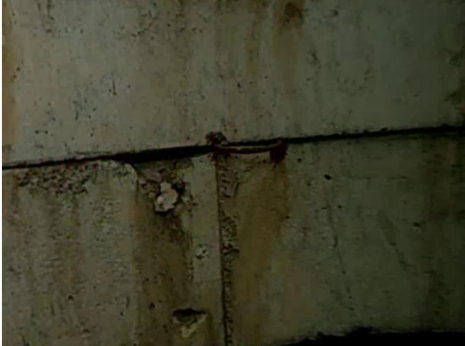
1.2	OBS - component:CMI Percent: 5 Clock At 5 Remark = LIFTING POINT Grade = 1	000010

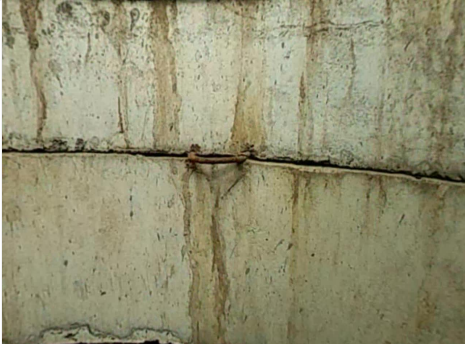
1.2	OBS - component:CMI Percent: 5 Clock At 10 Remark = LIFTING POINT Grade = 1	000010

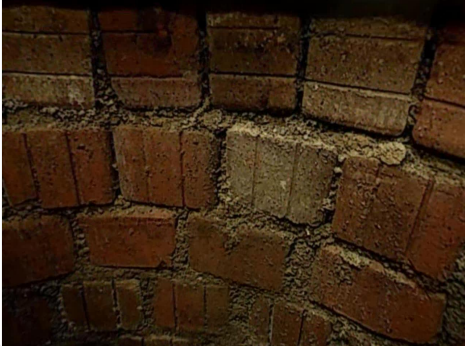
1.9	MMS - component:CMI Continuous: S02 Clock from 12 to 12 Grade = 2	000012

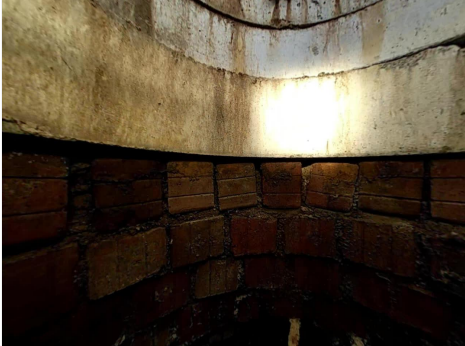
2	SRI - component:CMI Continuous: F01 Joint: True Clock from 12 to 12 Grade = 1	000012

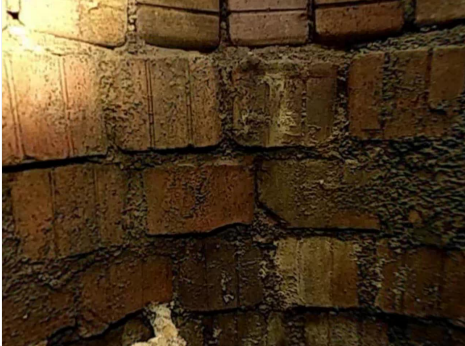
2.6	DAZ - component:CMI Continuous: S03 Percent: 5 Clock from 12 to 12 Remark = DIRT/DEBRIS Grade = 1	000013

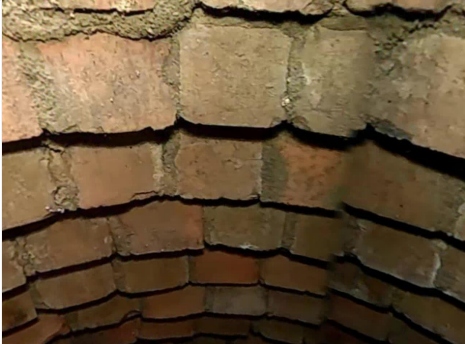
4	MMS - component:CMI Continuous: F02 Clock from 12 to 12 Grade = 2	000022

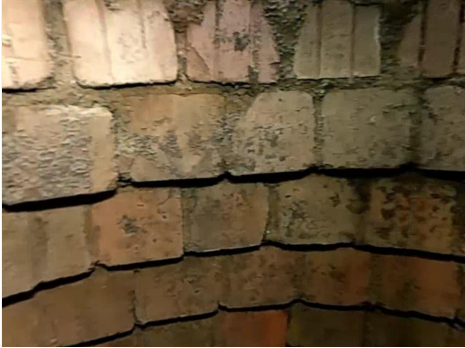
4.1	DAZ - component:CMI Continuous: F03 Percent: 5 Clock from 12 to 12 Remark = DIRT/DEBRIS Grade = 1	000022

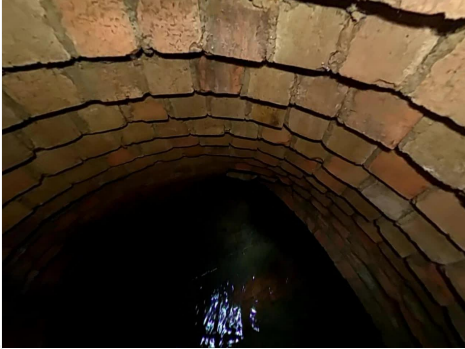
4.2	MMS - component:COI Continuous: S04 Clock from 12 to 12 Grade = 2	000025

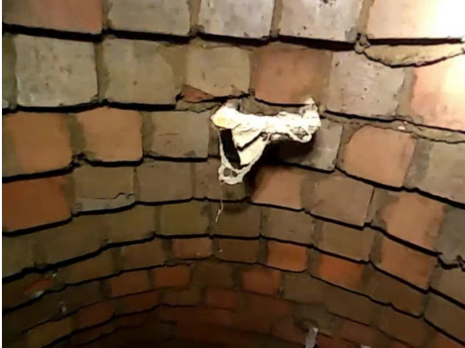
4.7	DAZ - component:COI Percent: 5 Clock At 3 Remark = DEBRIS Grade = 1	000027

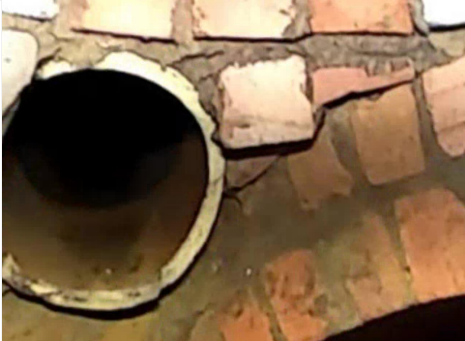
7.7	DB - component:COI Clock At 11 Grade = 3	000033

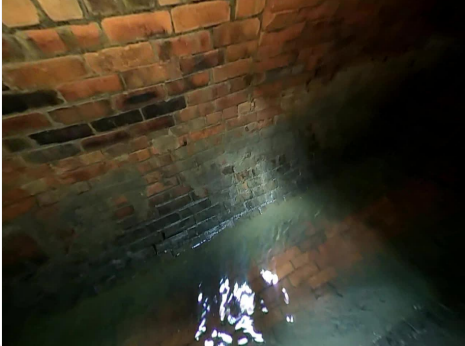
8.5	MMS - component:COI Continuous: F04 Clock from 12 to 12 Grade = 2	000038

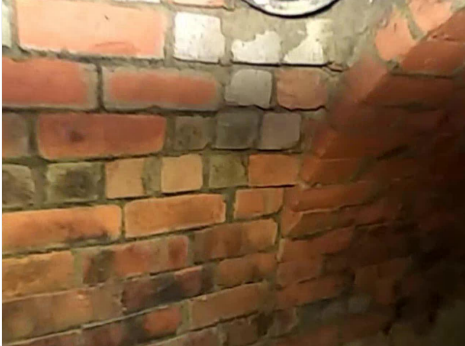
8.7	MMS - component:C Continuous: S05 Clock from 12 to 12 Grade = 2	000038

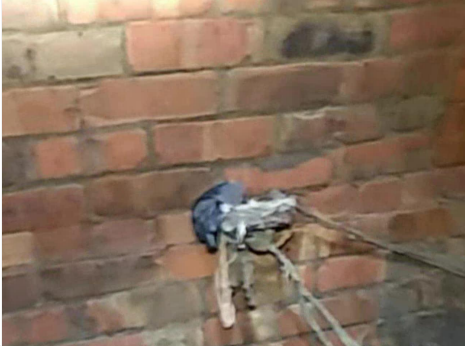
11.9	DAZ - component:C Percent: 5 Clock At 3 Remark = WASTE/DEBRIS Grade = 1	000041

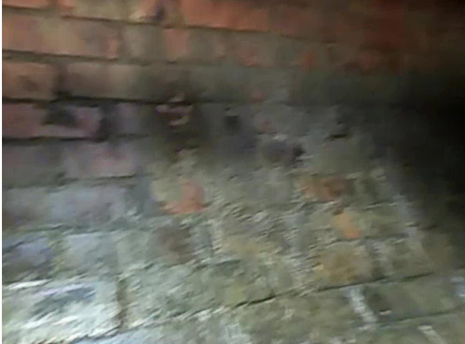
11.9	MMS - component:C Continuous: F05 Clock from 12 to 12 Grade = 2	000057

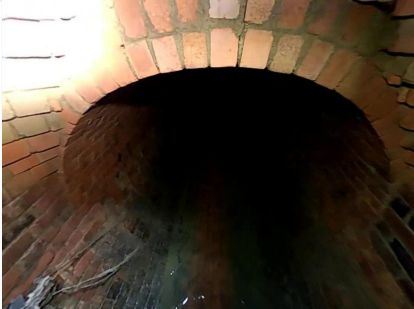
1	Outgoing Connection Shape = Circle Height = 78 Pipe Condition = D Pipe Seal Condition = D Pipe type = GR Comments = MMS	14.3	6

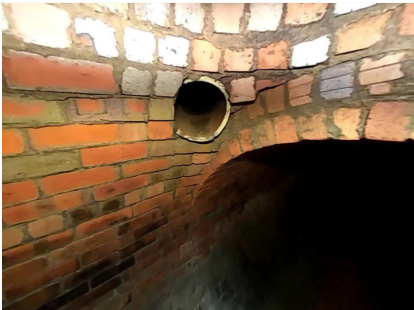
2	Incoming Connection Shape = Circle Height = 10 Pipe Condition = S Pipe Seal Condition = D Pipe type = GR Comments = DB, MMS	8	11

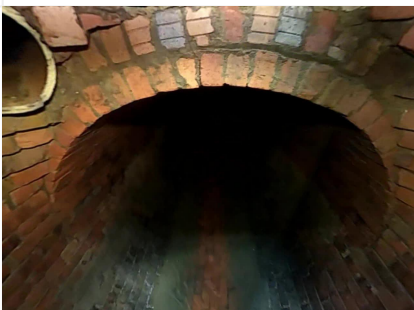
3	Incoming Connection Shape = Circle Height = 78 Pipe Condition = D Pipe Seal Condition = D Pipe type = GR Comments = MMS	14.2	12
