| Project: | | Date/Time: | June 28 2024 - |
| Street and City: | 1650 Holland Rd. - Marion | Weather: | Unknown Weather |
| Reviewer Name and Certificate: | chad pauls P0036127-022022 | MH: | MH4 |

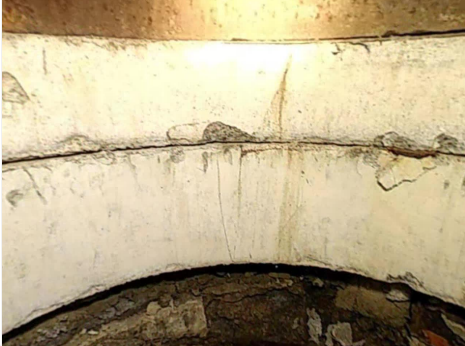
| Photo | Distance | Description | Time |
|---|---|--|---|
| | 0.7 | SSC - component:CMI Clock from 12 to 12 Grade = 2 | 000012 |

| Component | Dist. | Code | Cont. | Dim. 1 | Dim. 2 | % | Joint | Clock From | Clock To | Remarks |
|---|---|---|---|---|---|---|---|---|---|---|
| Chimney Interior | 0.7 | SSC | | | | | | 12 | 12 | |

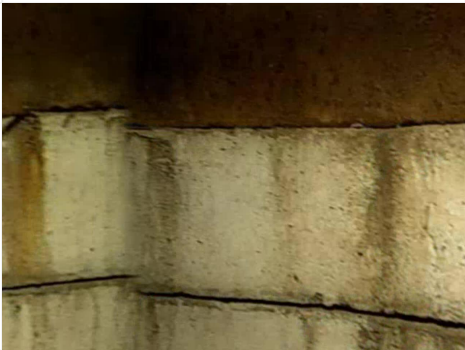
| Photo | Distance | Description | Time |
|---|---|--|---|
| | 0.7 | ISJ - component:CMI Joint: True Clock from 12 to 12 Grade = 1 | 000012 |

| Component | Dist. | Code | Cont. | Dim. 1 | Dim. 2 | % | Joint | Clock From | Clock To | Remarks |
|---|---|---|---|---|---|---|---|---|---|---|
| Chimney Interior | 0.7 | ISJ | | | | | True | 12 | 12 | |

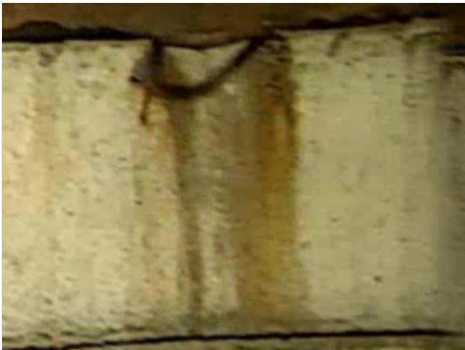
| Photo | Distance | Description | Time |
|---|---|--|---|
| | 0.7 | OBZ - component:CMI Percent: 5 Joint: True Clock At 2 Remark = METAL LOOP Grade = 1 | 000012 |

| Component | Dist. | Code | Cont. | Dim. 1 | Dim. 2 | % | Joint | Clock From | Clock To | Remarks |
|---|---|---|---|---|---|---|---|---|---|---|
| Chimney Interior | 0.7 | OBZ | | | | 5 | True | 2 | | METAL LOOP |

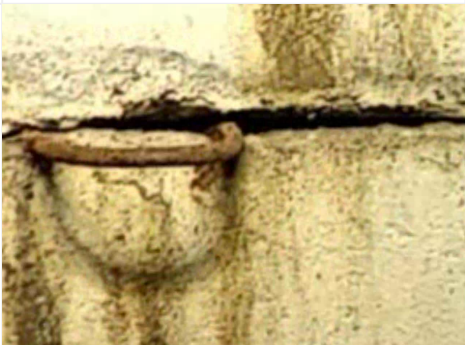
| Photo | Distance | Description | Time |
|---|---|--|---|
| | 0.8 | OBZ - component:CMI Percent: 5 Joint: True Clock At 7 Remark = METAL LOOP Grade = 1 | 000013 |

| Component | Dist. | Code | Cont. | Dim. 1 | Dim. 2 | % | Joint | Clock From | Clock To | Remarks |
|---|---|---|---|---|---|---|---|---|---|---|
| Chimney Interior | 0.8 | OBZ | | | | 5 | True | 7 | | METAL LOOP |

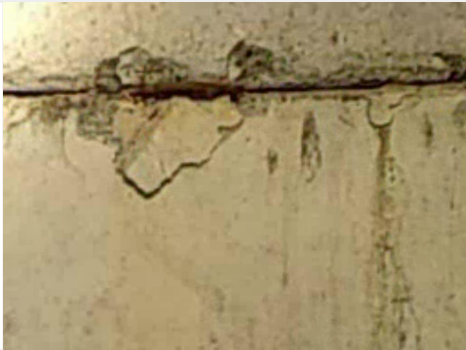
| Photo | Distance | Description | Time |
|---|---|--|---|
| | 1 | OBZ - component:CMI Percent: 5 Joint: True Clock At 1 Remark = METAL LOOP Grade = 1 | 000014 |

| Component | Dist. | Code | Cont. | Dim. 1 | Dim. 2 | % | Joint | Clock From | Clock To | Remarks |
|---|---|---|---|---|---|---|---|---|---|---|
| Chimney Interior | 1 | OBZ | | | | 5 | True | 1 | | METAL LOOP |

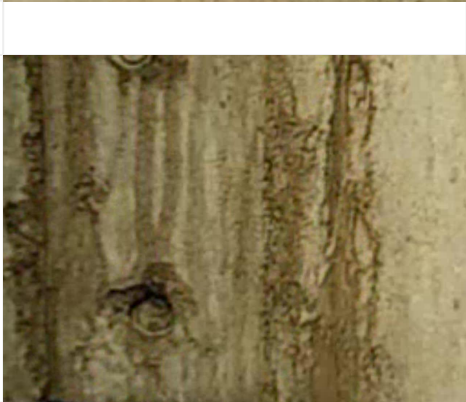
| Photo | Distance | Description | Time |
|---|---|--|---|
| | 1.1 | OBZ - component:CMI Percent: 5 Clock At 3 Remark = BOLTS Grade = 1 | 000014 |

| Component | Dist. | Code | Cont. | Dim. 1 | Dim. 2 | % | Joint | Clock From | Clock To | Remarks |
|---|---|---|---|---|---|---|---|---|---|---|
| Chimney Interior | 1.1 | OBZ | | | | 5 | | 3 | | BOLTS |

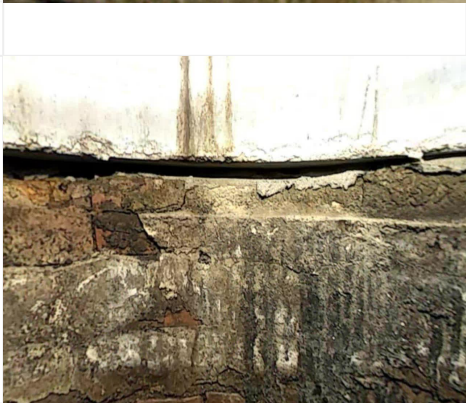
| Photo | Distance | Description | Time |
|---|---|--|---|
| | 1.6 | SSC - component:WI Clock from 12 to 12 Grade = 2 | 000016 |

| Component | Dist. | Code | Cont. | Dim. 1 | Dim. 2 | % | Joint | Clock From | Clock To | Remarks |
|---|---|---|---|---|---|---|---|---|---|---|
| Chimney Interior | 1.6 | SSC | | | | | | 12 | 12 | |

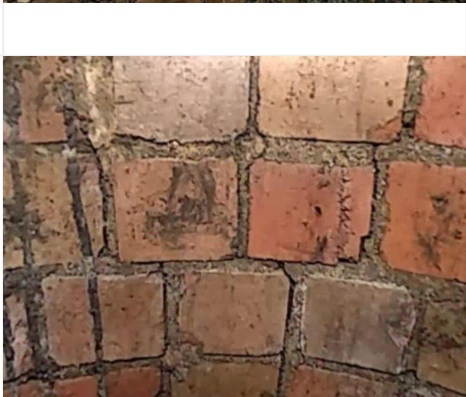
| Photo | Distance | Description | Time |
|---|---|--|---|
| | 2.2 | MMS - component:WI Continuous: S02 Clock from 12 to 12 Grade = 2 | 000017 |

| Component | Dist. | Code | Cont. | Dim. 1 | Dim. 2 | % | Joint | Clock From | Clock To | Remarks |
|---|---|---|---|---|---|---|---|---|---|---|
| Wall Interior | 2.2 | MMS | S02 | | | | | 12 | 12 | |

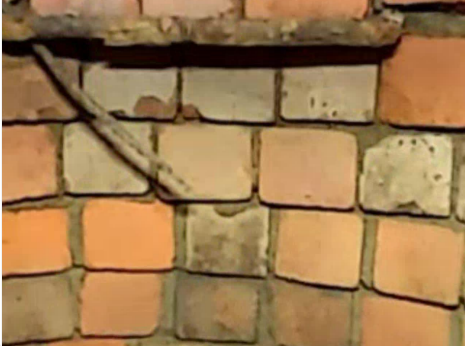
| Photo | Distance | Description | Time |
|---|---|---|---|
| | 6.1 | DAZ - component:WI Percent: 5 Clock At 3 Remark = MISC MATERIAL Grade = 1 | 000037 |

| Component | Dist. | Code | Cont. | Dim. 1 | Dim. 2 | % | Joint | Clock From | Clock To | Remarks |
|---|---|---|---|---|---|---|---|---|---|---|
| Wall Interior | 6.1 | DAZ | | | | 5 | | 3 | | MISC MATERIAL |

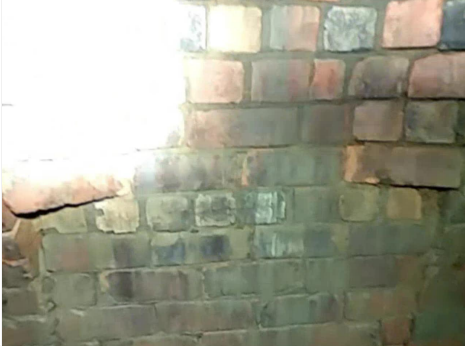
| Photo | Distance | Description | Time |
|---|---|---|---|
| | 8.4 | MMS - component:WI Continuous: F02 Clock from 12 to 12 Grade = 2 | 000046 |

| Component | Dist. | Code | Cont. | Dim. 1 | Dim. 2 | % | Joint | Clock From | Clock To | Remarks |
|---|---|---|---|---|---|---|---|---|---|---|
| Wall Interior | 8.4 | MMS | F02 | | | | | 12 | 12 | |

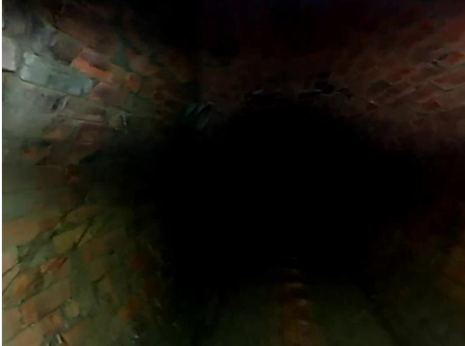
| Photo | Distance | Description | Time |
|---|---|---|---|
| | 9.7 | RFB - component:B Clock At 12 Grade = 1 | 000050 |

| Component | Dist. | Code | Cont. | Dim. 1 | Dim. 2 | % | Joint | Clock From | Clock To | Remarks |
|---|---|---|---|---|---|---|---|---|---|---|
| Bench | 9.7 | RFB | | | | | | 12 | | |

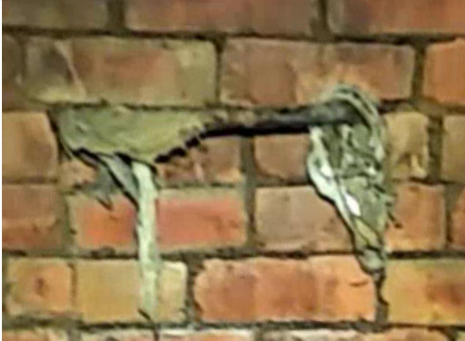
| Photo | Distance | Description | Time |
|---|---|---|---|
| | 9.7 | DAZ - component:B Percent: 5 Clock At 3 Remark = DEBRIS Grade = 1 | 000050 |

| Component | Dist. | Code | Cont. | Dim. 1 | Dim. 2 | % | Joint | Clock From | Clock To | Remarks |
|---|---|---|---|---|---|---|---|---|---|---|
| Bench | 9.7 | DAZ | | | | 5 | | 3 | | DEBRIS |

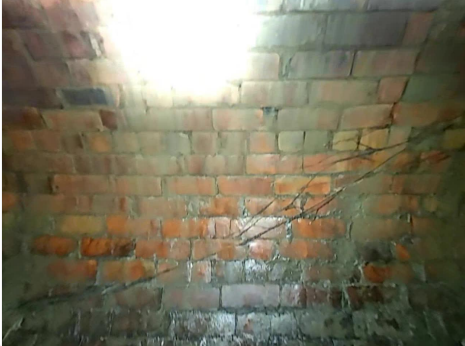
| Photo | Distance | Description | Time |
|--|---|--|---|
| | 9.7 | RFB - component:C Clock At 9 Grade = 2 | 000050 |

| Component | Dist. | Code | Cont. | Dim. 1 | Dim. 2 | % | Joint | Clock From | Clock To | Remarks |
|---|---|---|---|---|---|---|---|---|---|---|
| Channel | 9.7 | RFB | | | | | | 9 | | |

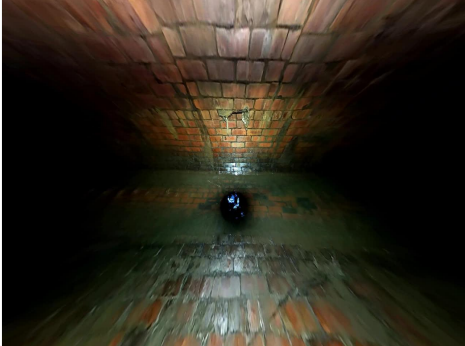
| Photo | Distance | Description | Time |
|--|---|--|---|
| | 13.5 | MMS - component:C Clock from 6 to 12 Grade = 2 | 000050 |

| Component | Dist. | Code | Cont. | Dim. 1 | Dim. 2 | % | Joint | Clock From | Clock To | Remarks |
|---|---|---|---|---|---|---|---|---|---|---|
| Channel | 13.5 | MMS | | | | | | 6 | 12 | |

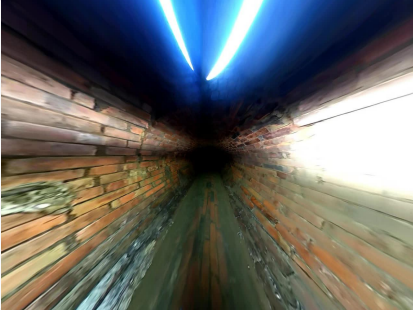
| Photo | Number | Description | Depth | Clock |
|--|---|---|---|---|
| | 1 | Outgoing Connection Shape = Circle Height = 75 Pipe Condition = S Pipe Seal Condition = S Pipe type = GR | 13.7 | 6 |

| Pipe No. | Clock | Rim to Invert | Direction | Material | Shape | Height (Dia.) | Condition | Seal Cond. | Pipe ID |
|---|---|---|---|---|---|---|---|---|---|
| 1 | 6 | 13.7 | O | BR | Circular | 75 | S | S | |

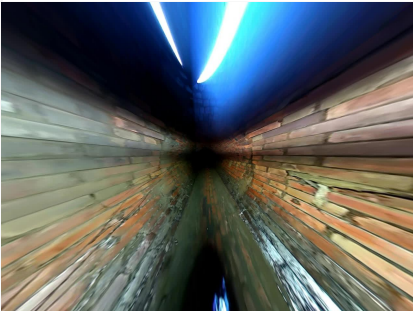
| Photo | Number | Description | Depth | Clock |
|--|---|---|---|---|
| | 2 | Incoming Connection Shape = Circle Height = 75 Pipe Condition = D Pipe Seal Condition = S Pipe type = GR Comments = RFB/DAE | 13.6 | 12 |

| Pipe No. | Clock | Rim to Invert | Direction | Material | Shape | Height (Dia.) | Condition | Seal Cond. | Pipe ID |
|---|---|---|---|---|---|---|---|---|---|
| 2 | 12 | 13.7 | I | BR | Circular | 75 | D | S | |
