Project:		Date/Time:	June 28 2024 -
Street and City:	1045 Holland Rd. - Marion	Weather:	Dry - No precipitation during survey
Owner:		P.O. #	
Customer:		Inspection Status:	Remote Inspection
Surveyor Name and Certificate:	Dan Shrodes U-716-07004752	Inspection Level:	2
Reviewer Name and Certificate:	Kyle King P0047679-042024	MH:	MH5

Asset Details and Measurements

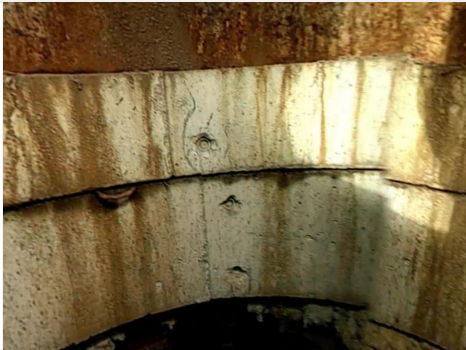
0.5	ISB - component:CMI Joint: True Clock from 12 to 12 Grade = 1	000005

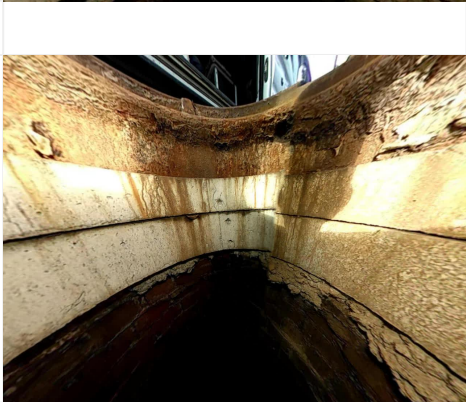
0.7	SRI - component:CMI Clock At 10 Grade = 1	000006

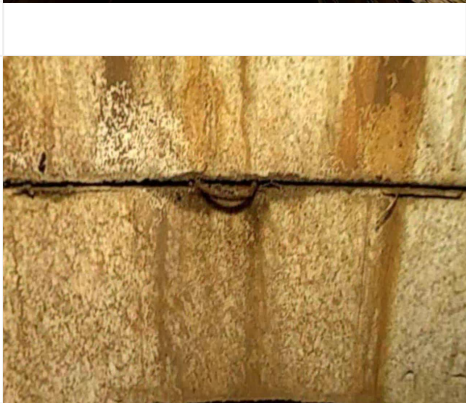
0.8	OBS - component:CMI Percent: 5 Clock At 9 Remark = LIFTING POINT Grade = 1	000006

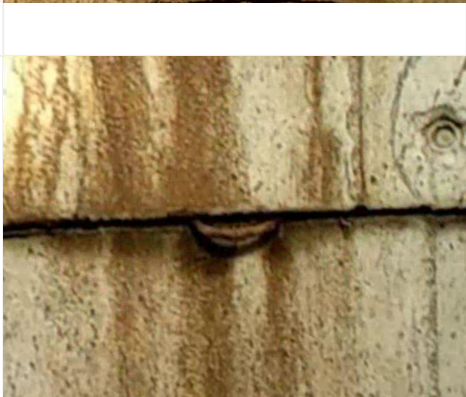
0.8	OBS - component:CMI Percent: 5 Clock At 3 Grade = 1	000006

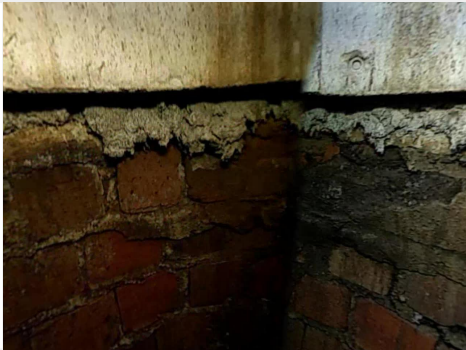
1.4	MMS - component:CMI Clock from 12 to 12 Grade = 2	000007

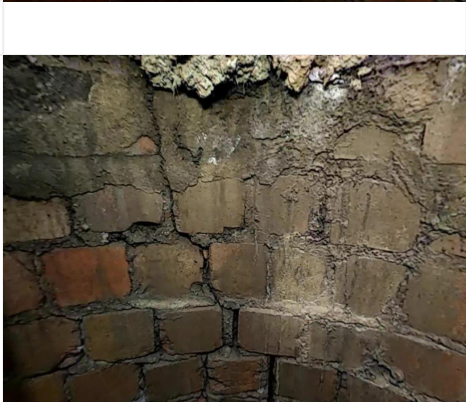
1.7	FS - component:CMI Continuous: S02 Clock from 5 to 6 Grade = 3	000007

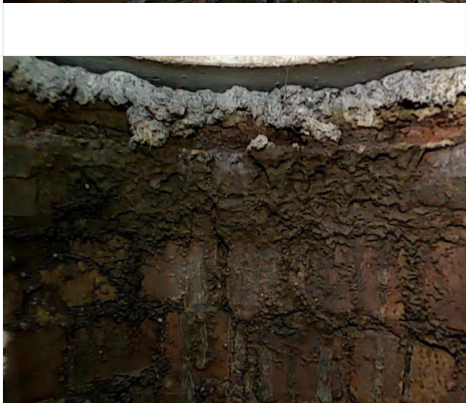
1.7	DAZ - component:CMI Percent: 5 Clock from 10 to 12 Remark = DIRT/DEBRIS Grade = 1	000007

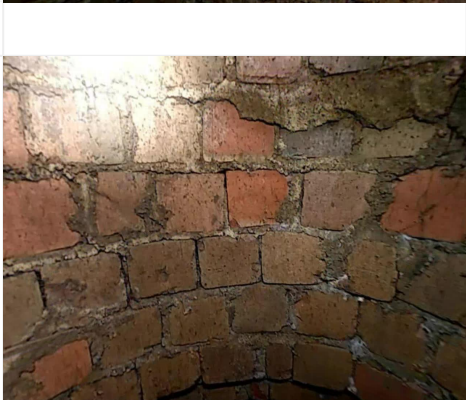
2.1	MMS - component:CMI Continuous: S01 Clock from 12 to 12 Grade = 2	000008

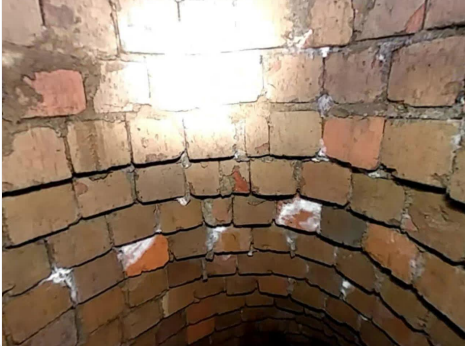
3.4	MMS - component:CMI Continuous: F01 Clock from 12 to 12 Grade = 2	000011

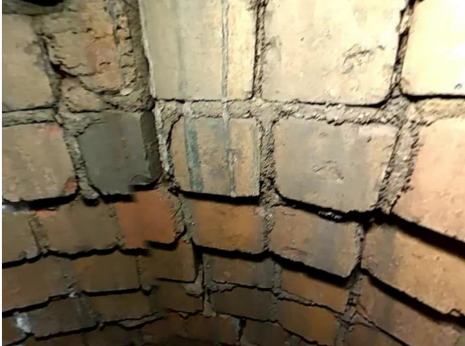
3.4	FS - component:CMI Continuous: F02 Clock from 5 to 6 Grade = 3	000011

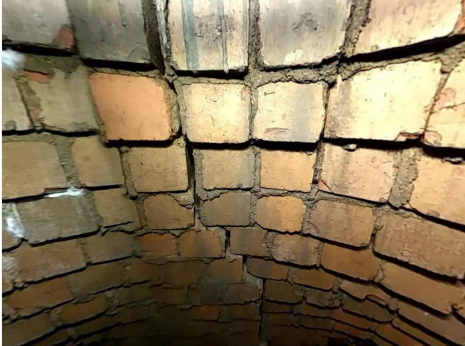
3.6	FS - component:COI Continuous: S04 Clock from 6 to 7 Grade = 3	000015

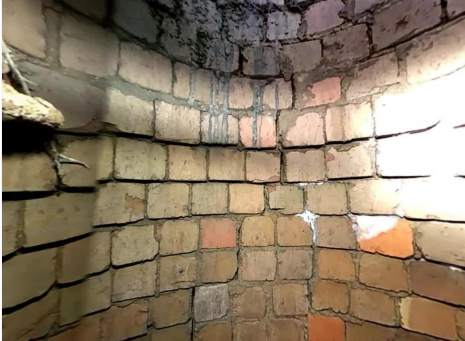
3.6	MMS - component:COI Continuous: S03 Clock from 12 to 12 Grade = 2	000015

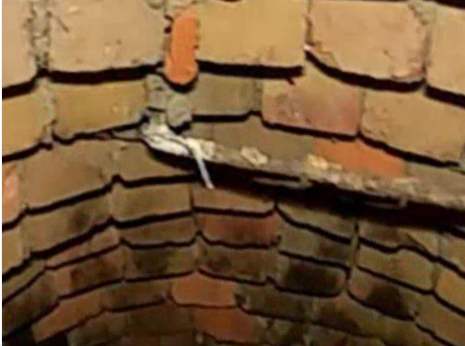
4.1	RFB - component:COI Clock At 9 Grade = 1	000017

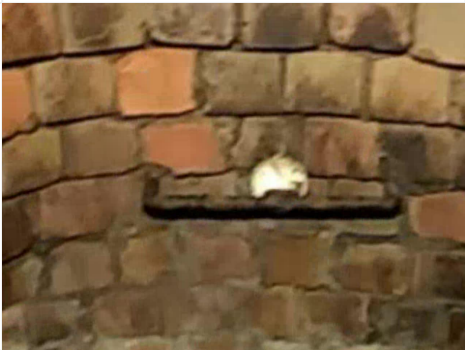
6	DAZ - component:COI Percent: 5 Clock At 9 Remark = DEBRIS Grade = 1	000021

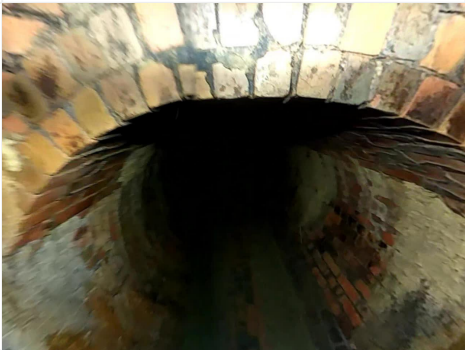
7.4	FS - component:COI Continuous: F04 Clock from 6 to 7 Grade = 3	000024

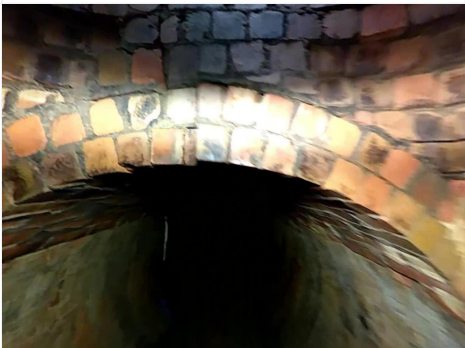
7.4	MMS - component:COI Continuous: F03 Clock from 12 to 12 Grade = 2	000024

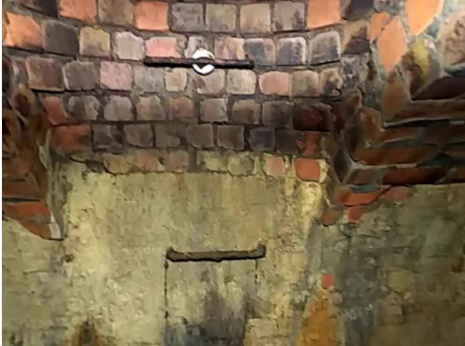
7.6	MMS - component:WI Clock from 12 to 12 Grade = 2	000025

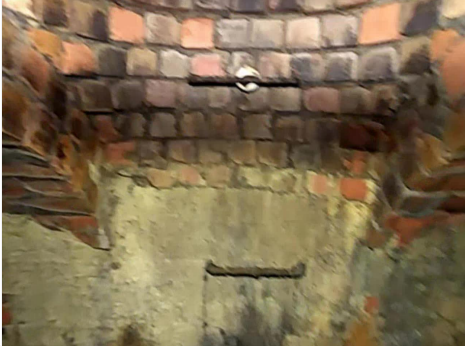
8.1	IWC - component:WI Clock from 6 to 12 Grade = 2	000024

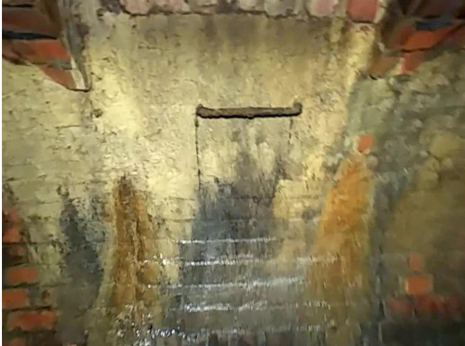
8.1	DAE - component:WI Percent: 5 Clock from 6 to 12 Grade = 1	000025

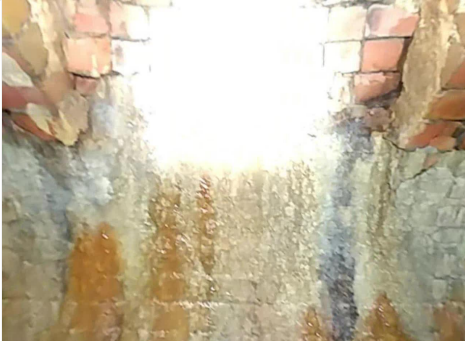
8.3	IWC - component:WI Clock from 12 to 6 Grade = 2	000026

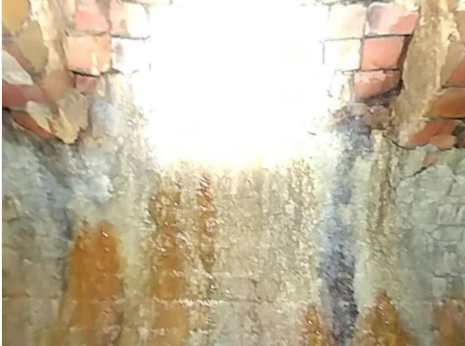
8.3	DAE - component:WI Percent: 5 Clock from 12 to 6 Grade = 1	000026

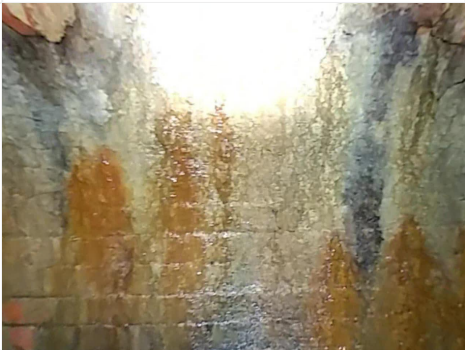
8.7	IWC - component:C Continuous: S06 Clock from 12 to 6 Grade = 2	000027

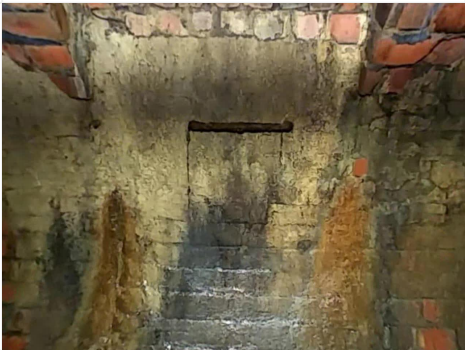
8.7	IWC - component:C Continuous: S05 Clock from 6 to 12 Grade = 2	000027

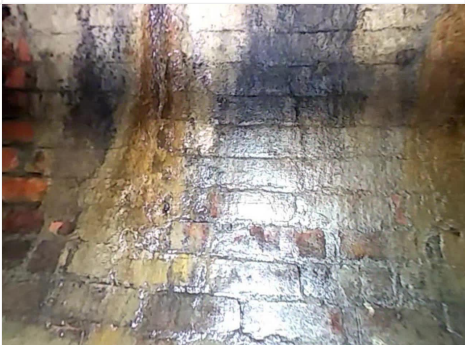
12.5	IWC - component:C Continuous: F05 Clock from 6 to 12 Grade = 2	000036

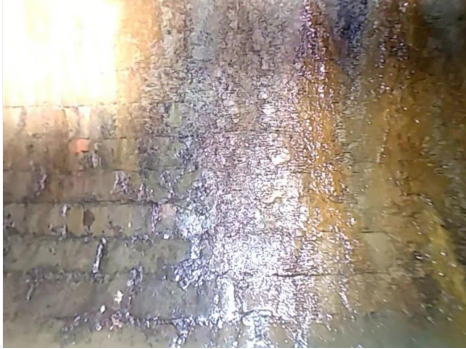
12.5	IWC - component:C Continuous: F06 Clock from 12 to 6 Grade = 2	000036

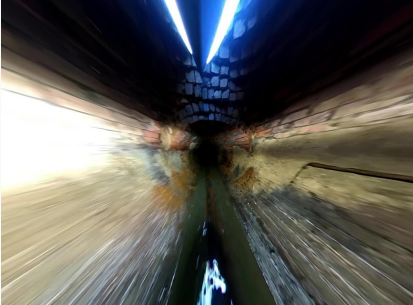
1	Outgoing Connection Shape = Circle Height = 71 Pipe Condition = D Pipe Seal Condition = D Pipe type = GR	13.1	6

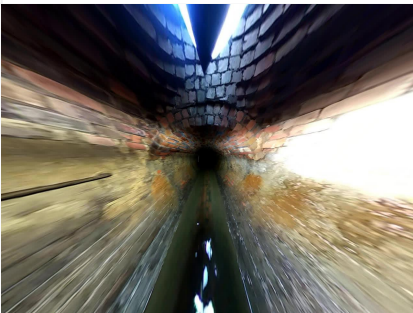
2	Incoming Connection Shape = Circle Height = 71 Pipe Condition = D Pipe Seal Condition = D Pipe type = GR	13	12
