Project:		Date/Time:	June 28 2024 -
Street and City:	1045 Holland Rd. - Marion	Weather:	Dry - No precipitation during survey
Owner:		P.O. #	
Customer:		Inspection Status:	Remote Inspection
Surveyor Name and Certificate:	Dan Shrodes U-716-07004752	Inspection Level:	2
Reviewer Name and Certificate:	Kyle King P0047679-042024	MH:	MH6

Asset Details and Measurements

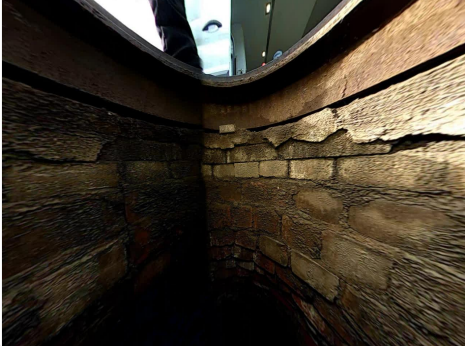
0.8	MMS - component:CMI Continuous: S01 Clock from 12 to 12 Grade = 2	000005

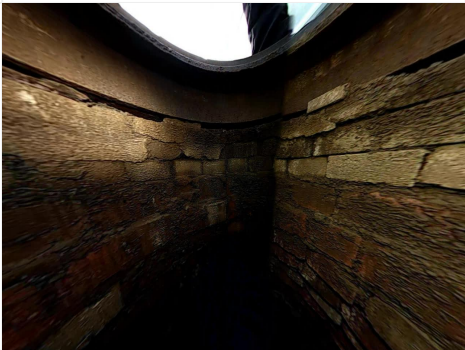
0.8	DAZ - component:CMI Continuous: S02 Percent: 5 Clock from 12 to 12 Remark = WASTE/DEBRIS Grade = 1	000005

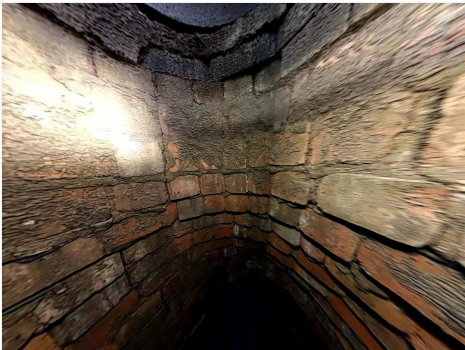
1.8	DAZ - component:CMI Continuous: F02 Percent: 5 Clock from 12 to 12 Remark = WASTE/DEBRIS Grade = 1	000007

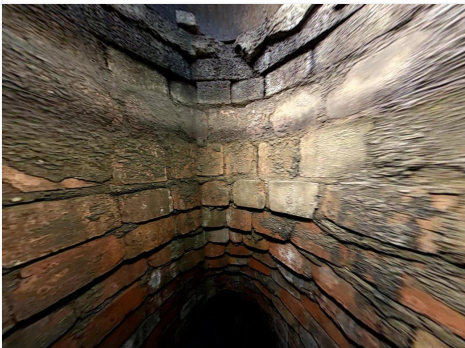
1.8	MMS - component:CMI Continuous: F01 Clock from 12 to 12 Grade = 2	000007

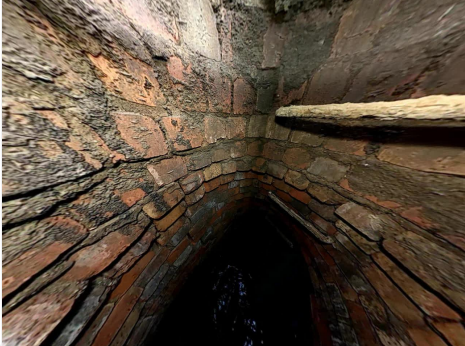
1.9	MMS - component:COI Continuous: S03 Clock from 12 to 12 Grade = 2	000008

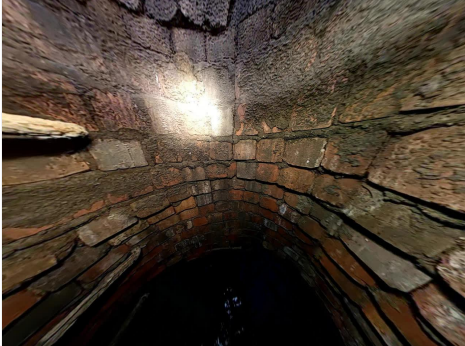
1.9	DAZ - component:COI Percent: 5 Clock from 12 to 12 Remark = WASTE/DEBRIS Grade = 1	000008

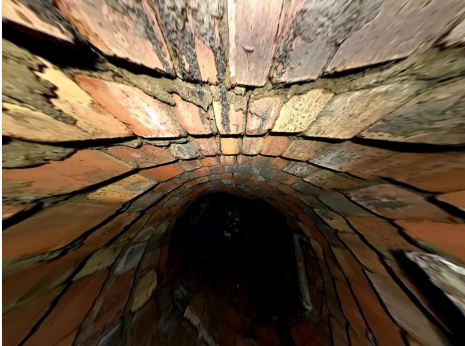
2.6	FS - component:COI Continuous: S04 Clock from 5 to 6 Grade = 3	000009

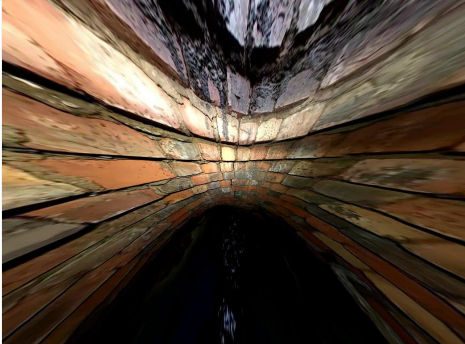
3	MMM - component:COI Continuous: S05 Clock from 5 to 6 Grade = 3	000010

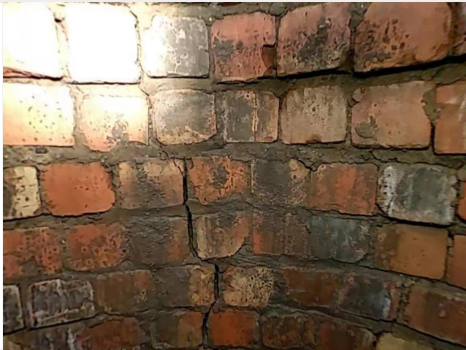
3.2	FL - component:COI Continuous: S06 Clock At 12 Grade = 3	000011

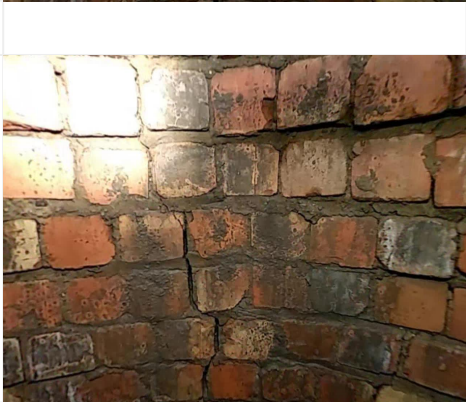
3.2	MMM - component:COI Continuous: S07 Clock At 12 Grade = 3	000011

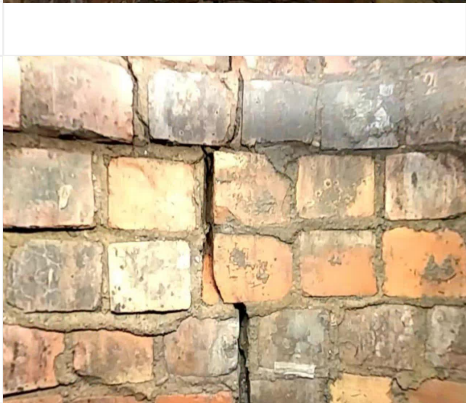
3.8	B - component:COI Clock At 5 Grade = 5	000011

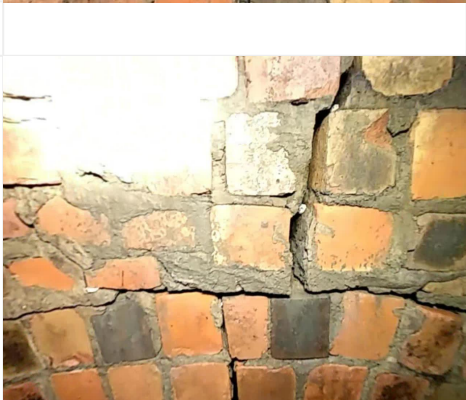
5.9	MMM - component:COI Continuous: F07 Clock At 12 Grade = 3	000015

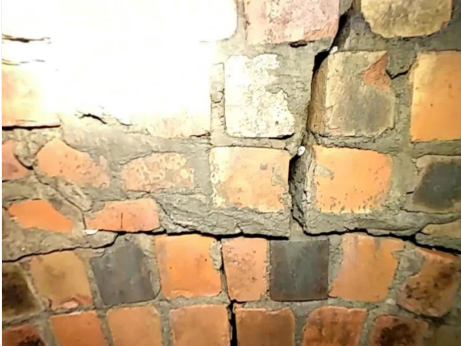
5.9	FL - component:COI Continuous: F06 Clock At 12 Grade = 3	000015

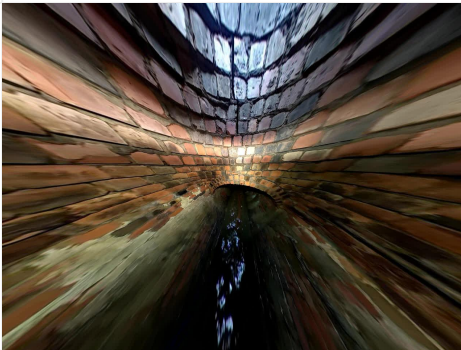
5.9	MMM - component:COI Continuous: F05 Clock from 5 to 7 Grade = 3	000015

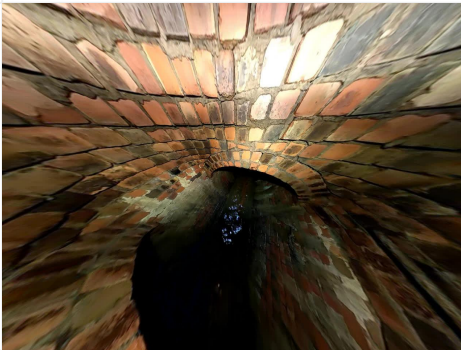
5.9	FS - component:COI Continuous: F04 Clock from 5 to 7 Grade = 3	000015

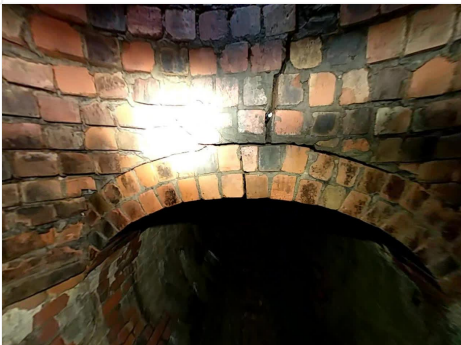
6.4	DB - component:COI Clock At 12 Grade = 3	000021

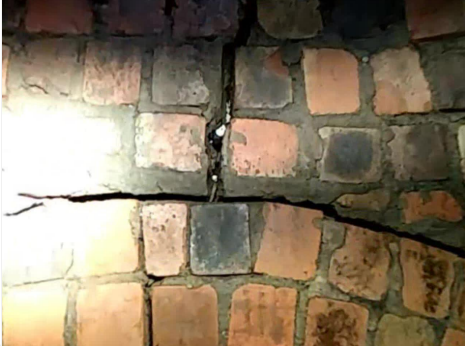
6.5	H - component:COI Clock At 12 Grade = 2	000021

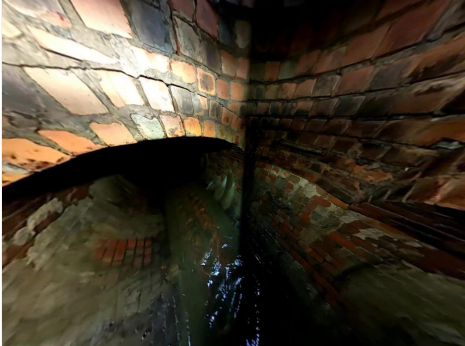
6.8	MMS - component:COI Continuous: F03 Clock from 12 to 12 Grade = 2	000022

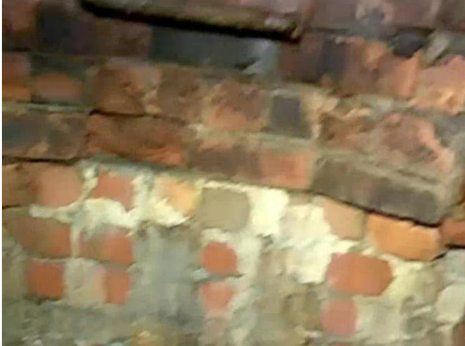
7.3	MMS - component:WI Clock from 12 to 12 Grade = 2	000023

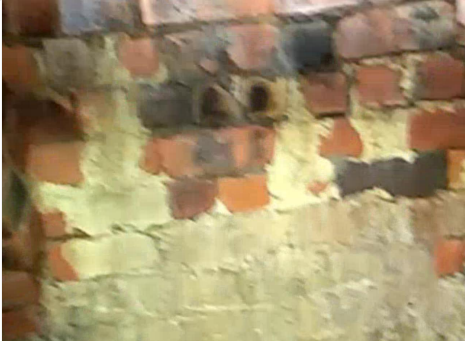
7.3	ISB - component:WI Clock from 2 to 4 Grade = 1	000023

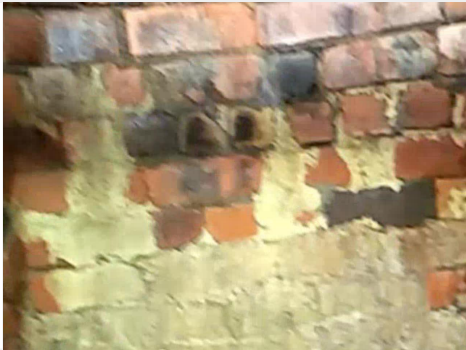
7.4	DAE - component:WI Percent: 5 Clock from 2 to 4 Grade = 1	000023

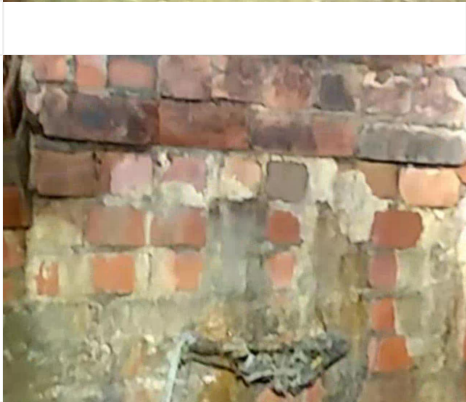
8.2	ISB - component:C Clock from 8 to 10 Grade = 1	000024

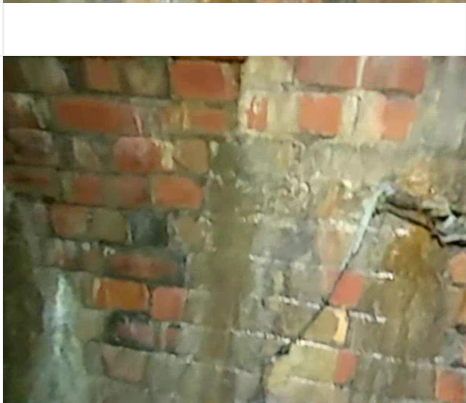
8.2	IWC - component:C Continuous: S10 Clock At 7 Grade = 2	000024

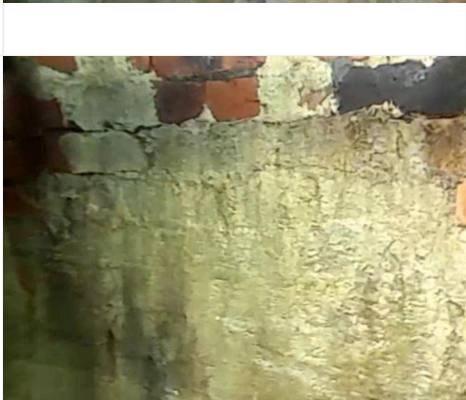
8.2	DAE - component:C Continuous: S09 Percent: 5 Clock from 1 to 5 Grade = 1	000024

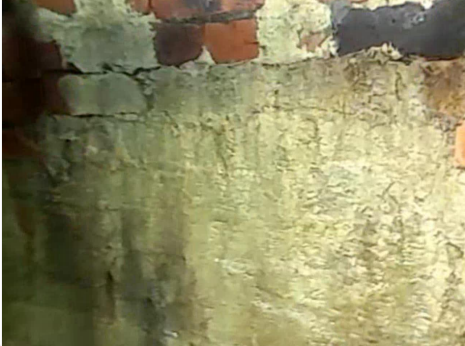
8.2	IWC - component:C Continuous: S08 Clock from 1 to 5 Grade = 2	000024

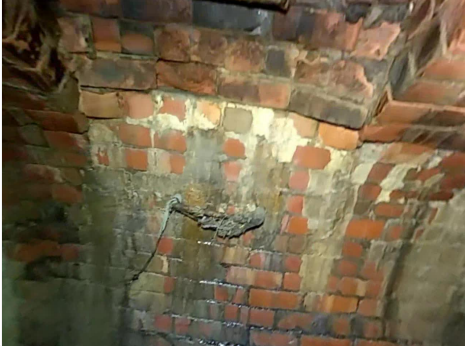
9.1	DAR - component:C Percent: 5 Clock At 9 Remark = WASTE/DEBRIS Grade = 1	000023

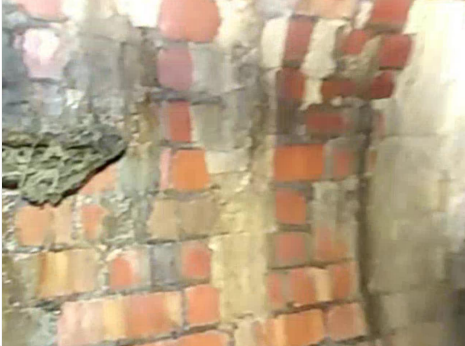
9.1	IWC - component:C Clock At 11 Grade = 2	000025

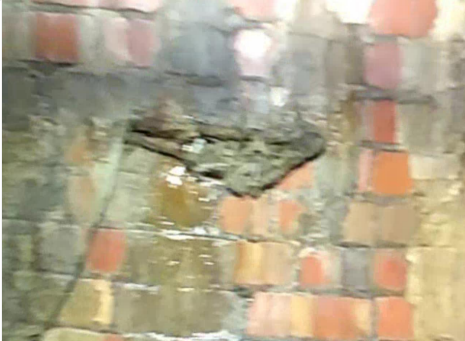
9.2	IWB - component:C Clock At 9 Grade = 2	000025

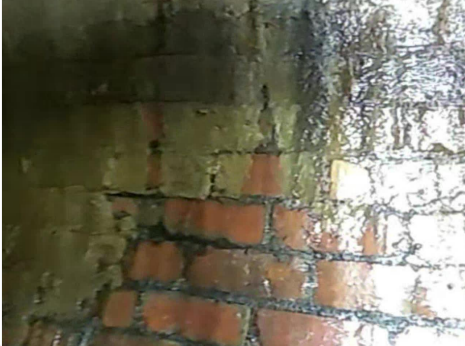
11.5	DAE - component:C Continuous: F09 Percent: 5 Clock from 1 to 5 Grade = 1	000031

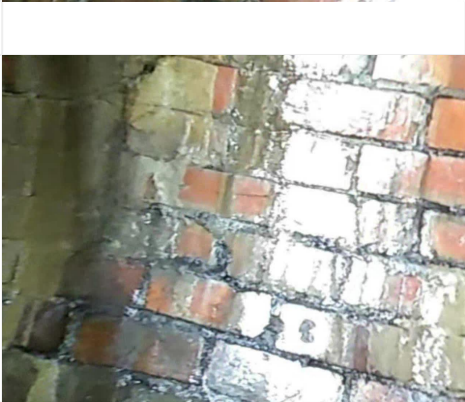
11.5	IWC - component:C Continuous: F10 Clock At 7 Grade = 2	000031

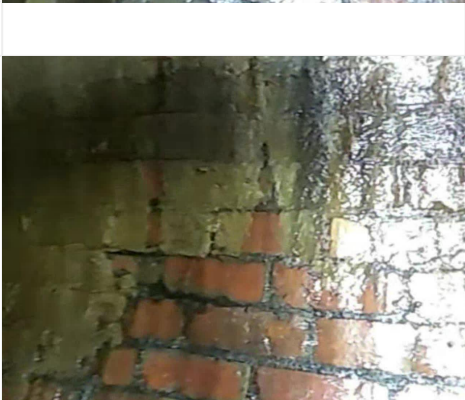
11.5	IWC - component:C Continuous: F08 Clock from 1 to 5 Grade = 2	000031

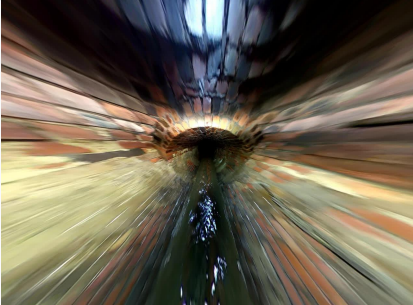
1	Outgoing Connection Shape = Circle Height = 78 Pipe Condition = D Pipe Seal Condition = D Pipe type = GR Comments = MMM, FS	12.7	6

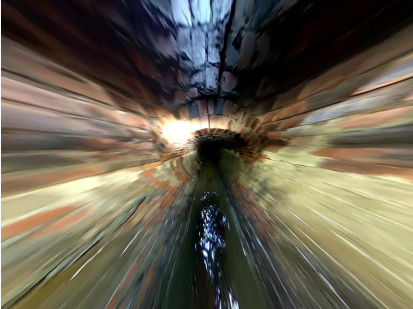
2	Incoming Connection Shape = Circle Height = 78 Pipe Condition = D Pipe Seal Condition = D Pipe type = GR Comments = H, DB, FL, MMM	12.6	12
