Project:		Date/Time:	June 28 2024 -
Street and City:	Holland Rd. - Marion	Weather:	Unknown Weather
Owner:		P.O. #	
Customer:		Inspection Status:	Remote Inspection
Surveyor Name and Certificate:	Dan Shrodes U-716-07004752	Inspection Level:	2
Reviewer Name and Certificate:	Jessy Vargas-Bloom P0034044-102021	MH:	MH7

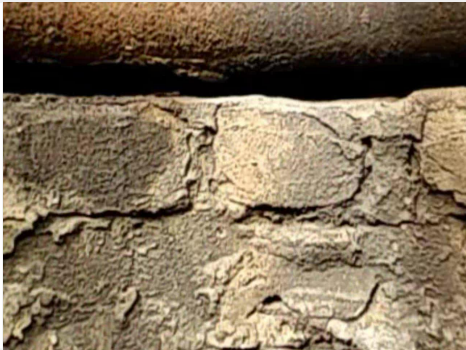
0.7	SSC - component:CMI Continuous: S01 Clock from 12 to 12 Grade = 2	000005

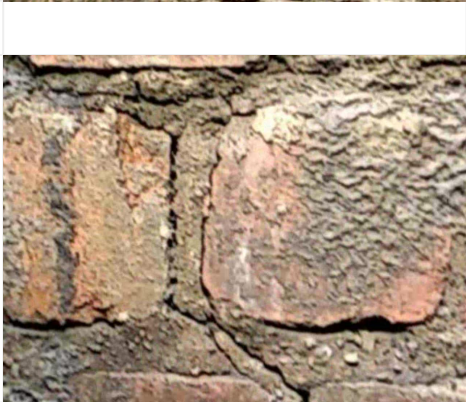
2.2	FM - component:CMI Clock from 3 to 4 Grade = 4	000007

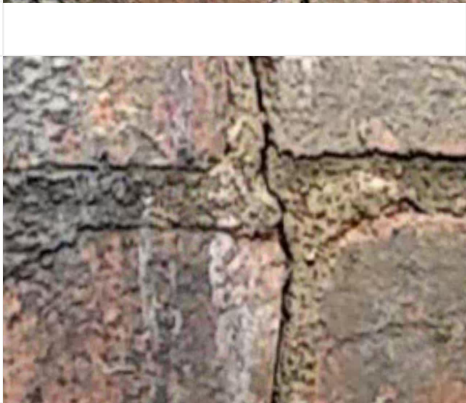
2.5	FL - component:CMI Clock At 5 Grade = 3	000008

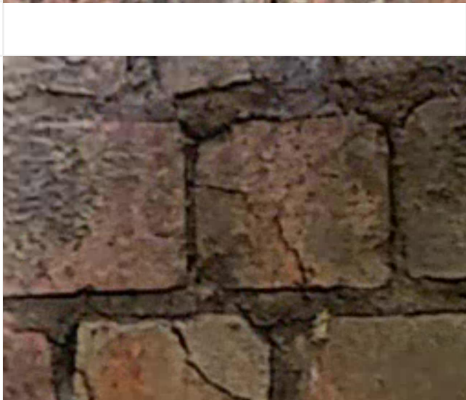
2.6	CM - component:CMI Clock from 12 to 1 Grade = 3	000010

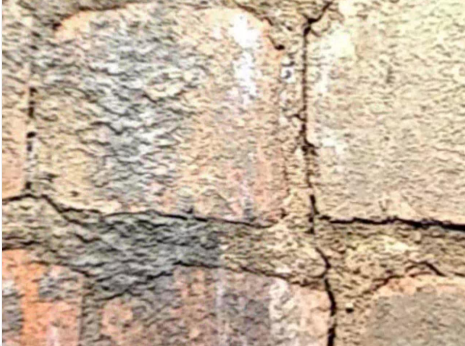
2.7	SSC - component:CMI Continuous: F01 Clock from 12 to 12 Grade = 2	000010

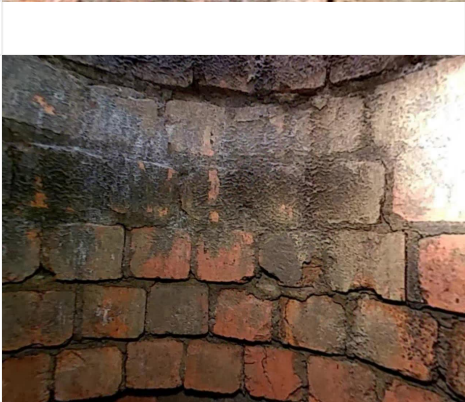
2.8	SSC - component:COI Clock from 12 to 12 Grade = 2	000011

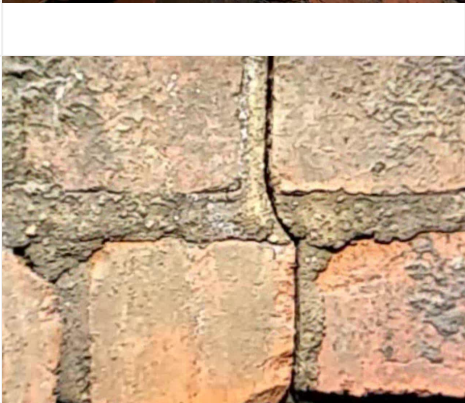
2.8	FM - component:COI Clock from 4 to 5 Grade = 4	000011

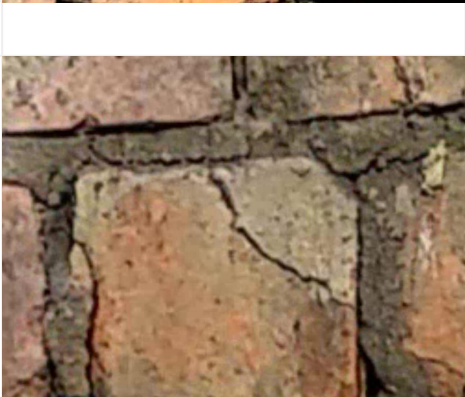
2.8	FS - component:COI Clock from 12 to 1 Grade = 3	000011

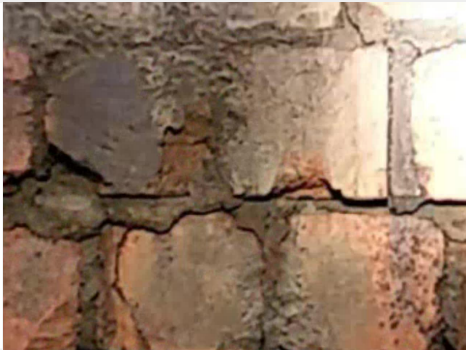
3	SSS - component:COI Clock At 10 Grade = 2	000011

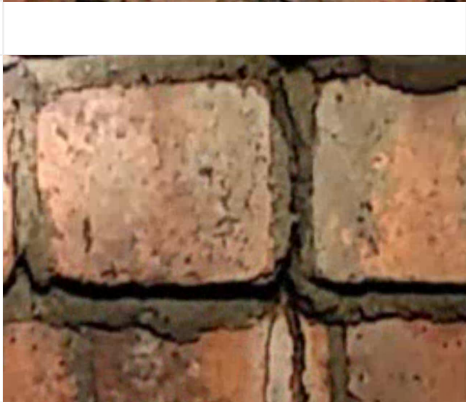
3.1	FL - component:COI Continuous: S02 Clock At 12 Grade = 3	000012

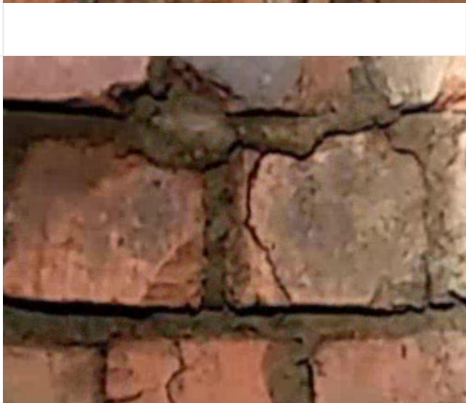
3.3	FL - component:COI Clock At 10 Grade = 3	000012

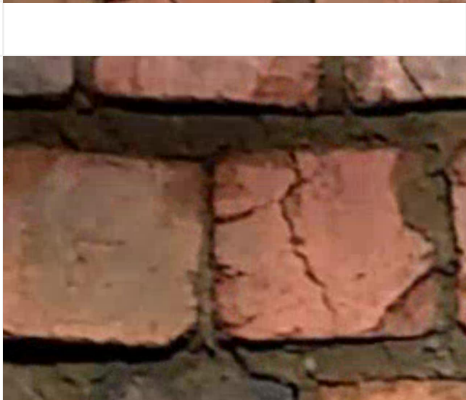
3.6	FM - component:COI Clock from 9 to 10 Grade = 4	000012

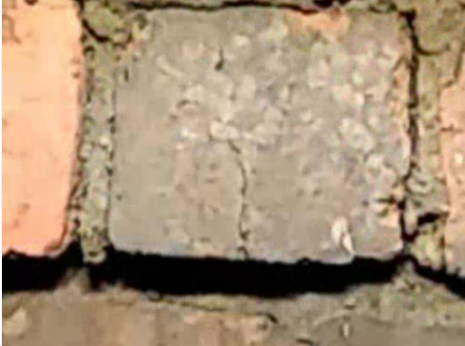
3.6	CL - component:COI Clock At 5 Grade = 2	000012

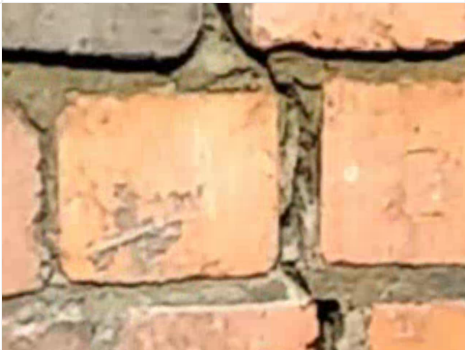
4	FL - component:COI Continuous: S03 Clock At 5 Grade = 3	000013

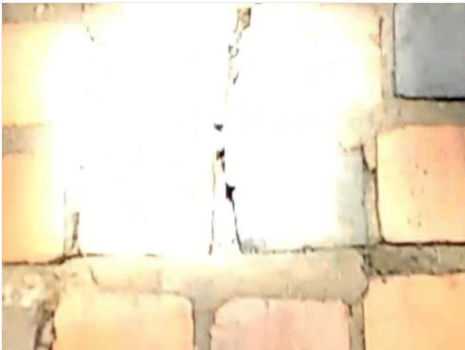
5.9	FL - component:COI Continuous: F02 Clock At 11 Grade = 3	000015

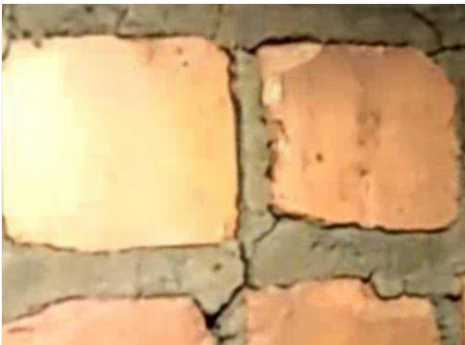
6.3	FM - component:COI Clock from 12 to 1 Grade = 4	000016

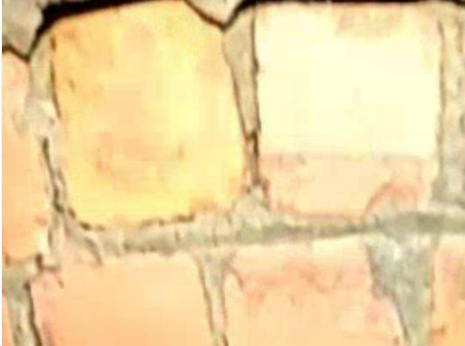
7.1	FL - component:COI Continuous: F03 Clock At 5 Grade = 3	000017

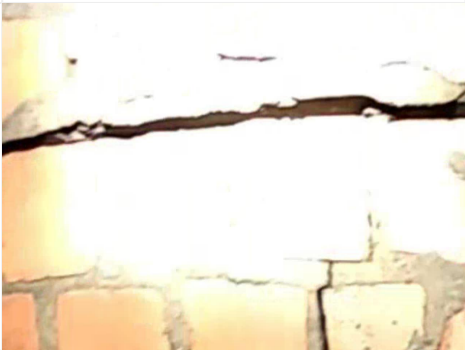
7.3	FM - component:COI Clock from 10 to 1 Grade = 4	000017

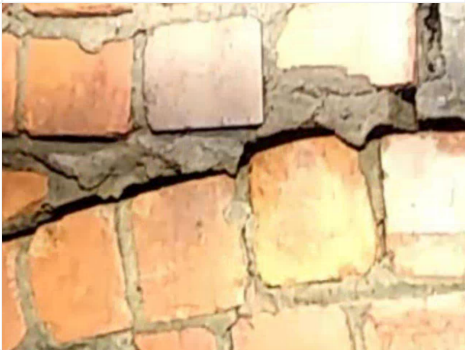
7.3	FM - component:COI Clock from 4 to 7 Grade = 4	000017

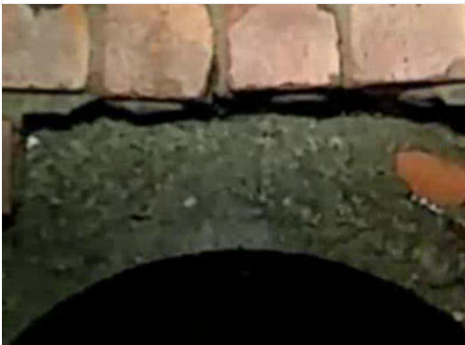
7.8	MML - component:COI Clock from 2 to 3 Grade = 4	000020

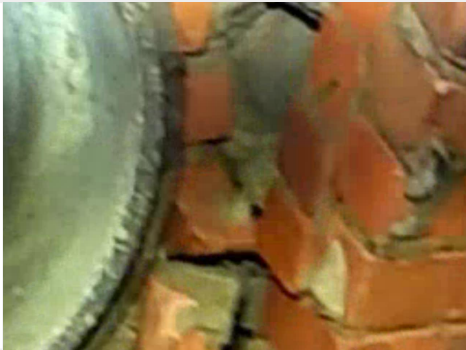
8.9	MML - component:COI Clock At 4 Grade = 4	000022

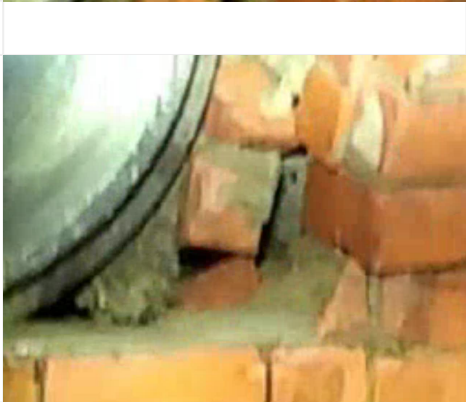
9.7	DB - component:COI Clock At 3 Grade = 3	000023

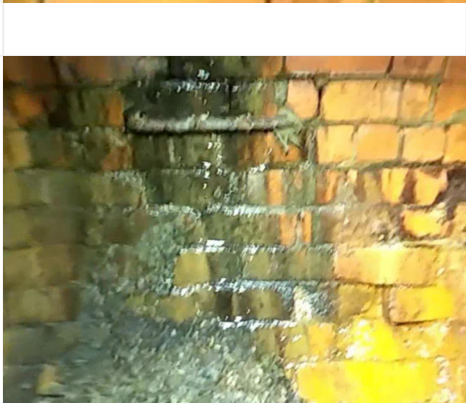
10.1	IWB - component:C Clock from 1 to 5 Grade = 2	000023

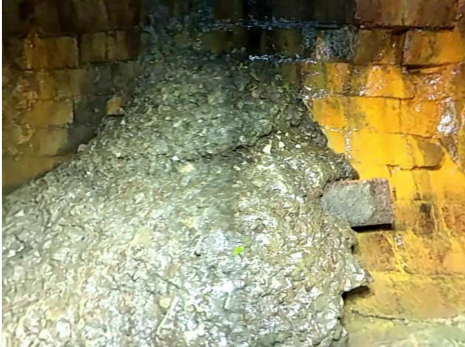
13.9	DSC - component:C Percent: 30 Clock from 12 to 5 Grade = 3	000028

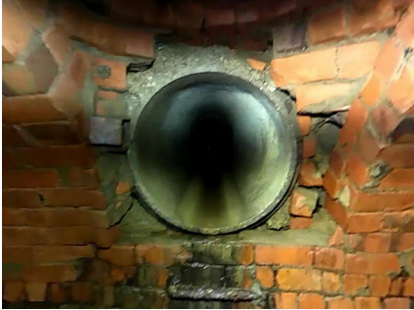
3	Incoming Connection Shape = Circle Height = 26 Pipe Condition = S Pipe Seal Condition = D Pipe type = GR Comments = COI-DB, MML	9.8	3

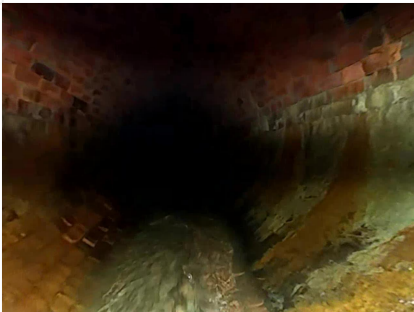
1	Outgoing Connection Shape = Circle Height = 74 Pipe Condition = D Pipe Seal Condition = S Pipe type = GR Comments = DAE, IWB	13.9	6

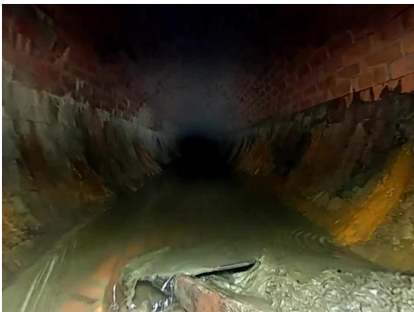
2	Incoming Connection Shape = Circle Height = 74 Pipe Condition = D Pipe Seal Condition = S Pipe type = GR Comments = DAE, IWB	13.8	12
