Project:		Date/Time:	June 28 2024 -
Street and City:	939 Holland Rd. - Marion	Weather:	Unknown Weather
Owner:		P.O. #	
Customer:		Inspection Status:	Remote Inspection
Surveyor Name and Certificate:	Dan Shrodes U-716-07004752	Inspection Level:	2
Reviewer Name and Certificate:	chad pauls P0036127-022022	MH:	MH8

Overall Quick Rating: 413B			
Structural Quick Rating:	413B	O&M Quick Rating:	3221
Overall MH Rating Index: 2.3			
Structural MH Rating Index:	2.4	O&M MH Rating Index:	1.7
Overall MH Rating: 90.0			
Structural MH Rating:	78.0	O&M MH Rating:	12.0

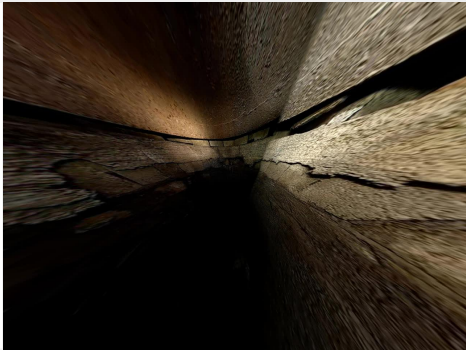
1.2	SSC - component:CMI Clock from 1 to 7 Grade = 2	000004

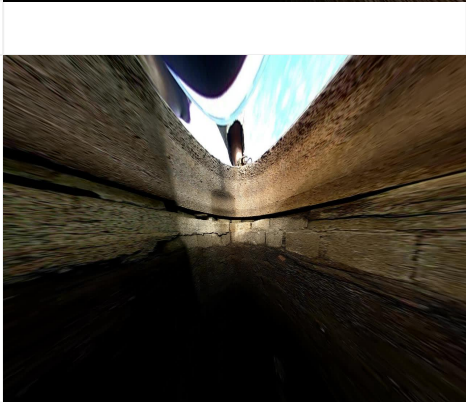
1.2	DB - component:CMI Clock from 6 to 8 Grade = 3	000004

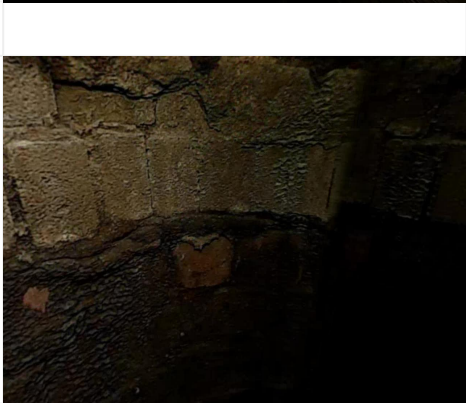
1.2	LFD - component:CMI Clock from 8 to 12 Grade = 4	000004

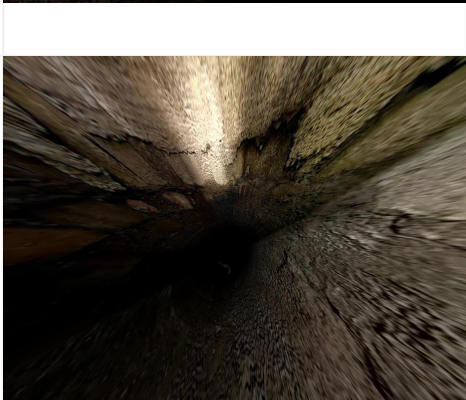
1.7	SSC - component:CMI Continuous: S01 Clock from 12 to 12 Grade = 2	000005

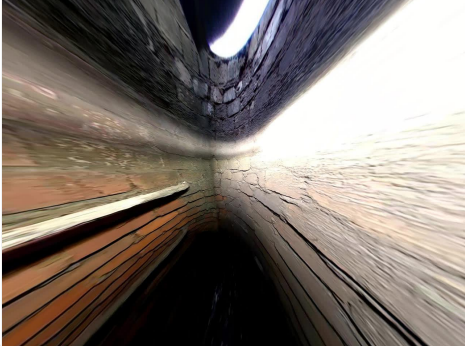
4.1	SSC - component:CMI Continuous: F01 Clock from 12 to 12 Grade = 2	000012

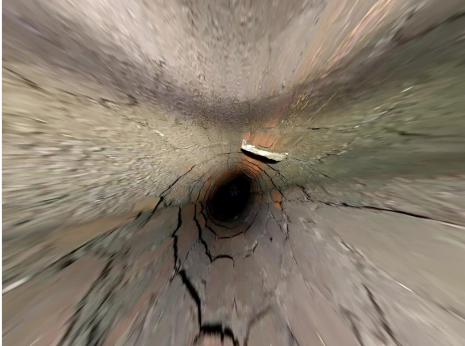
4.2	MMS - component:COI Continuous: S02 Clock from 12 to 12 Grade = 2	000012

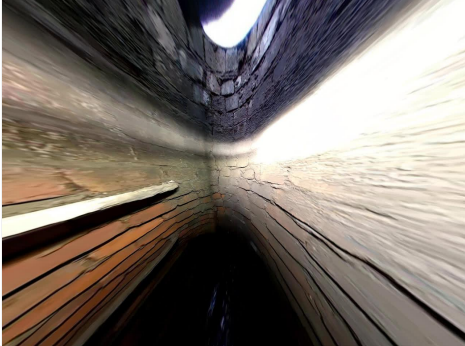
4.2	FL - component:COI Continuous: S03 Clock At 12 Grade = 3	000012

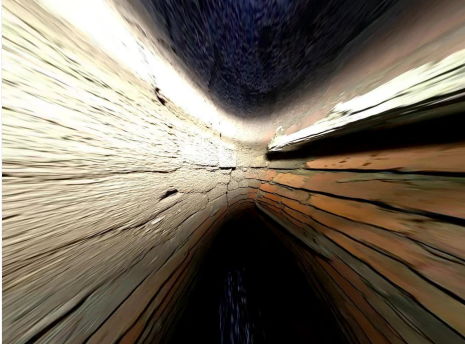
4.9	FL - component:COI Continuous: S04 Clock At 8 Grade = 3	000013

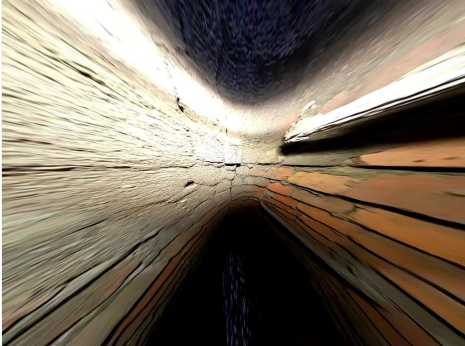
4.9	DB - component:COI Clock At 7 Grade = 3	000013

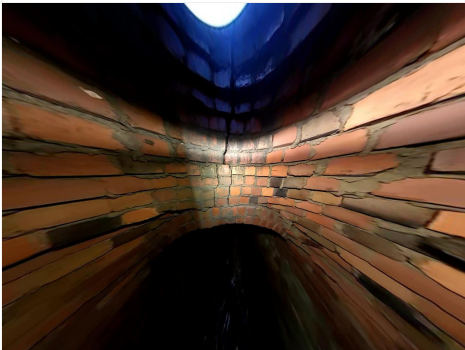
8.2	FL - component:COI Continuous: F04 Clock At 8 Grade = 3	000018

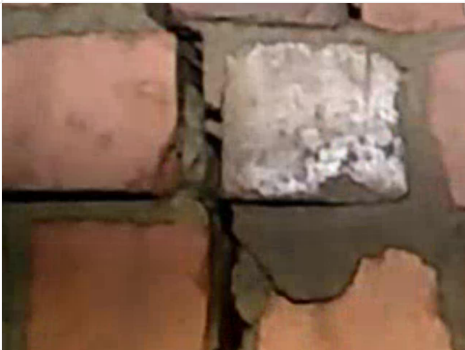
8.6	FL - component:COI Continuous: F03 Clock At 12 Grade = 3	000018

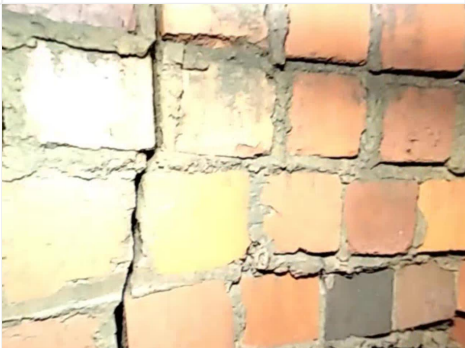
8.7	FL - component:COI Clock At 7 Grade = 3	000019

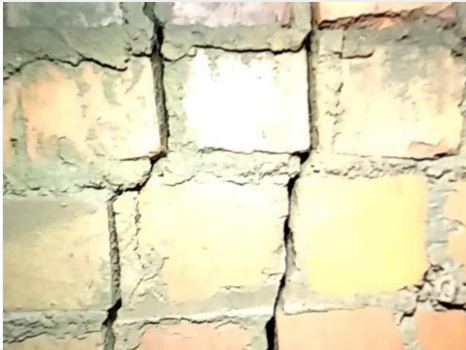
8.7	DB - component:COI Clock At 6 Grade = 3	000019

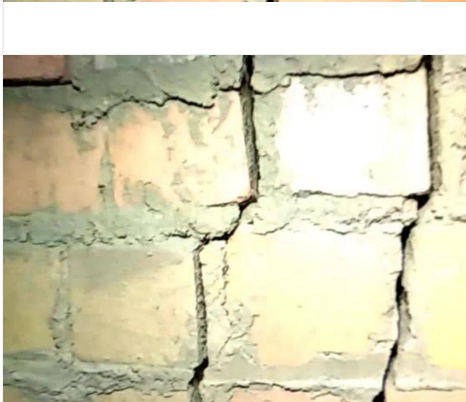
8.7	FL - component:COI Clock At 6 Grade = 3	000019

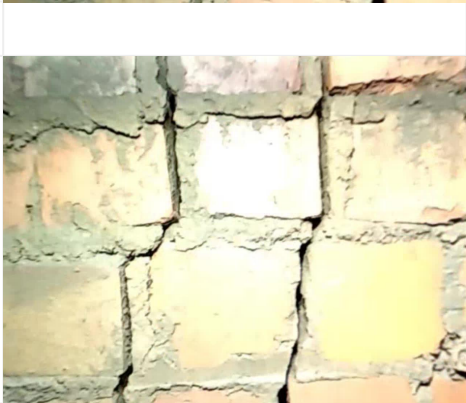
8.7	MMM - component:COI Clock At 6 Grade = 3	000019

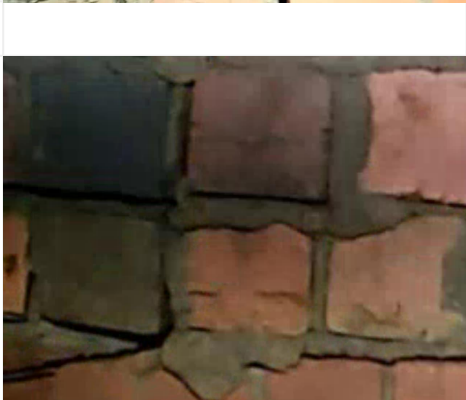
9	FL - component:COI Clock At 12 Grade = 3	000019

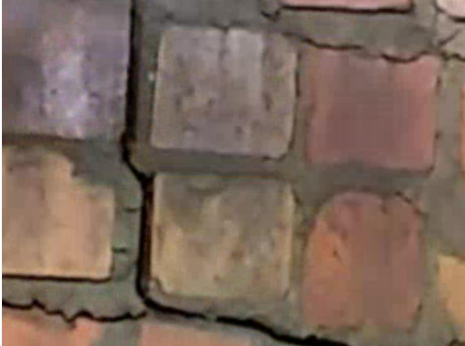
9	FL - component:COI Clock At 1 Grade = 3	000019

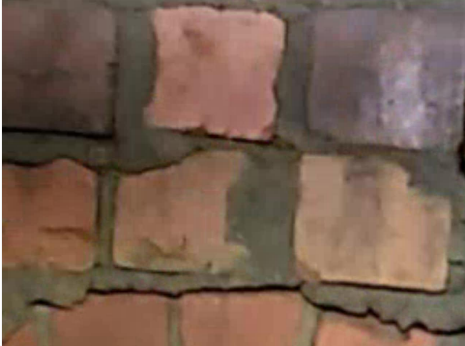
9	MMM - component:COI Clock At 12 Grade = 3	000019

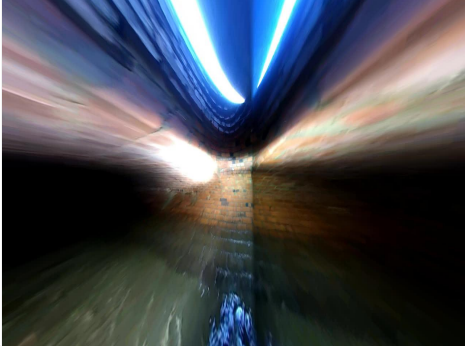
11.1	MMS - component:COI Continuous: F02 Clock from 12 to 12 Grade = 2	000026

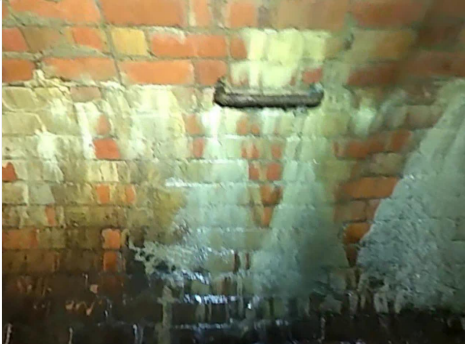
11.8	DAE - component:C Percent: 5 Clock At 9 Grade = 1	000027

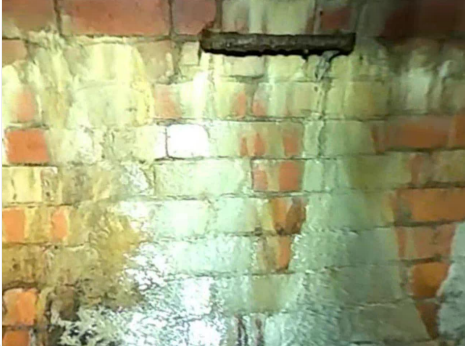
13.2	IWB - component:C Clock At 10 Grade = 2	000032

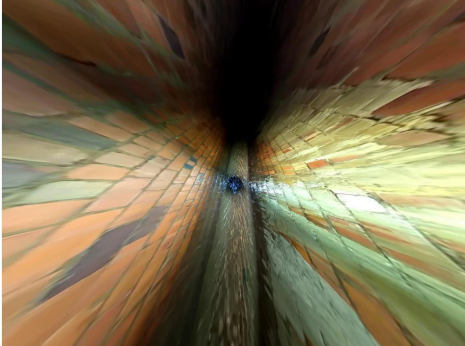
17	MMS - component:C Clock from 6 to 12 Grade = 2	000032

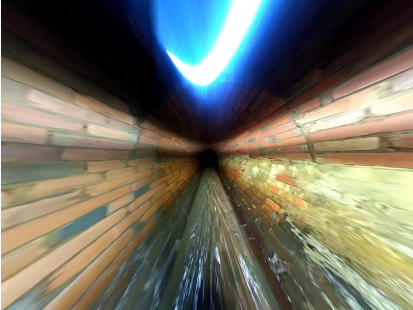
1	Outgoing Connection Shape = Circle Height = 81 Pipe Condition = D Pipe Seal Condition = S Pipe type = GR Comments = MMS/DAE	17.3	6

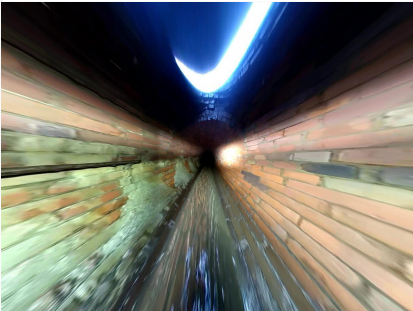
2	Incoming Connection Shape = Circle Height = 81 Pipe Condition = D Pipe Seal Condition = S Pipe type = GR Comments = MMS/DAE	17.2	12
