Project:	Rock Swale	Date/Time:	June 28 2024 -
Street and City:	Silver & Kenton - Marion	Weather:	Unknown Weather
Owner:	City of Marion	P.O. #	
Customer:	CT Consultants	Inspection Status:	Remote Inspection
Surveyor Name and Certificate:	Dan Shrodes U-716-07004752	Inspection Level:	2
Reviewer Name and Certificate:	chad pauls P0036127-022022	MH:	MH9

Overall Quick Rating: 433B			
Structural Quick Rating:	433A	O&M Quick Rating:	3421
Overall MH Rating Index: 2.3			
Structural MH Rating Index:	2.5	O&M MH Rating Index:	1.8
Overall MH Rating: 87.0			
Structural MH Rating:	67.0	O&M MH Rating:	20.0

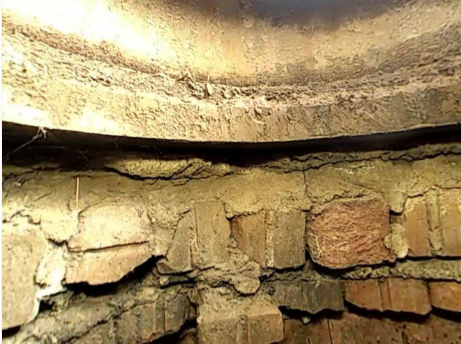
1	MMM - component:COI Clock from 12 to 12 Grade = 3	000006

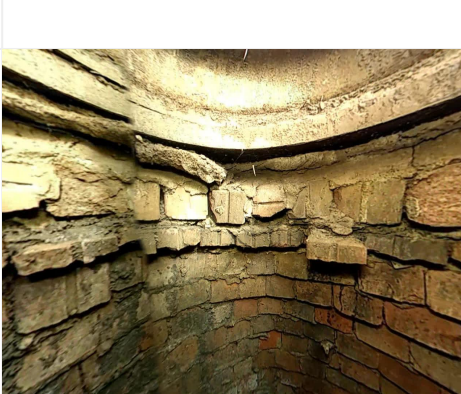
1.2	DB - component:COI Clock from 12 to 12 Grade = 3	000006

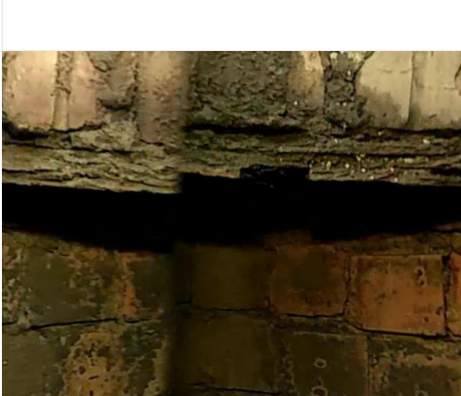
1.5	OBS - component:COI Percent: 5 Clock from 11 to 1 Remark = MISC MATERIAL/ BRACE Grade = 1	000006

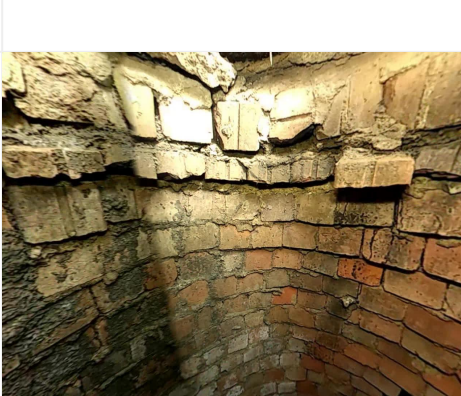
1.5	MMS - component:COI Continuous: S01 Clock from 12 to 12 Grade = 2	000006

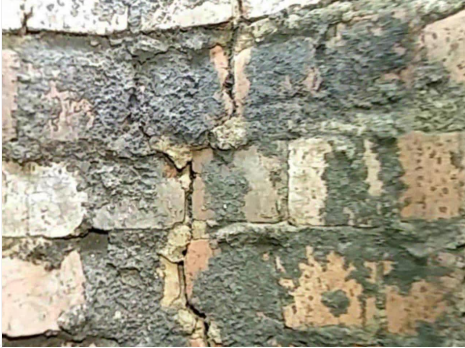
3.1	FL - component:COI Continuous: S02 Clock At 5 Grade = 3	000012

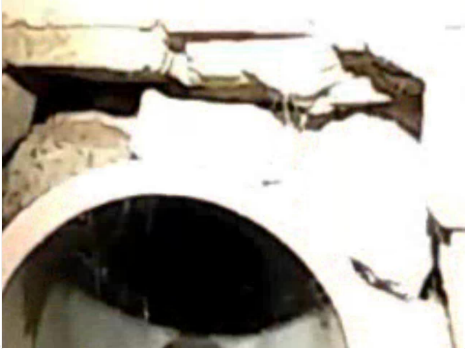
3.6	MML - component:COI Clock At 3 Grade = 4	000013

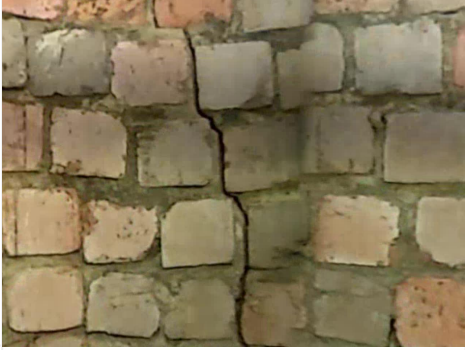
4.7	FL - component:COI Continuous: S03 Clock At 12 Grade = 3	000015

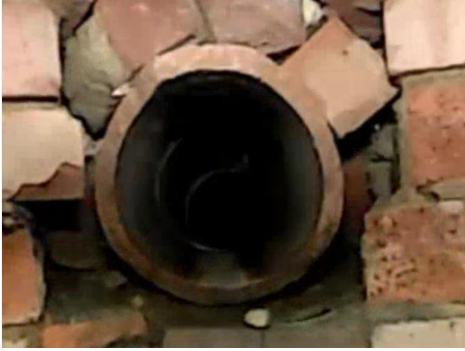
5	MB - component:COI Clock At 9 Grade = 4	000016

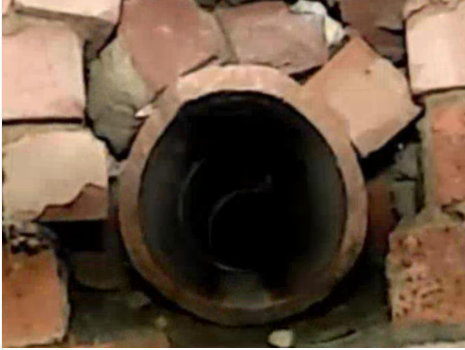
5	DB - component:COI Clock At 9 Grade = 3	000016

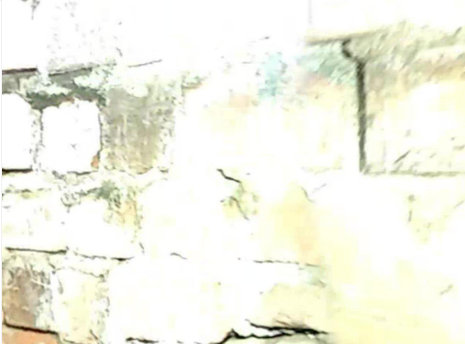
7	FL - component:COI Continuous: F02 Clock At 5 Grade = 3	000024

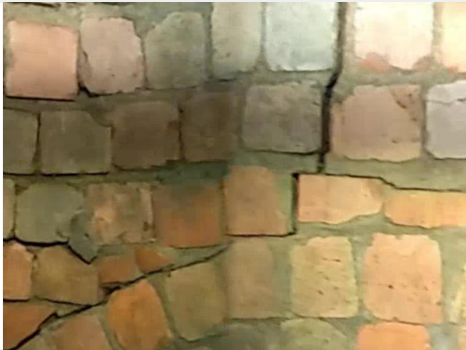
7.3	FL - component:COI Continuous: F03 Clock At 12 Grade = 3	000025

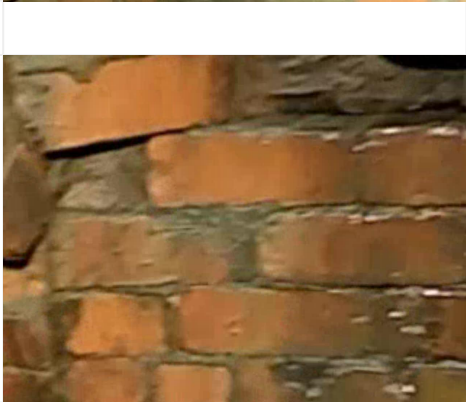
8.7	DB - component:COI Clock At 8 Grade = 3	000028

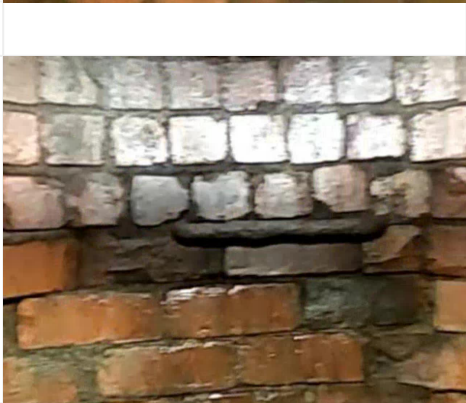
9	MMS - component:COI Continuous: F01 Clock from 12 to 12 Grade = 2	000028

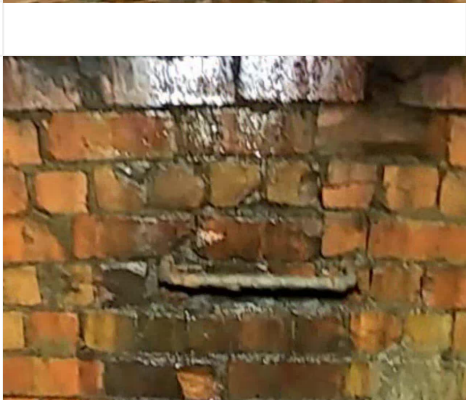
9.6	IWB - component:C Clock At 9 Grade = 2	000030

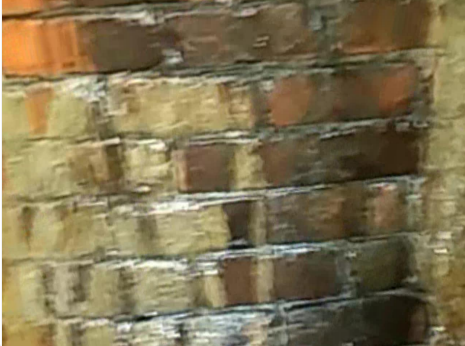
13	DAE - component:C Percent: 5 Clock At 9 Grade = 1	000032

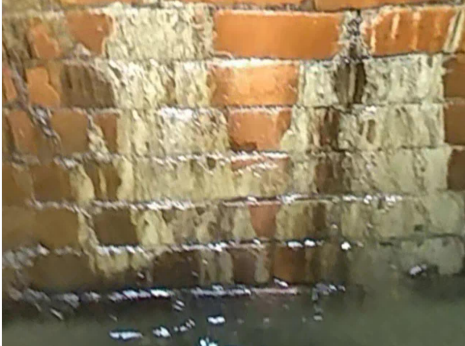
13	DAE - component:C Percent: 5 Clock At 3 Grade = 1	000032

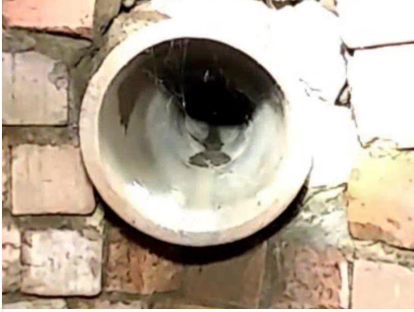
4	Incoming Connection Shape = Circle Height = 8 Pipe Condition = D Pipe Seal Condition = S Pipe type = GR Comments = H/MB/MML	3.8	3

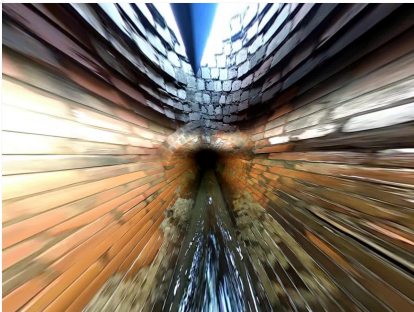
1	Incoming Connection Shape = Circle Height = 70 Pipe Condition = D Pipe Seal Condition = S Pipe type = GR Comments = DAE	14.5	6

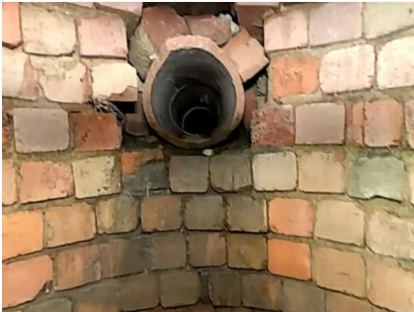
2	Incoming Connection Shape = Circle Height = 8 Pipe Condition = D Pipe Seal Condition = S Pipe type = GR Comments = DB/MB	5.1	9

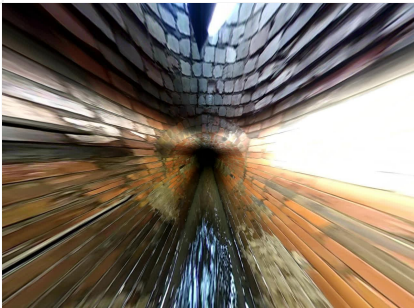
3	Incoming Connection Shape = Circle Height = 70 Pipe Condition = D Pipe Seal Condition = S Pipe type = GR Comments = DAE	14.4	12
