| Inspection | Marion County, Ohio |
| US Manhole | 2 |
| DS Manhole | HB |
| Inspected | October 10, 2024 |

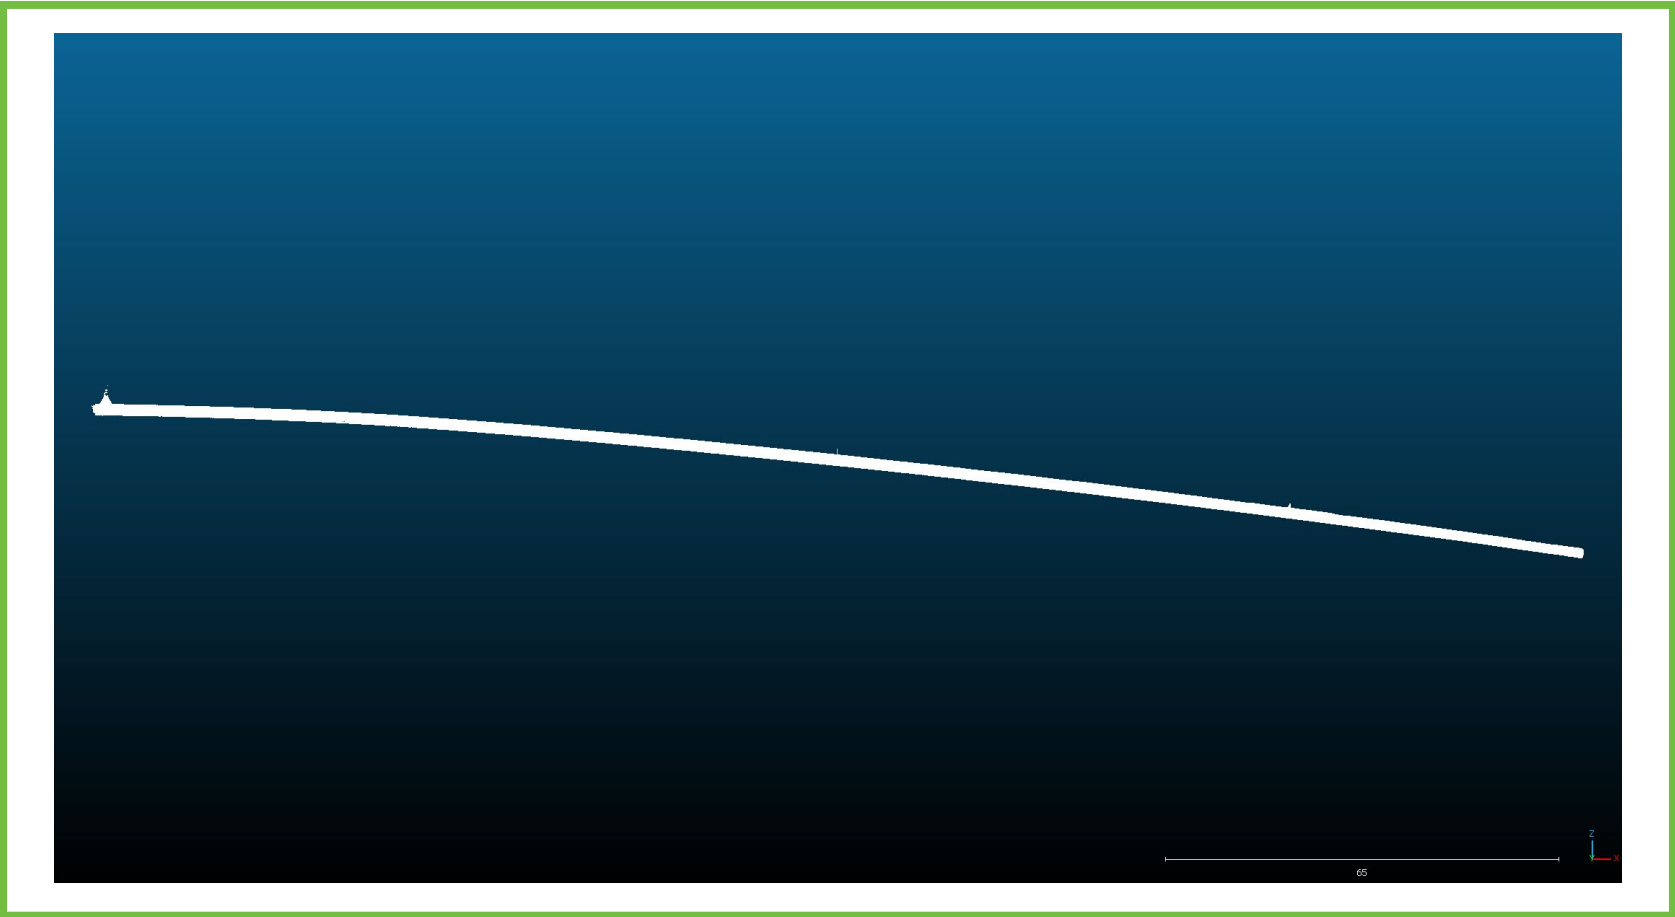
Void @ 778.7 ft (distance from origin)

53.9"

4.72"
5.96"
