Inspection	Marion County, Ohio
US Manhole	7A
DS Manhole	7
Inspected	October 4, 2024
Platform	Aerial Drone
Sensor	3D Lidar
Report Date	October 29, 2024

DATE: 10/4/2024
PIPE SEG REF. MH 7A - MH 7
UP MH: MH 7A
DOWN MH: MH 7

Inspection Date 10/4/2024 12:00 AM	Pipe Segment Reference MH 7A - MH 7	Surveyed By SHAWN DUNNELL	Certificate Number U-915-70001437
Project 2420053PW	Street SILVER ST	Upstream MH MH 7A	Downstream MH MH 7
Direction Upstream	Pre-Cleaning No Pre-Cleaning	Total Length (ft)	Length Surveyed (ft) 124.6

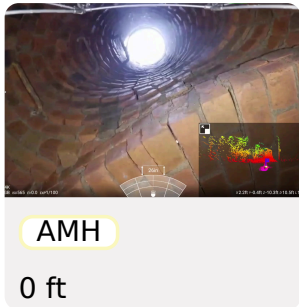
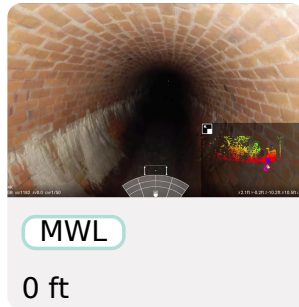
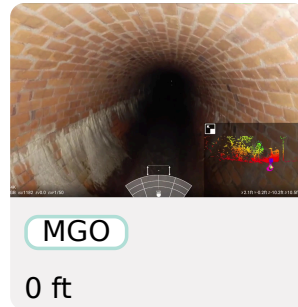
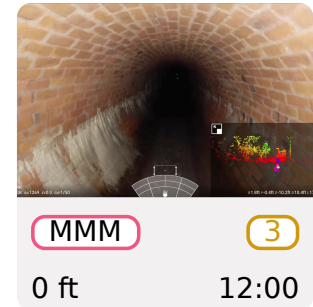
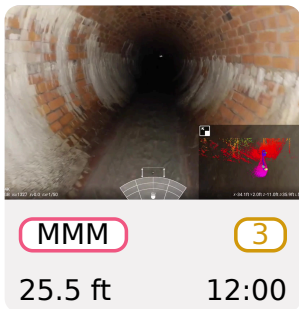
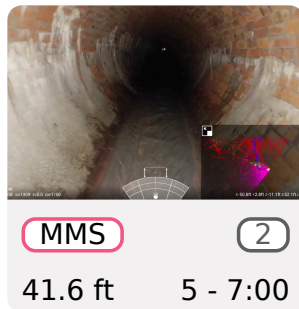
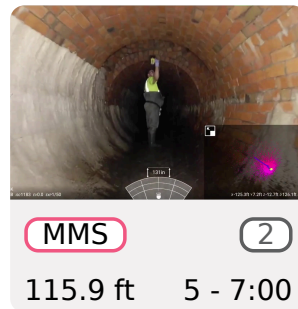
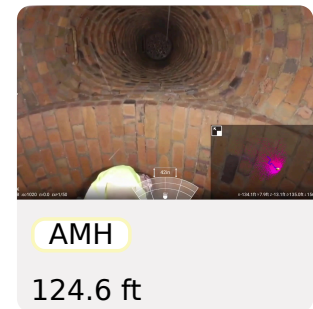
Dist	Time	Description	Code	Clock	Dim. 1	Dim. 2	%	Remarks	Cont.	Grade
0	0:06	Manhole	AMH	-	-	-	-	MH 7	-	-
0	0:11	Miscellaneous Water Level	MW	-	-	-	5	-	-	-
0	0:11	Miscellaneous General Observation...	MOG	-	-	-	-	10.5 FT OFF SET	-	-
0	0:11	Missing Mortar Medium	MM

-	-	-	-	S01	3
25.5	0:39	Missing Mortar Medium	MM

-	-	-	-	F01	3
41.6	0:45	Missing Mortar Small	MMS

-	-	-	-	S02	2
115.9	1:10	Missing Mortar Small	MMS

-	-	-	-	F02	2
124.6	1:14	Manhole	AMH	-	-	-	-	MH 7A	-	-
