Inspection	Marion County, Ohio
US Manhole	9
DS Manhole	7A
Inspected	October 3, 2024
Platform	Aerial Drone
Sensor	3D Lidar
Report Date	October 29, 2024

DATE: 10/4/2024
PIPE SEG REF. MH 8 - MH 7A
UP MH: MH 8
DOWN MH: MH 7A

DATE: 10/3/2024
PIPE SEG REF. MH 9 - MH 8
UP MH: MH 9
DOWN MH: MH 8

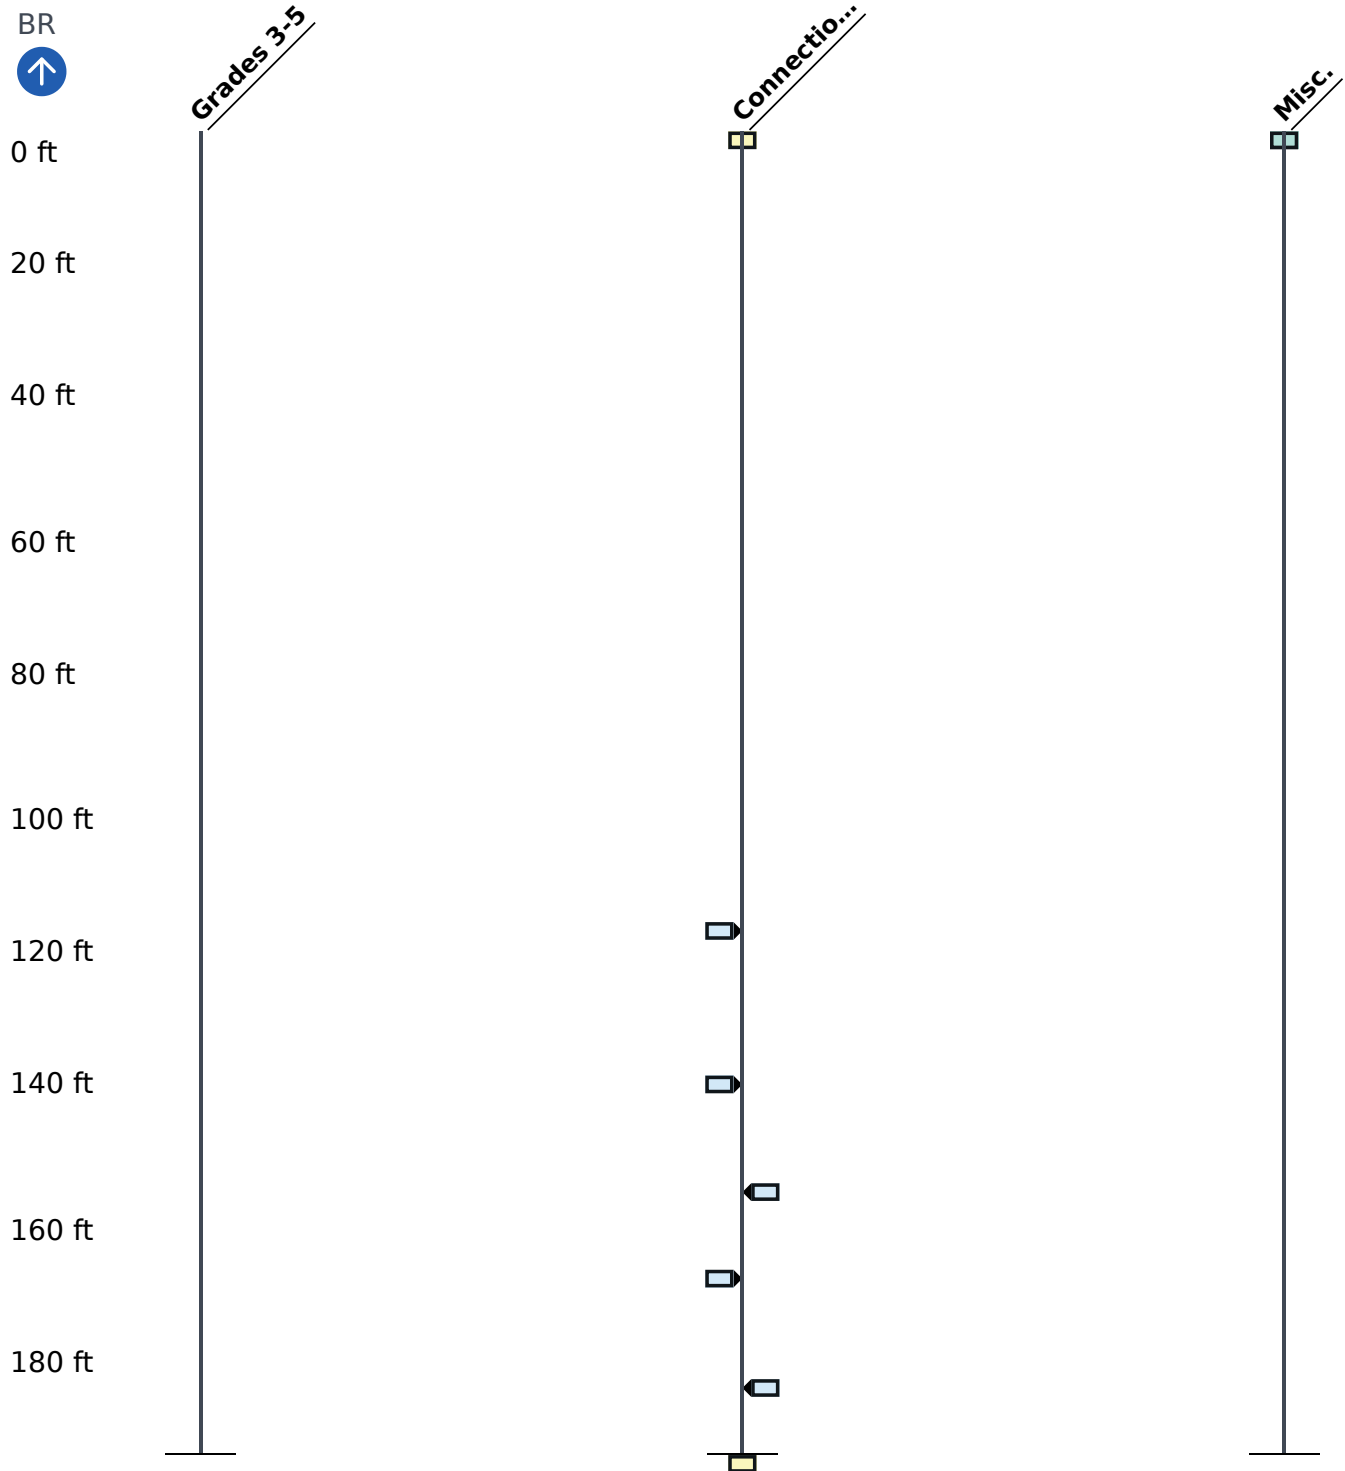
SMART DIAGRAM

Dist	Time	Description	Code	Clock	Dim. 1	Dim. 2	%	Remarks	Cont.	Grade
0	0:02	Manhole	AMH	-	-	-	-	MH 7A	-	-
0	0:08	Miscellaneous Water Level	MW	-	-	-	5	-	-	-
0	0:08	Miscellaneous General Observation...	MOG	-	-	-	-	136 FT OFFS ET	-	-
114.6	0:54	Tap Break-in Activity	TBA		24	-	-	-	-	-
136.9	1:11	Tap Break-in Intruding	TBI		6	3	-	-	-	2
152.5	1:26	Tap Break-in/Hammer	TB		6	-	-	-	-	-
165.1	1:43	Tap Break-in/Hammer	TB		6	-	-	-	-	-
181	1:53	Tap Break-in/Hammer	TB		6	-	-	-	-	-
192	1:57	Manhole	AMH	-	-	-	-	MH 8	-	-

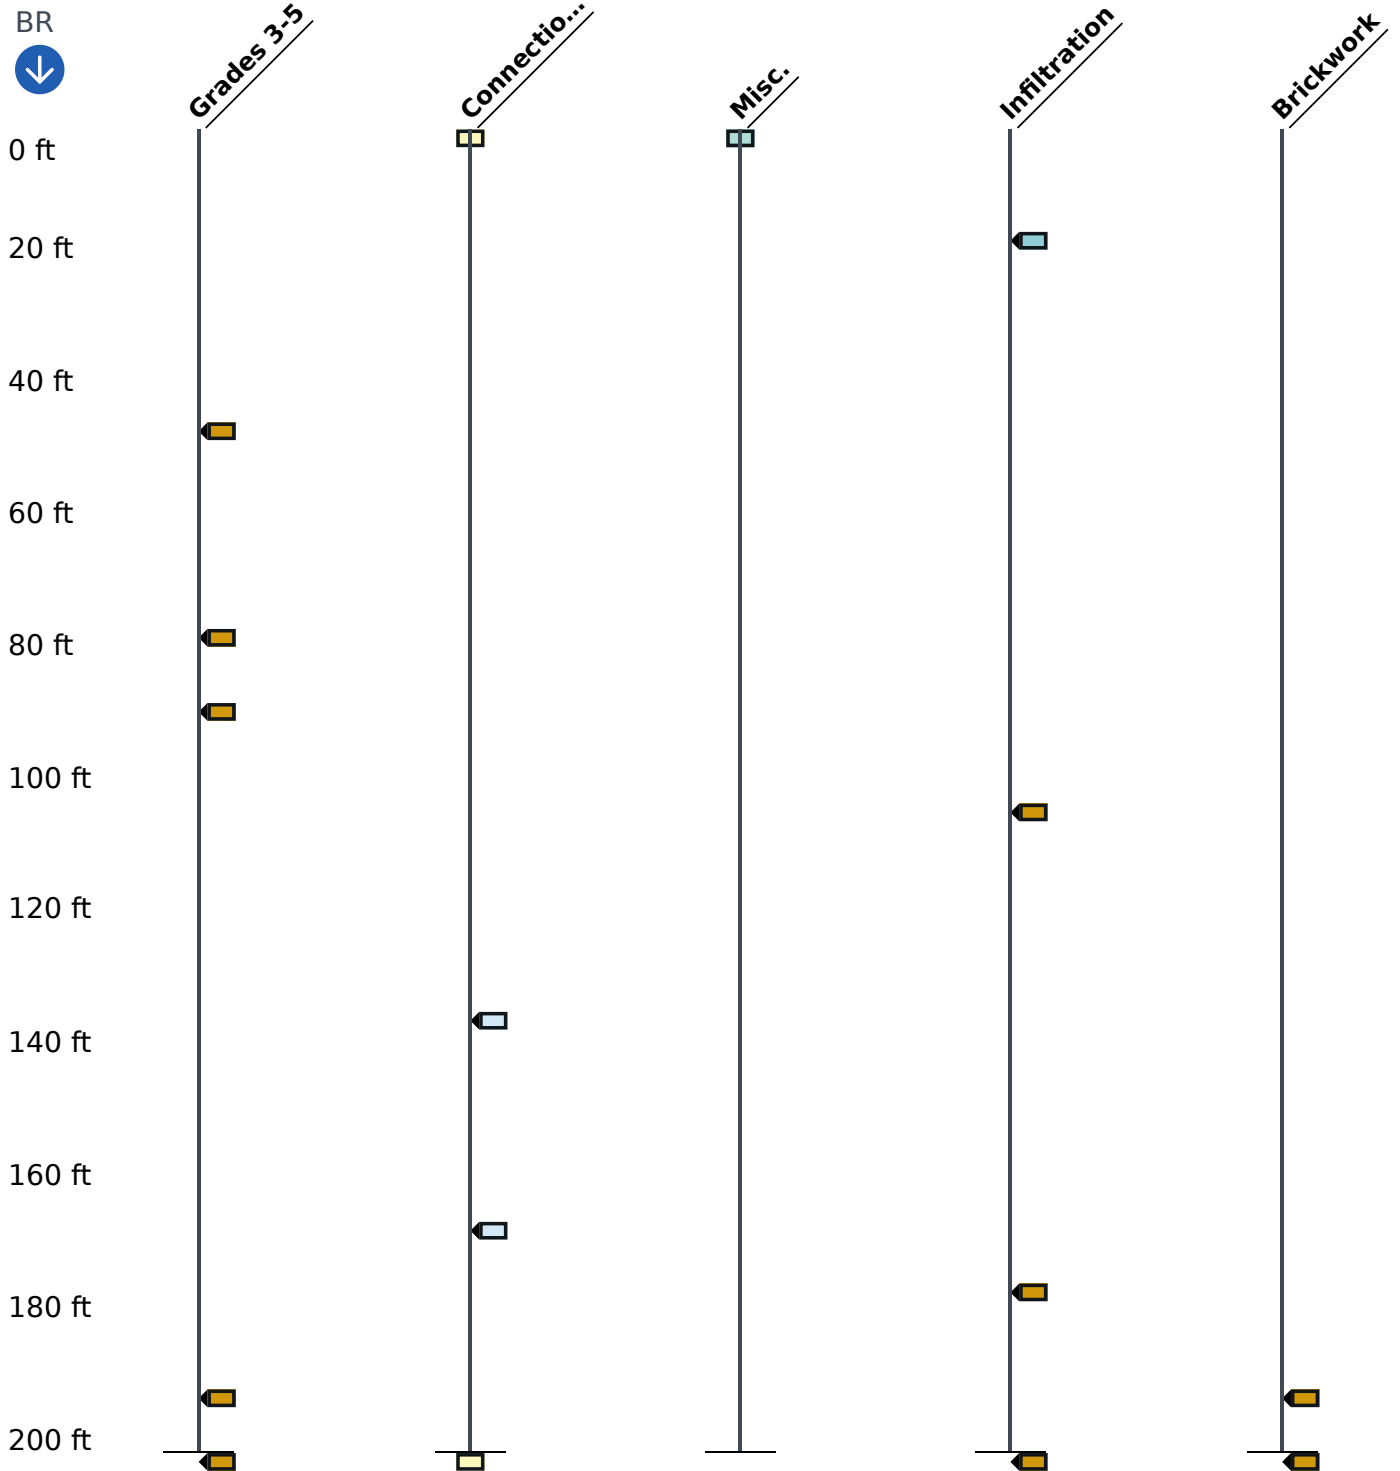
SMART DIAGRAM

Dist	Time	Description	Code	Clock	Dim. 1	Dim. 2	%	Remarks	Cont.	Grade
0	0:13	Manhole	AMH	-	-	-	-	MH 9	-	-
0	0:13	Miscellaneous Water Level	MWL	-	-	-	5	-	-	-
0	0:13	Miscellaneous General Observatio...	MOG	-	-	-	-	OFFSET 11.3	-	-
6.1	0:22	Infiltration Weeper Barrel	IWB		-	-	-	-	-	2
40.1	0:52	Infiltration Dripper	ID		-	-	-	-	-	3
68.6	1:05	Infiltration Dripper	ID		-	-	-	-	-	3
78.7	1:12	Infiltration Dripper	ID		-	-	-	-	-	3
133.8	1:47	Tap Break-in Intruding	TBI		4	6	-	-	-	2
165.7	2:09	Tap Break-in/Hammer	TB		6	-	-	-	-	-
172.7	2:20	Missing Mortar Medium	MM		-	-	-	-	S01	3
181.5	2:24	Missing Mortar Medium	MM		-	-	-	-	F01	3
200.6	2:30	Manhole	AMH	-	-	-	-	MH 8	-	-
