Inspection	Marion County, Ohio
US Manhole	12A
DS Manhole	12
Inspected	October 10, 2024
Platform	Aerial Drone
Sensor	3D Lidar
Report Date	October 29, 2024

DATE: 10/3/2024
PIPE SEG REF. MH 12A - MH 12
UP MH: MH 12A
DOWN MH: MH 12

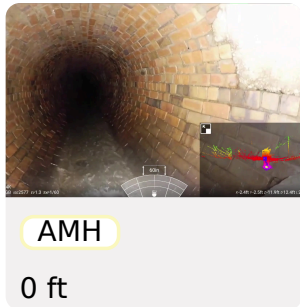
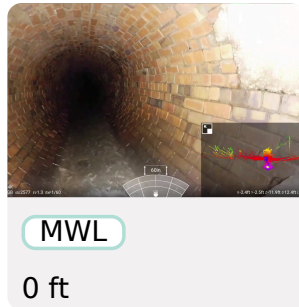
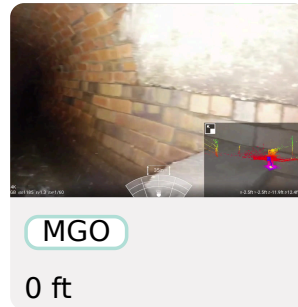
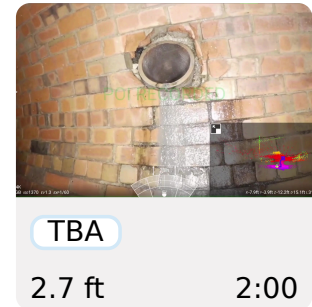
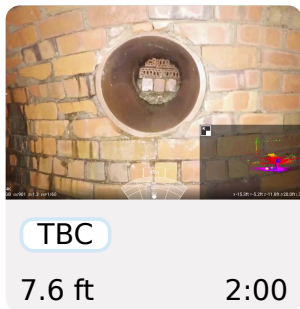
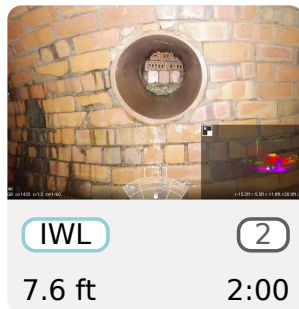
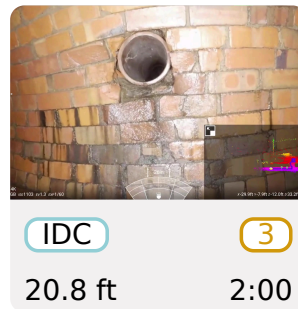
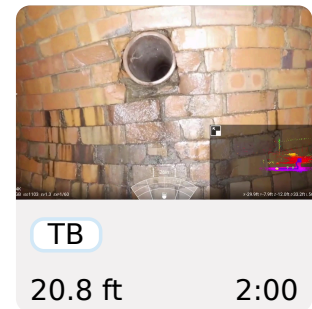
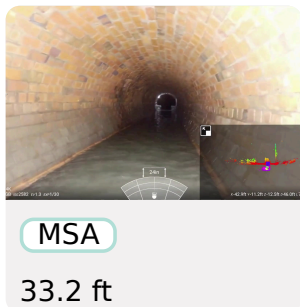
OBSERVATION SNAPSHOTS

Dist	Time	Description	Code	Clock	Dim. 1	Dim. 2	%	Remarks	Cont.	Grade
0	0:35	Manhole	AM	-	-	-	-	MH 12	-	-
0	0:35	Miscellaneous Water Level	MLW	-	-	-	10	-	-	-
0	0:36	Miscellaneous General Observatio...	MOG	-	-	-	-	12.4 FT DISTANCE OFFSET	-	-
2.7	0:54	Tap Break-in Activity	TBA

6	-	-	-	-	-
7.6	1:09	Tap Break-in Capped	TBC

15	-	-	-	-	-
7.6	1:11	Infiltration Weeper Lateral	IWL

-	-	-	-	-	2
20.8	1:31	Infiltration Dripper Connection	IDC

-	-	-	-	-	3
20.8	1:31	Tap Break-in/Hammer	TB

8	-	-	-	-	-
33.2	1:51	Miscellaneous Survey Abandoned	MSA	-	-	-	-	INSPECTION POINT REACHED	-	-
