Project:	2320059	Date/Time:	September 26 2023 - 13:24
Street and City:	ST. ALBANS AVE - BOARDMAN	Weather:	Dry - No precipitation during survey
Owner:	CITY OF BOARDMAN	Inspection Status:	Complete Inspection
Customer:	ABC WATER	Segment:	BO119.01-B0119.01A
Surveyor Name and Certificate:	SHAWN DUNNELL 915-70001437	Direction:	Downstream
Reviewer Name and Certificate:		Up MH:	BO119.01
P.O. #		Down MH:	BO119.01A

BOARDMAN — September 26 2023	Up MH: BO119.01
Pipe: BO119.01-B0119.01A	Down MH: BO119.01A

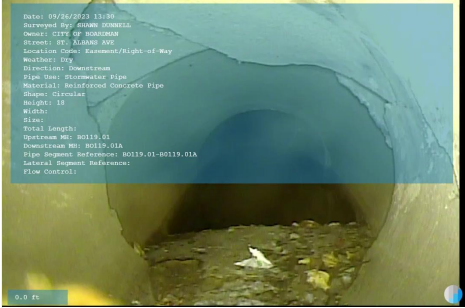
0	AMH - Manhole Remark = BO119.01	00:00:00

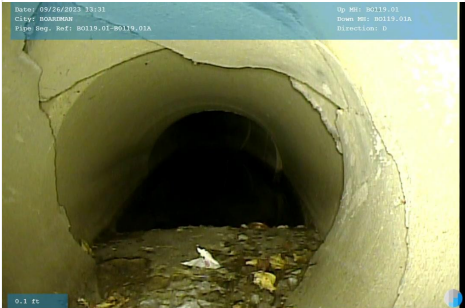
0	MWL - Miscellaneous Water Level	00:00:51

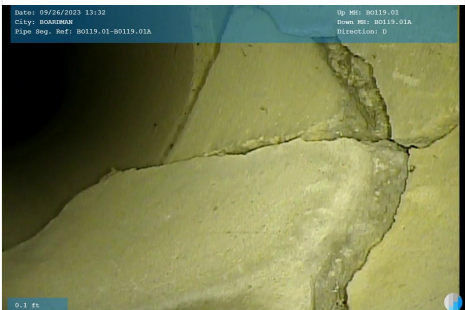
0.1	B - Broken Clock from 9 to 5 Grade = 4	00:01:15

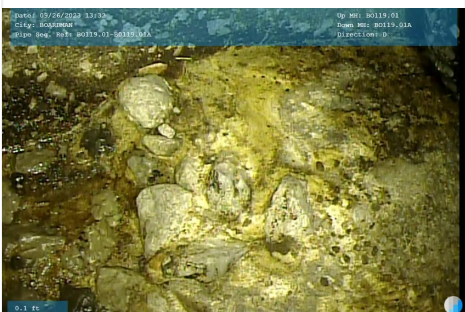
3	DSC - Deposits Settled Hard/Compacted Percent: 20 Clock from 4 to 8 Grade = 3	00:01:46

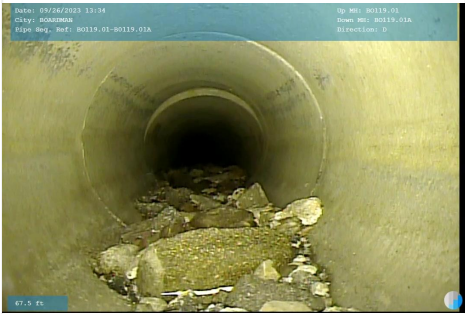
67.5	OBR - Obstruction Rocks Continuous: S01 Percent: 20 Clock from 4 to 8 Grade = 3	00:03:34

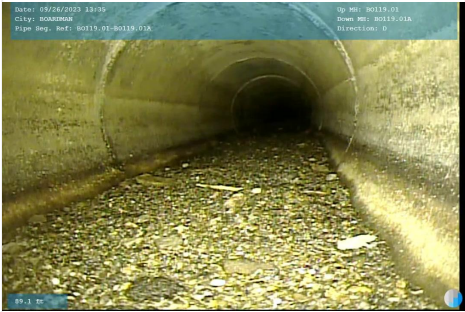
89.1	OBR - Obstruction Rocks Continuous: F01 Percent: 20 Clock from 4 to 8 Grade = 3	00:04:41

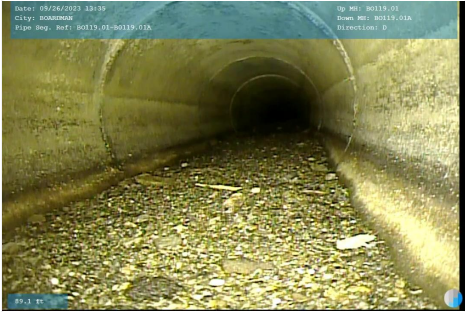
89.1	DSGV - Deposits Settled Gravel Continuous: S02 Percent: 20 Clock from 4 to 8 Grade = 3	00:04:44

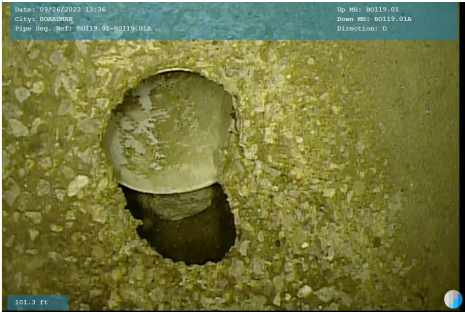
101.3	TB - Tap Break-in/Hammer Measurement 1: 6 Clock At 10	00:05:18

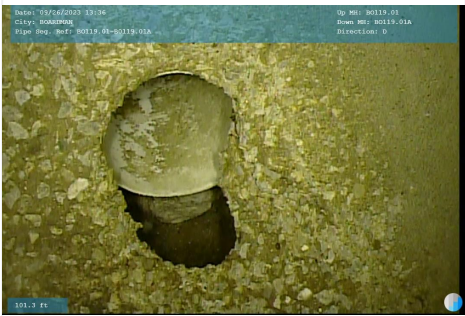
101.3	HWV - Hole Void Visible Clock At 10 Remark = AT BREAK IN CONNECTION Grade = 5	00:05:24

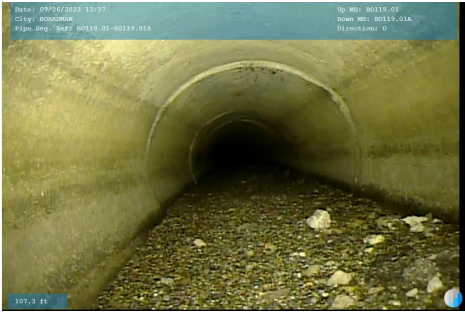
107.3	DSGV - Deposits Settled Gravel Continuous: F02 Percent: 20 Clock from 4 to 8 Grade = 3	00:05:50

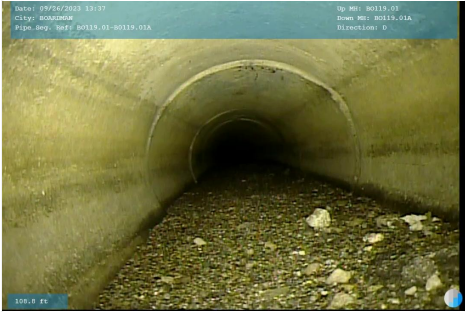
108.8	DSGV - Deposits Settled Gravel Continuous: S03 Percent: 35 Clock from 3 to 9 Grade = 5	00:05:53

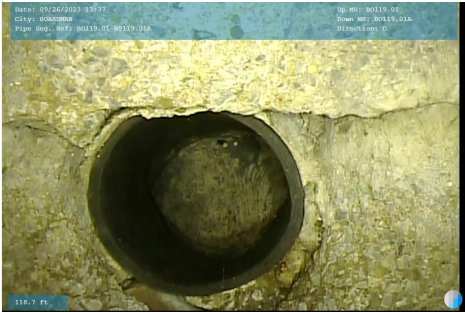
118.7	TB - Tap Break-in/Hammer Measurement 1: 6 Clock At 12	00:06:27

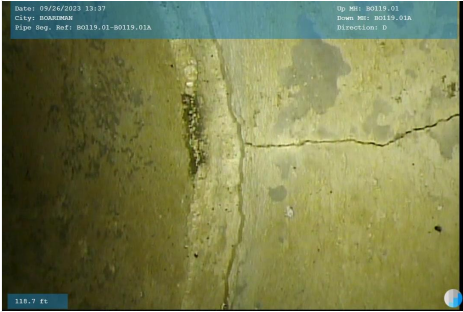
118.8	CL - Crack Longitudinal Joint: True Clock At 12 Grade = 2	00:06:38

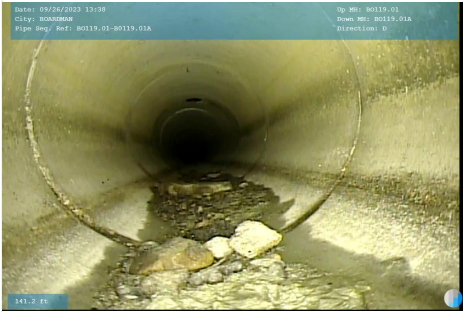
141.2	DSGV - Deposits Settled Gravel Continuous: F03 Percent: 35 Clock from 3 to 9 Grade = 5	00:07:17

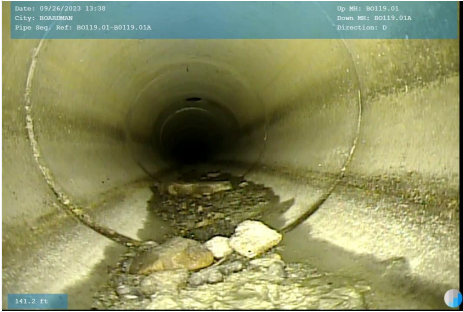
141.2	OBR - Obstruction Rocks Continuous: S04 Percent: 5 Clock from 5 to 7 Grade = 2	00:07:21

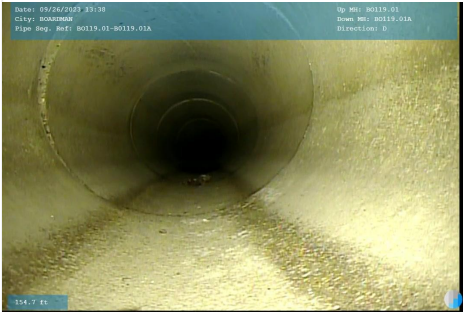
154.7	OBR - Obstruction Rocks Continuous: F04 Percent: 5 Clock from 5 to 7 Grade = 2	00:07:46

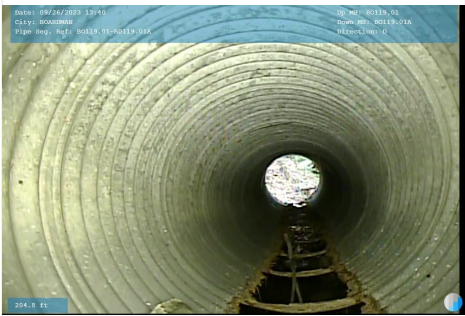
204.8	MMC - Miscellaneous Material Change Remark = RCP TO CMP	00:09:14

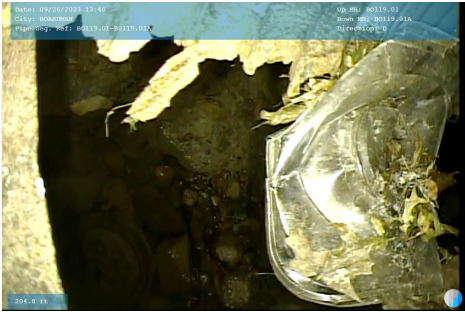
204.8	HVV - Hole Void Visible Continuous: S05 Clock from 5 to 7 Grade = 5	00:09:29

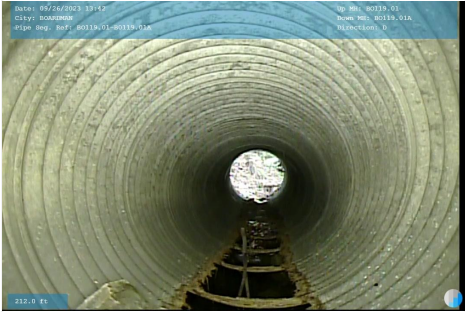
212	LD - Line Down Continuous: S06 Percent: 10 Grade = 1	00:10:50

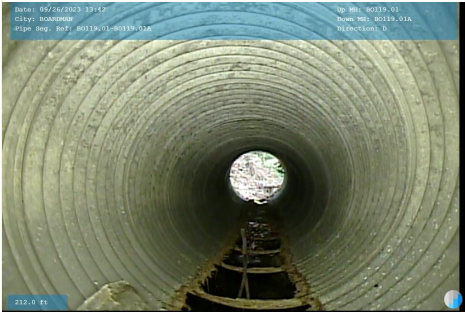
219	LD - Line Down Continuous: F06 Percent: 10 Grade = 1	00:10:59

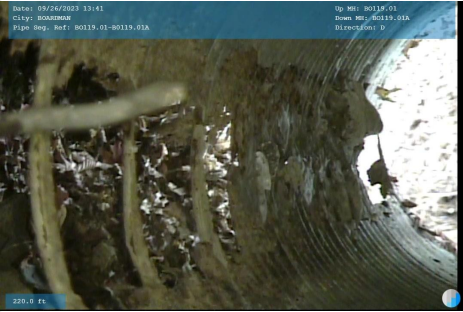
220	HWV - Hole Void Visible Continuous: F05 Clock from 5 to 7 Grade = 5	00:10:17

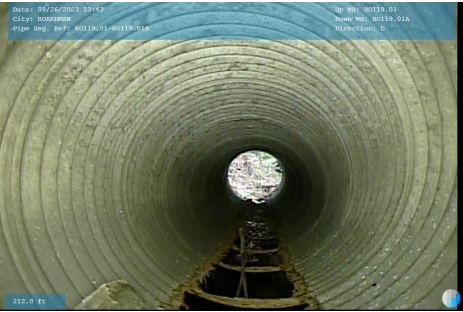
224	AEP - Access Point End of Pipe Remark = BO119.01A	00:11:13
