Project:	2320059	Date/Time:	September 26 2023 - 13:43
Street and City:	ST. ALBANS AVE - BOARDMAN	Weather:	Dry - No precipitation during survey
Owner:	CITY OF BOARDMAN	Inspection Status:	Complete Inspection
Customer:	ABC WATER	Segment:	BO119.02-B0119.01
Surveyor Name and Certificate:	SHAWN DUNNELL 915-70001437	Direction:	Upstream
Reviewer Name and Certificate:		Up MH:	BO119.02
P.O. #		Down MH:	BO119.01

BOARDMAN — September 26 2023	Up MH: BO119.02
Pipe: BO119.02-BO119.01	Down MH: BO119.01

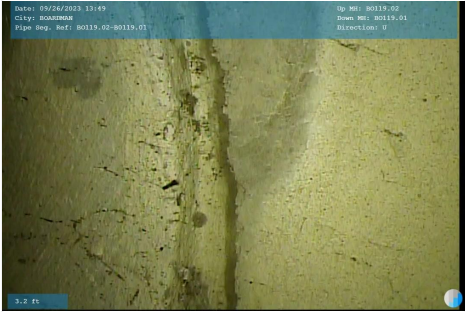
A video frame showing the interior of a manhole. The walls are made of concrete and appear slightly damp. A vertical pipe runs down the center. Metadata at the top: Date: 09/26/2023 13:49, City: BOARDMAN, Pipe Log Ref: BO119.02-BO119.01, Up MH: BO119.02, Down MH: BO119.01, Direction: U. A scale bar at the bottom left indicates 3.2 ft.	0	AMH - Manhole Remark = BO119.01	00:00:20

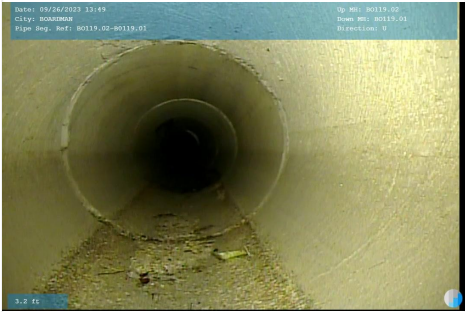
A video frame looking down a pipe. The water level is visible as a dark, still surface. Metadata at the top: Date: 09/26/2023 13:49, City: BOARDMAN, Pipe Log Ref: BO119.02-BO119.01, Up MH: BO119.02, Down MH: BO119.01, Direction: U. A scale bar at the bottom left indicates 3.2 ft.	0	MWL - Miscellaneous Water Level	00:00:40

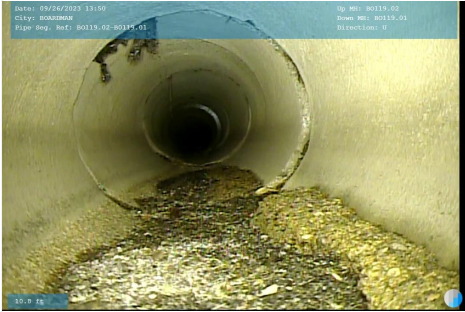
A video frame showing a large accumulation of dark, granular deposits (likely silt or compacted material) at the bottom of a pipe. The pipe walls are visible above the deposit. Metadata at the top: Date: 09/26/2023 13:50, City: BOARDMAN, Pipe Log Ref: BO119.02-BO119.01, Up MH: BO119.02, Down MH: BO119.01, Direction: U. A scale bar at the bottom left indicates 10.8 ft.	10.8	DSC - Deposits Settled Hard/Compacted Percent: 10 Clock from 5 to 7 Grade = 2	00:01:03

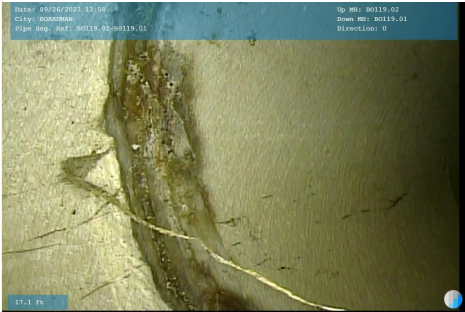
A video frame showing a close-up of a pipe joint. A thin, light-colored root is visible protruding from the joint. The pipe walls are concrete. Metadata at the top: Date: 09/26/2023 13:50, City: BOARDMAN, Pipe Log Ref: BO119.02-BO119.01, Up MH: BO119.02, Down MH: BO119.01, Direction: U. A scale bar at the bottom left indicates 17.1 ft.	17.1	RFJ - Roots Fine Joint Joint: True Clock At 12 Grade = 1	00:01:24

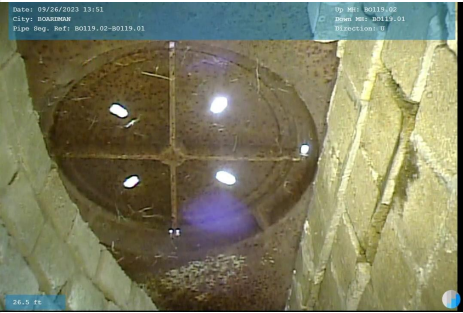
26.5	ACB - Access Point Catch Basin Remark = BO119.02	00:02:18
