BOARDMAN — September 26 2023	Up MH: BO657.02
Pipe: BO657.02-BO657.01	Down MH: BO657.01

Observations & Defects

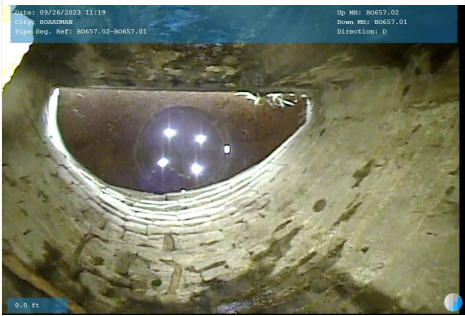
0	AMH - Manhole Remark = BO657.02	00:00:21

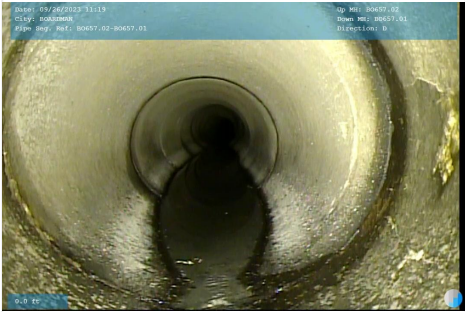
0	MWL - Miscellaneous Water Level Percent: 5	00:00:35

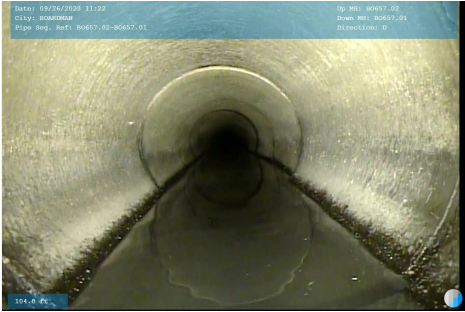
104.8	MWL - Miscellaneous Water Level Percent: 20	00:03:15

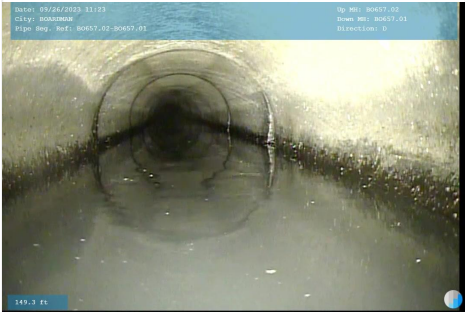
149.3	MWL - Miscellaneous Water Level Percent: 35	00:04:44

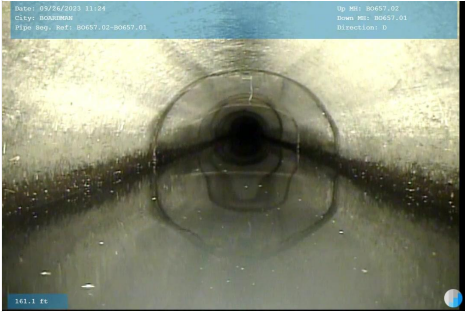
161.1	MWLS - Miscellaneous Water Level Sag Continuous: S01 Percent: 40 Grade = 3	00:05:22

ARE WE SUGGESTING TO REPLACE THIS 40-LF OF SEWER, PRIOR TO LINING?

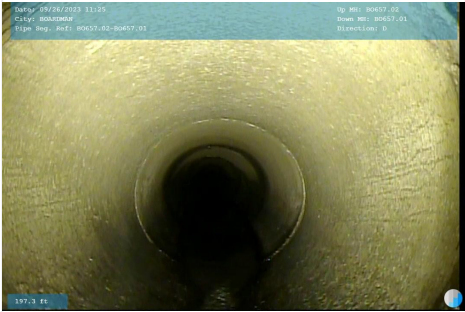
197.3	MWLS - Miscellaneous Water Level Sag Continuous: F01 Percent: 40 Grade = 3	00:06:27

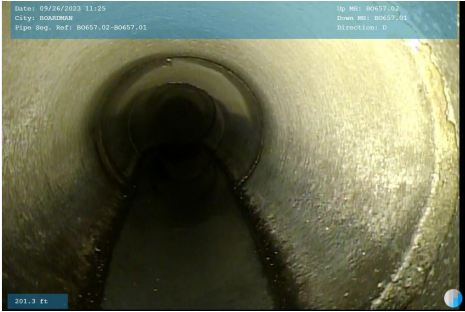
201.3	LD - Line Down Percent: 5 Grade = 1	00:06:50

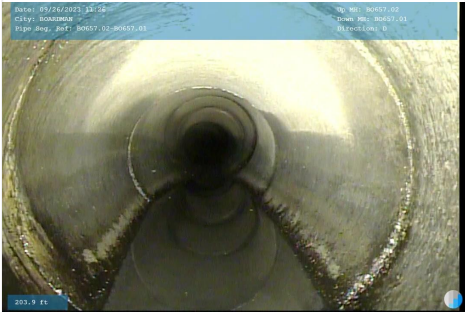
203.9	MWL - Miscellaneous Water Level Percent: 5	00:07:01

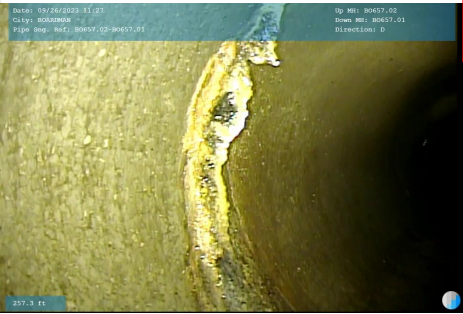
257.3	DAE - Deposits Attached Encrustation Percent: 5 Joint: True Clock from 7 to 5 Grade = 2 May be able to address with heavy cleaning, check spec	00:08:21

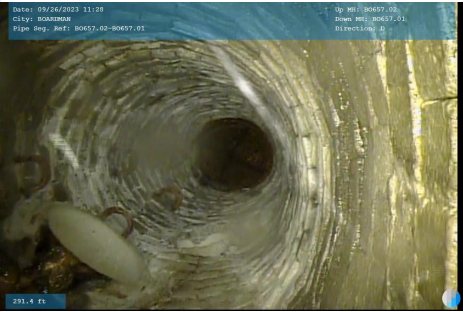
291.4	AMH - Manhole Remark = BO657.01	00:09:41
