Project:	2320059	Date/Time:	September 26 2023 - 10:50
Street and City:	PIERCE DR - BOARDMAN	Weather:	Dry - No precipitation during survey
Owner:	CITY OF BOARDMAN	Inspection Status:	Complete Inspection
Customer:	ABC WATER	Segment:	BO657.03-BO657.02
Surveyor Name and Certificate:	SHAWN DUNNELL 915-70001437	Direction:	Downstream
Reviewer Name and Certificate:		Up MH:	BO.657.03
P.O. #		Down MH:	BO.567.02

Pipe: BO657.03-BO657.02

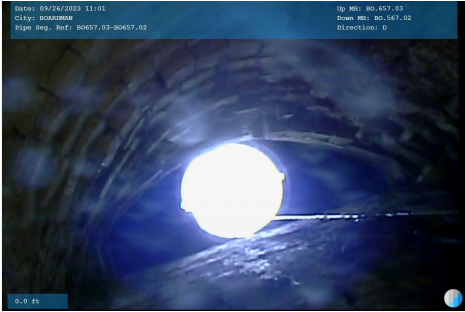
0	AMH - Manhole Remark = BO.657.03	00:00:32

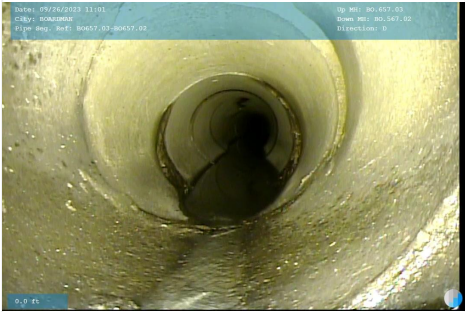
0	MWL - Miscellaneous Water Level Percent: 5	00:00:45

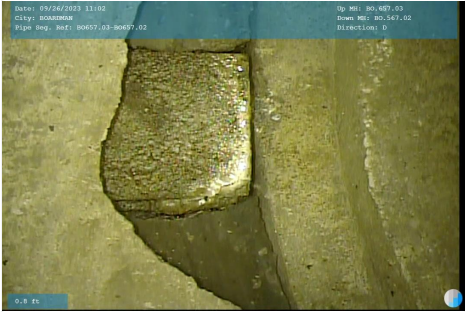
0.8	SMW - Surface Damage Missing Wall Joint: True Clock from 9 to 3 Grade = 5	00:01:17

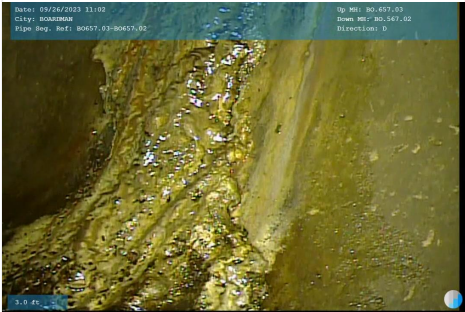
3	DAE - Deposits Attached Encrustation Percent: 10 Joint: True Clock from 7 to 5 Grade = 2	00:01:41

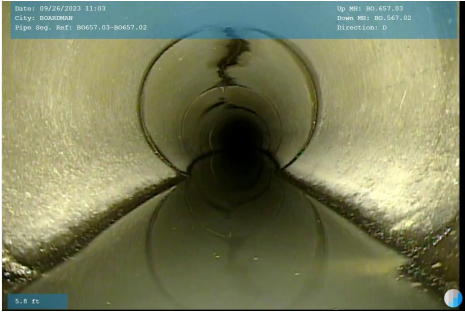
5.8	MWL - Miscellaneous Water Level Percent: 10	00:02:09

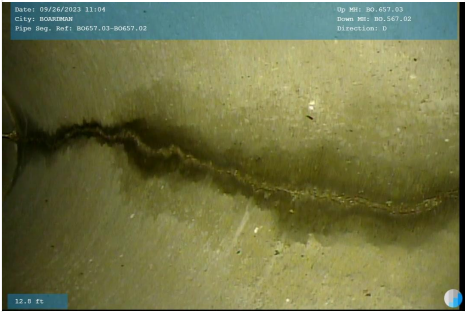
12.8	CL - Crack Longitudinal Continuous: S01 Clock At 12 Grade = 2	00:02:29

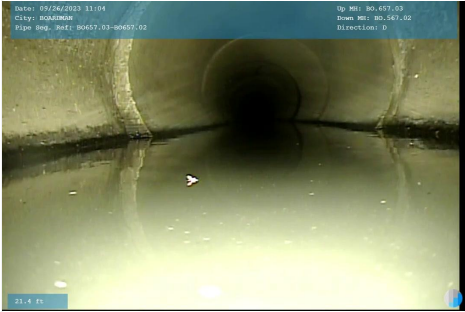
21.4	CL - Crack Longitudinal Continuous: F01 Clock At 12 Grade = 2	00:03:02

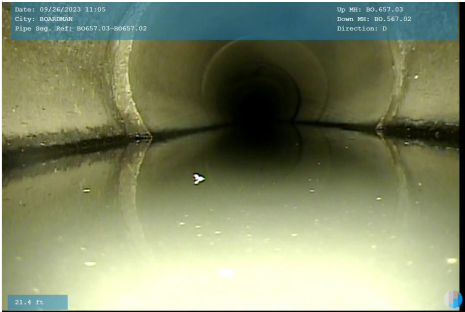
21.4	MWL - Miscellaneous Water Level Percent: 25	00:03:05

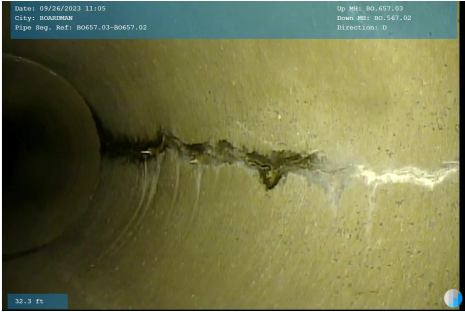
32.3	CL - Crack Longitudinal Continuous: S02 Clock At 12 Grade = 2	00:03:39

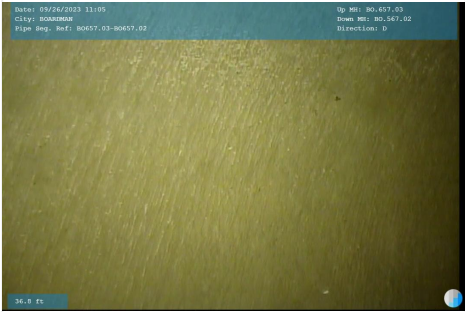
36.8	CL - Crack Longitudinal Continuous: F02 Clock At 12 Grade = 2	00:03:58

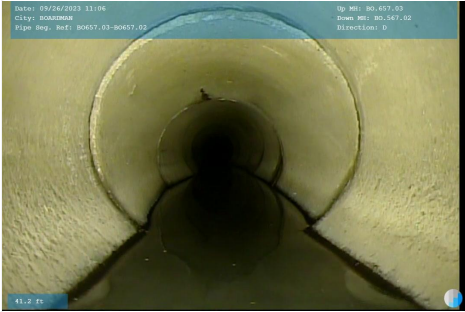
41.2	MWL - Miscellaneous Water Level Percent: 10	00:04:12

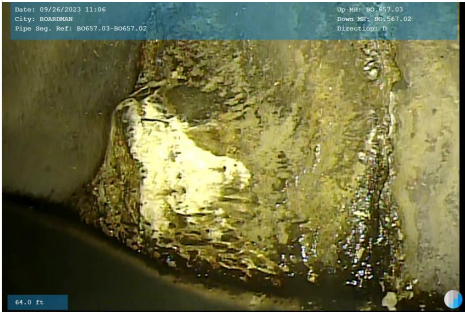
64	DAE - Deposits Attached Encrustation Percent: 5 Joint: True Clock from 3 to 5 Grade = 2	00:05:01

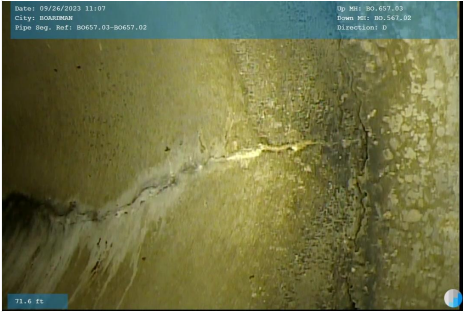
71.6	CL - Crack Longitudinal Continuous: S03 Clock At 12 Grade = 2	00:05:24

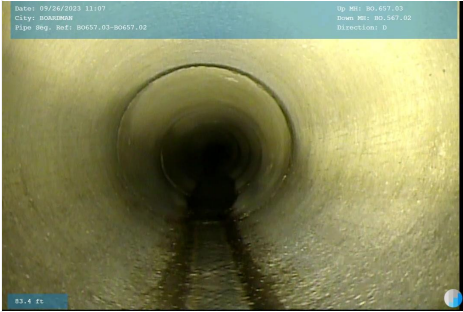
83.4	MWL - Miscellaneous Water Level Percent: 5	00:05:53

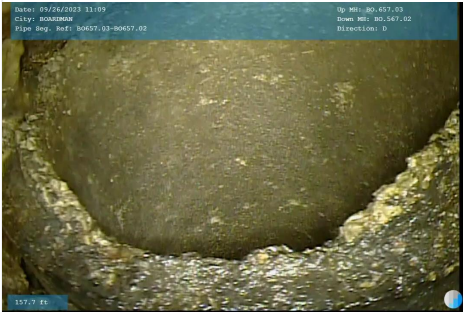
157.7	TBI - Tap Break-in Intruding Measurement 1: 10 Measurement 2: 1 Clock At 2 Grade = 2	00:07:34

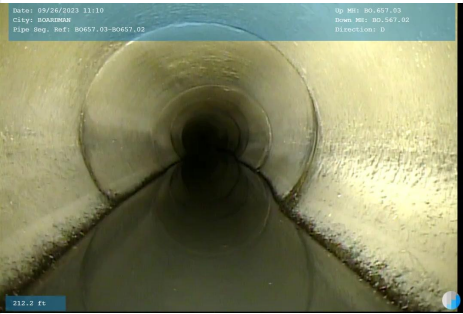
212.2	MWL - Miscellaneous Water Level Percent: 15	00:08:55

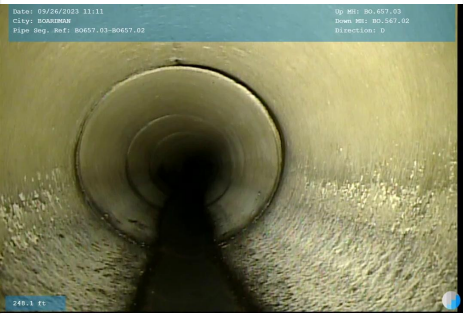
248.1	MWL - Miscellaneous Water Level Percent: 5	00:09:49

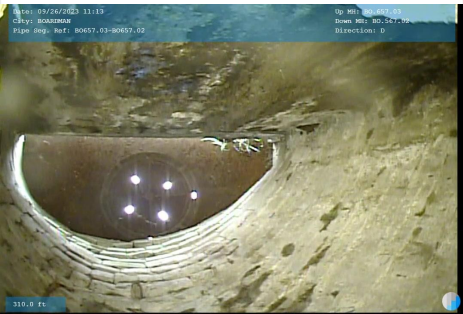
310	AMH - Manhole Remark = BO.567.02	00:11:42
