Project:	2320059	Date/Time:	September 26 2023 - 11:43
Street and City:	PIERCE DR - BOARDMAN	Weather:	Dry - No precipitation during survey
Owner:	CITY OF BOARDMAN	Inspection Status:	Complete Inspection
Customer:	ABC WATER	Segment:	BO657.04-BO657.03
Surveyor Name and Certificate:	SHAWN DUNNELL 915-70001437	Direction:	Downstream
Reviewer Name and Certificate:		Up MH:	BO657.04
P.O. #		Down MH:	B0657.03

BOARDMAN — September 26 2023	Up MH: BO657.04
Pipe: BO657.04-BO657.03	Down MH: B0657.03

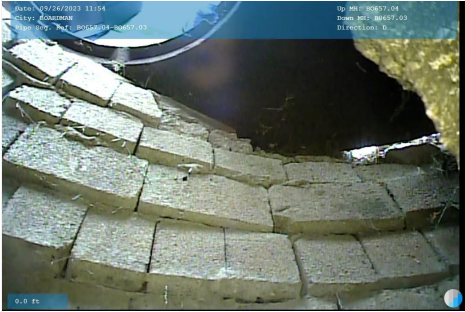
0	AMH - Manhole Remark = BO657.04	00:00:24

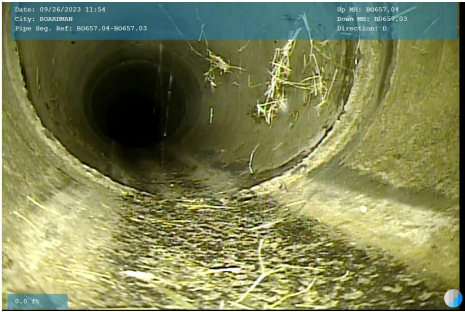
0	MWL - Miscellaneous Water Level	00:00:42

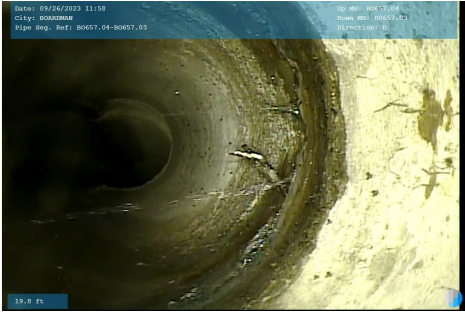
19.8	IR - Infiltration Runner Joint: True Clock from 10 to 2 Grade = 4	00:02:05

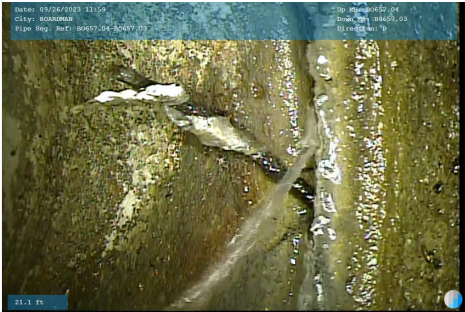
21.1	RFJ - Roots Fine Joint Joint: True Clock At 12 Grade = 1	00:02:21

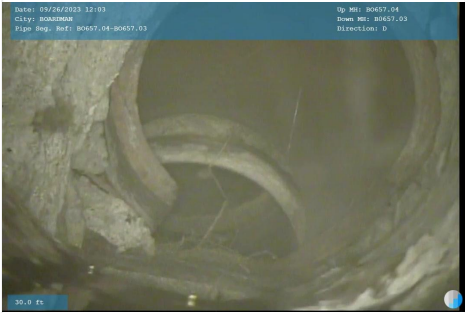
30	MSA - Miscellaneous Survey Abandoned Remark = LIND DOWN AND OFFSET JOINTS	00:05:41
