| Project: | 2320059 | Date/Time: | September 26 2023 - 09:37 |
| Street and City: | PIERCE DR - BOARDMAN | Weather: | Dry - No precipitation during survey |
| Customer: | GPD | Segment: | BO657.05-BO657.03 |

Inspection Technology Used: CCTV

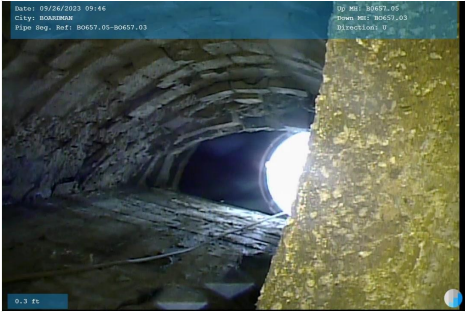
| Photo | Distance | Description | Time |
|---|---|--|---|
| A video frame showing the interior of a manhole. The walls are made of rough, textured concrete. A bright light source is visible at the end of the tunnel, creating a strong glare. A small blue bar at the bottom left indicates a distance of 0.3 ft. Metadata at the top includes: Date: 09/26/2023 09:46, City: BOARDMAN, Pipe Inv. Ref: B0657.05-B0657.03, Up MH: B0657.05, Down MH: B0657.03, Direction: U. | 0 | AMH - Manhole Remark = B0657.03 | 00:00:33 |

| Time | Dist. | Code | Cont. | Dim. 1 | Dim. 2 | % | Joint | Clock From | Clock To | Remarks |
|---|---|---|---|---|---|---|---|---|---|---|
| 00:00:33 | 0 | AMH | | | | | | | | BO657.03 |

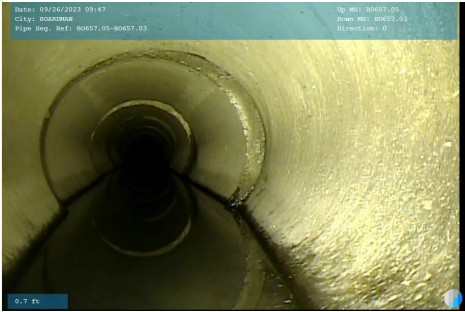
| Photo | Distance | Description | Time |
|---|---|--|---|
| A video frame showing a view down a pipe. The pipe is circular and appears to be made of metal or smooth concrete. The water level is visible, and the camera is positioned near the surface. A small blue bar at the bottom left indicates a distance of 0.7 ft. Metadata at the top includes: Date: 09/26/2023 09:47, City: BOARDMAN, Pipe Inv. Ref: B0657.05-B0657.03, Up MH: B0657.05, Down MH: B0657.03, Direction: D. | 0 | MWL - Miscellaneous Water Level Percent: 10 | 00:00:49 |

| Time | Dist. | Code | Cont. | Dim. 1 | Dim. 2 | % | Joint | Clock From | Clock To | Remarks |
|---|---|---|---|---|---|---|---|---|---|---|
| 00:00:49 | 0 | MWL | | | | 10 | | | | |

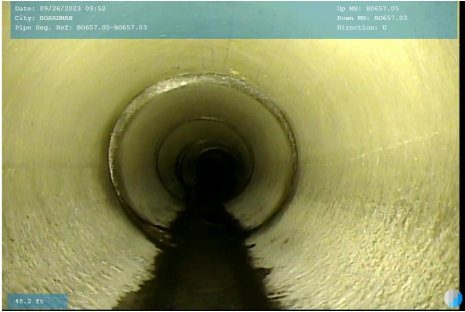
| Photo | Distance | Description | Time |
|---|---|--|---|
| A video frame showing a view down a pipe, similar to the previous one. The water level is lower, and the pipe walls are more visible. A small blue bar at the bottom left indicates a distance of 48.2 ft. Metadata at the top includes: Date: 09/26/2023 09:52, City: BOARDMAN, Pipe Inv. Ref: B0657.05-B0657.03, Up MH: B0657.05, Down MH: B0657.03, Direction: D. | 48.2 | MWL - Miscellaneous Water Level Percent: 5 | 00:02:20 |

| Time | Dist. | Code | Cont. | Dim. 1 | Dim. 2 | % | Joint | Clock From | Clock To | Remarks |
|---|---|---|---|---|---|---|---|---|---|---|
| 00:02:20 | 48.2 | MWL | | | | 5 | | | | |

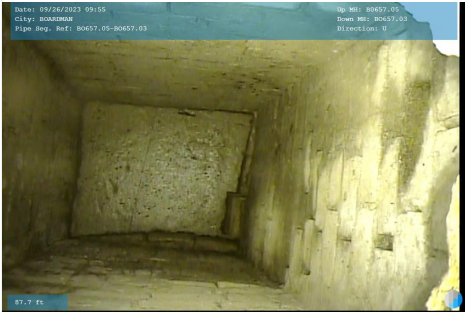
| Photo | Distance | Description | Time |
|---|---|--|---|
| A video frame showing the interior of a manhole. The walls are made of rough, textured concrete. The camera is positioned higher than in the first frame, showing more of the manhole's structure. A small blue bar at the bottom left indicates a distance of 87.7 ft. Metadata at the top includes: Date: 09/26/2023 09:58, City: BOARDMAN, Pipe Inv. Ref: B0657.05-B0657.03, Up MH: B0657.05, Down MH: B0657.03, Direction: D. | 87.7 | AMH - Manhole Remark = B0657.05 | 00:04:12 |

| Time | Dist. | Code | Cont. | Dim. 1 | Dim. 2 | % | Joint | Clock From | Clock To | Remarks |
|---|---|---|---|---|---|---|---|---|---|---|
| 00:04:12 | 87.7 | AMH | | | | | | | | B0657.05 |
