Project:	2320059	Date/Time:	September 26 2023 - 14:26
Street and City:	PIERCE DR - BOARDMAN	Weather:	Dry - No precipitation during survey
Owner:	CITY OF BOARDMAN	Inspection Status:	Complete Inspection
Customer:	ABC WATER	Segment:	BO657.06-BO657.05
Surveyor Name and Certificate:	SHAWN DUNNELL 915-70001437	Direction:	Downstream
Reviewer Name and Certificate:		Up MH:	BO657.06
P.O. #		Down MH:	BO657.05

Pipe: BO657.06-BO657.05

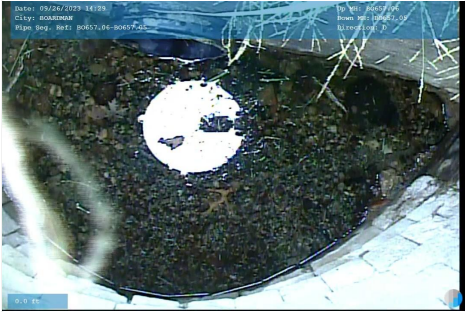
0	AMH - Manhole Remark = BO657.06	00:00:27

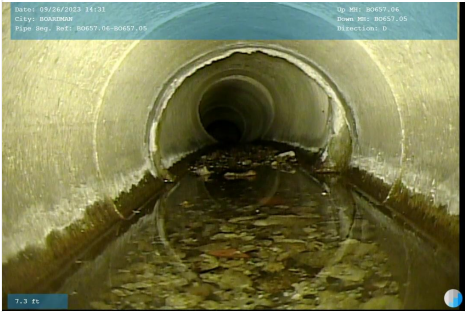
0	MWL - Miscellaneous Water Level Percent: 15	00:00:58

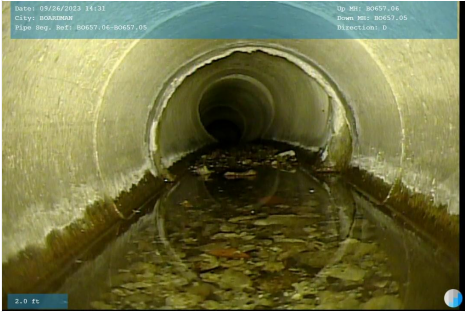
2	MMC - Miscellaneous Material Change Remark = PLASTIC TO RCP	00:01:10

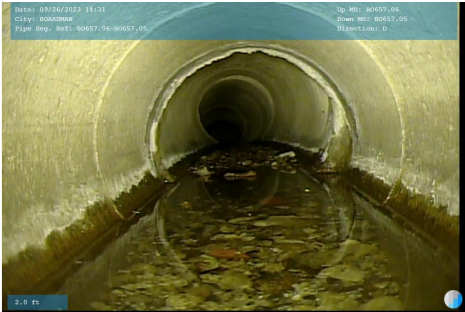
2	DSGV - Deposits Settled Gravel Continuous: S01 Percent: 10 Clock from 5 to 7 Grade = 2	00:01:22

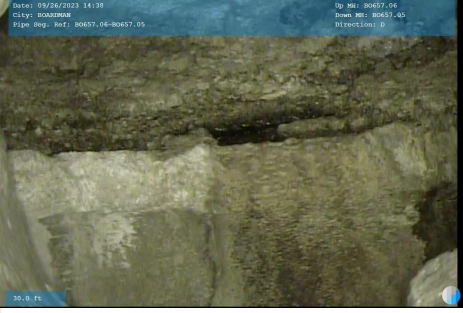
<p>30</p>	<p>ACB - Access Point Catch Basin          Remark = BO657.05</p>	<p>00:05:44</p>
