Project:	2320059	Date/Time:	October 3 2023 -
Street and City:	Flagler Lane - Boardman	Weather:	Unknown Weather
Owner:	City of Boardman	Inspection Status:	Complete Inspection
Customer:	ABC Water	Segment:	BO657.07-BO657.06
Surveyor Name and Certificate:	Robert Dean U-821-70402841	Direction:	Downstream
Reviewer Name and Certificate:		Up MH:	BO657.07
P.O. #		Down MH:	BO657.06

Pipe Details and Measurements

Boardman — October 3 2023	Up MH: BO657.07
Pipe: BO657.07-BO657.06	Down MH: BO657.06

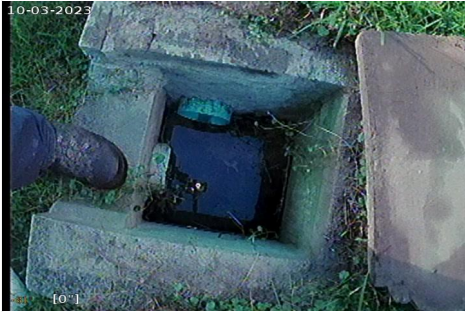
0	ACB - Access Point Catch Basin	00:00:00

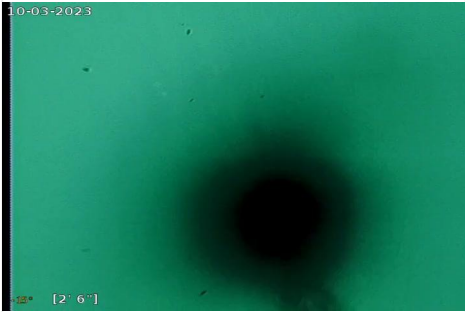
0	MWL - Miscellaneous Water Level	00:00:22

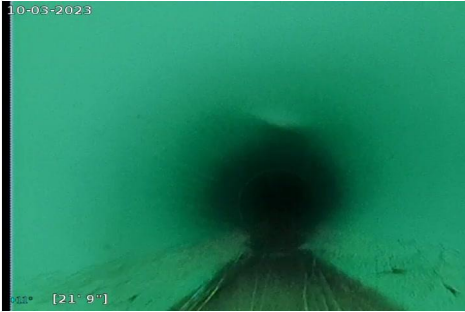
21.9	DFBR - Deformed Flexible Bulging Round Percent: 5 Clock At 12 Grade = 3	00:01:15

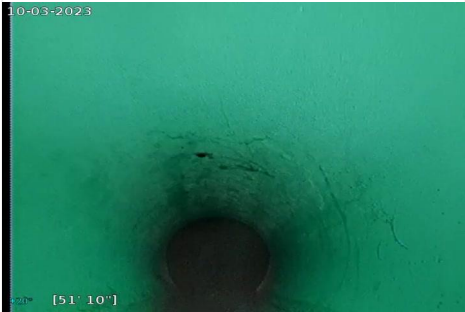
52.4	MWLS - Miscellaneous Water Level Sag Percent: 5 Grade = 2	00:01:54

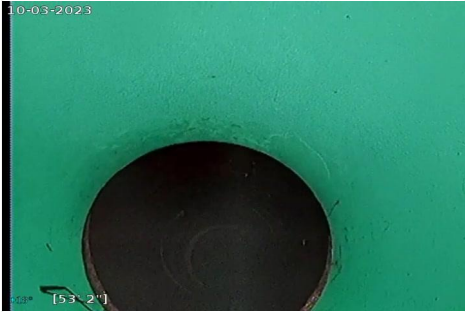
53.2	MMC - Miscellaneous Material Change Remark = PVC TO VCP	00:02:00

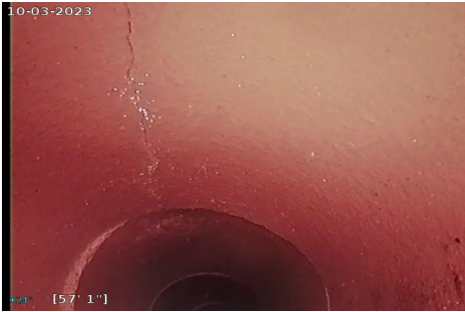
57.1	JOM - Joint Offset Medium Continuous: S01 Grade = 3	00:02:24

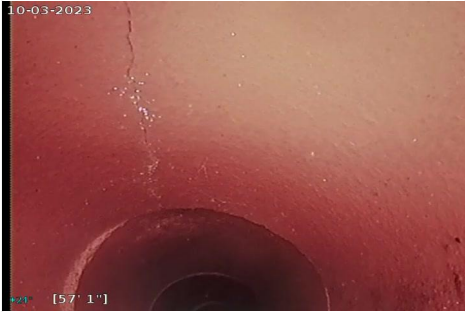
57.1	CL - Crack Longitudinal Clock At 12 Grade = 2	00:02:24

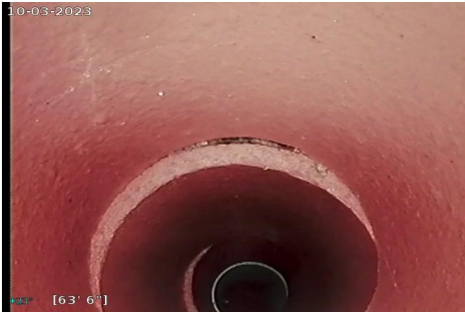
63.6	JOL - Joint Offset Large Grade = 4	00:02:56

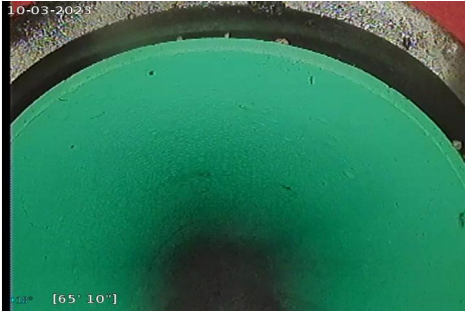
65.1	MMC - Miscellaneous Material Change Remark = VCP Back to PVC	00:03:13

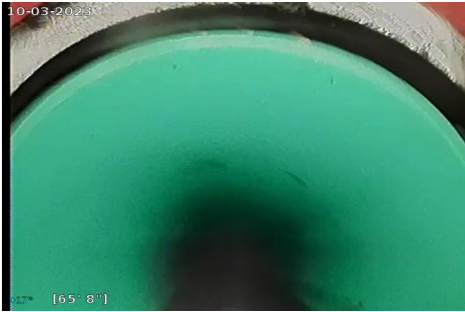
65.8	JSM - Joint Separated Medium Grade = 3	00:03:06

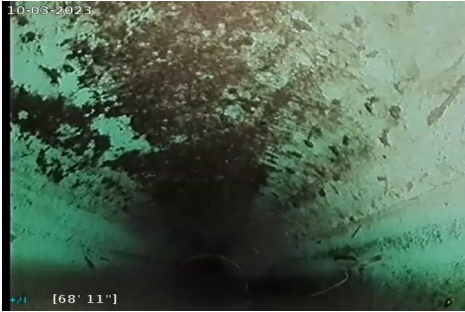
68.1	MWLS - Miscellaneous Water Level Sag Percent: 15 Grade = 2	00:03:23

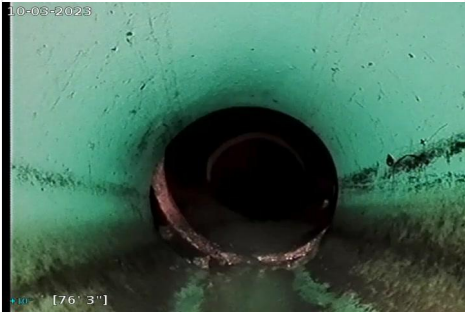
76.3	JOL - Joint Offset Large Grade = 4	00:04:00

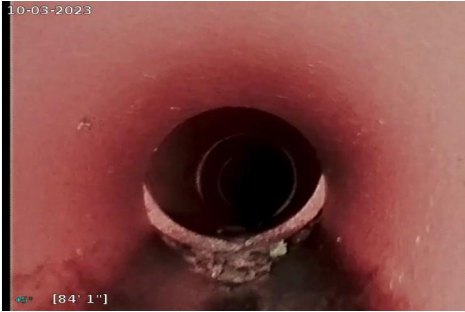
84.1	B - Broken Clock At 6 Grade = 4	00:04:41

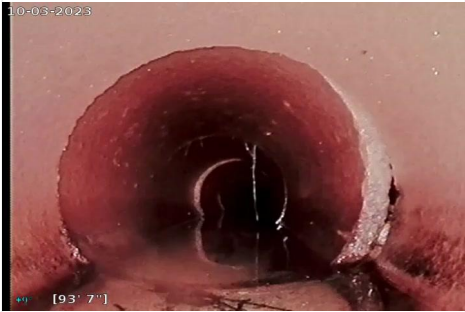
93.7	B - Broken Clock At 3 Grade = 4	00:05:29

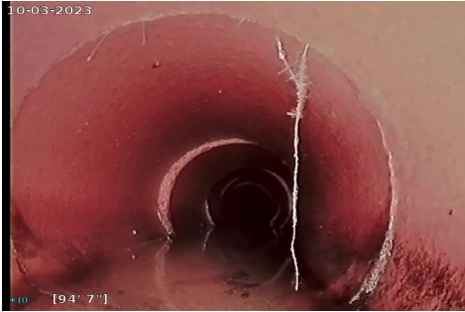
94.7	RFJ - Roots Fine Joint Joint: True Clock from 12 to 3 Grade = 1	00:05:36

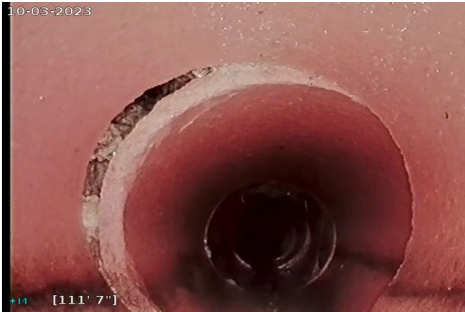
111.7	HSV - Hole Soil Visible Joint: True Clock from 8 to 11 Grade = 5	00:06:40

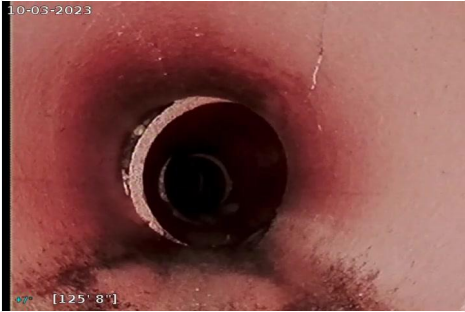
125.8	JOL - Joint Offset Large Grade = 4	00:07:57

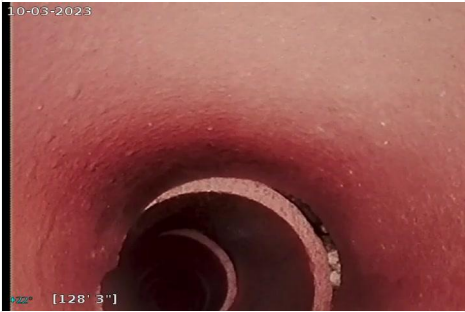
128.3	JOL - Joint Offset Large Grade = 4	00:08:19

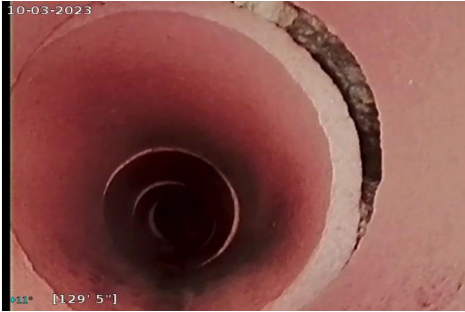
129.5	JOL - Joint Offset Large Grade = 4	00:08:44

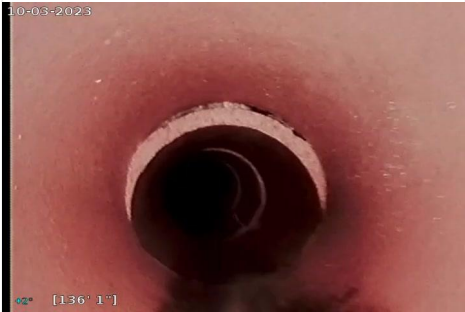
136.1	JOL - Joint Offset Large Grade = 4	00:09:15
