Project:	2320059	Date/Time:	September 28 2023 -
Street and City:	Flagler Lane - Boardman	Weather:	Unknown Weather
Owner:	City of Boardman	Inspection Status:	Complete Inspection
Customer:	ABC Water	Segment:	BO657.07-BO657.06
Surveyor Name and Certificate:	Robert Dean U-821-70402841	Direction:	Upstream
Reviewer Name and Certificate:		Up MH:	BO657.07
P.O. #		Down MH:	BO657.06

Boardman — September 28 2023	Up MH: BO657.07
Pipe: BO657.07-BO657.06	Down MH: BO657.06

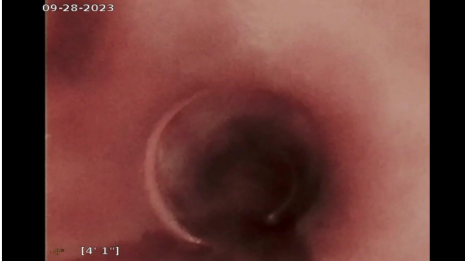
0	AM - Access Point Meter Remark = Start of line	00:00:11

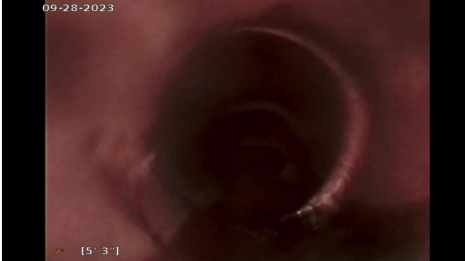
0	MWL - Miscellaneous Water Level Percent: 5	00:00:13

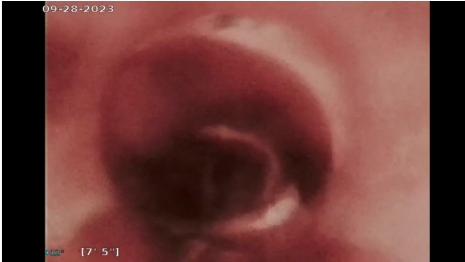
7.5	B - Broken Clock from 5 to 7 Grade = 4	00:00:37

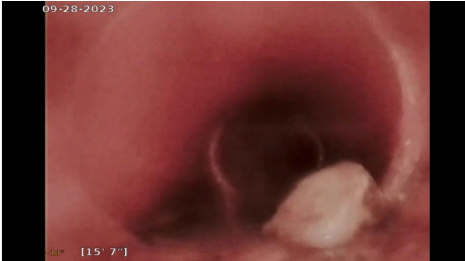
15.9	DSGV - Deposits Settled Gravel Percent: 15 Clock from 5 to 7 Grade = 3	00:00:55

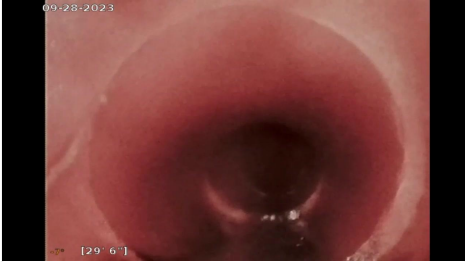
29.6	JOL - Joint Offset Large Grade = 4	00:01:18

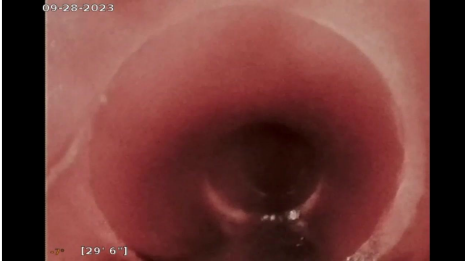
29.6	LU - Line Up Percent: 5 Grade = 1	00:01:18

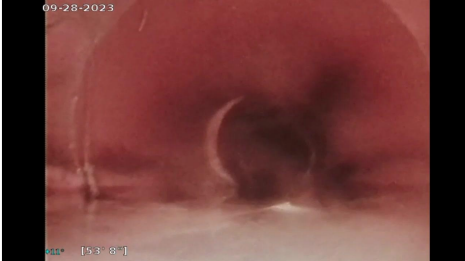
53.8	MWLS - Miscellaneous Water Level Sag Percent: 5 Remark = end of sag Grade = 2	00:03:08

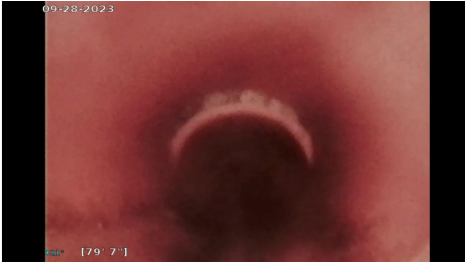
79.7	JOL - Joint Offset Large Grade = 4	00:04:26

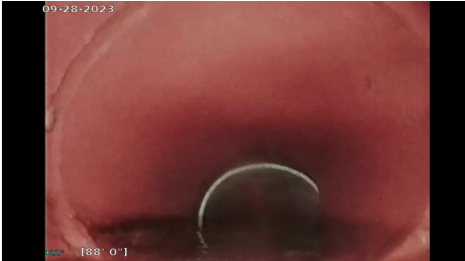
88.1	JOM - Joint Offset Medium Grade = 3	00:04:37

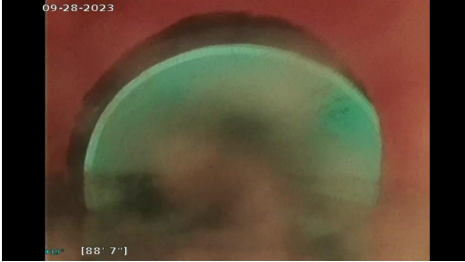
88.7	MMC - Miscellaneous Material Change Remark = VCP TO PVC	00:04:38

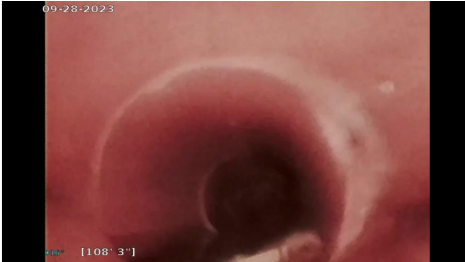
108.6	DSZ - Deposits Settled Other Percent: 15 Clock from 5 to 7 Remark = Rock/Pipe Material Grade = 3	00:06:01

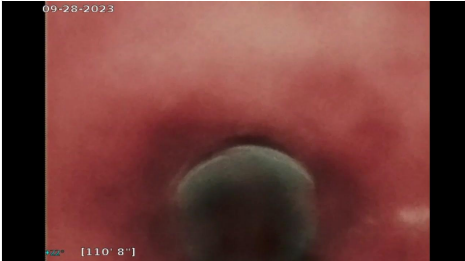
110.8	MMC - Miscellaneous Material Change Remark = VCP TO PVC	00:06:33
