Project:	2320059	Date/Time:	September 26 2023 - 09:56
Street and City:	PIERCE DR - BOARDMAN	Weather:	Unknown Weather
Owner:	CITY OF BOARDMAN	Inspection Status:	Complete Inspection
Customer:	ABC WATER	Segment:	BO657.08-BO657.05
Surveyor Name and Certificate:	SHAWN DUNNELL 915-70001437	Direction:	Upstream
Reviewer Name and Certificate:		Up MH:	BO657.08
P.O. #		Down MH:	BO657.05

BOARDMAN — September 26 2023	Up MH: BO657.08
Pipe: BO657.08-BO657.05	Down MH: BO657.05

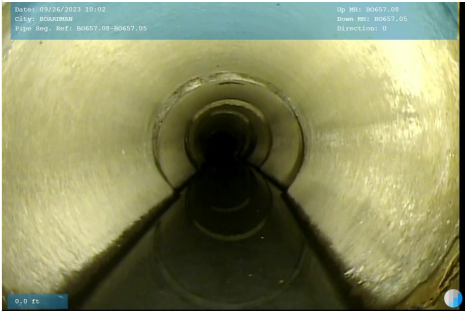
A photograph showing a water level measurement inside a pipe. A dark, circular object, likely a float or sensor, is visible in the center of the pipe. The water level is indicated by a dark line. A small blue label in the bottom left corner reads "0.0 ft".	0	MWL - Miscellaneous Water Level Percent: 10	00:00:41

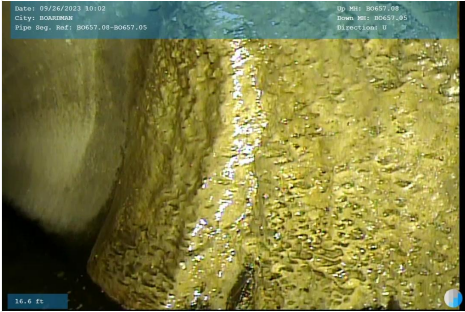
A photograph showing a close-up view of the interior of a pipe. The walls are covered with a thick, yellowish-brown deposit, likely encrustation or scale. The deposit is uneven and appears to be growing on the pipe wall. A small blue label in the bottom left corner reads "16.6 ft".	16.6	DAE - Deposits Attached Encrustation Percent: 10 Clock from 1 to 5 Grade = 2	00:01:17

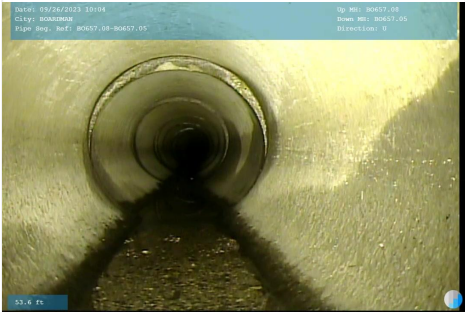
A photograph showing a water level measurement inside a pipe. A dark, circular object, likely a float or sensor, is visible in the center of the pipe. The water level is indicated by a dark line. A small blue label in the bottom left corner reads "53.6 ft".	53.6	MWL - Miscellaneous Water Level Percent: 5	00:02:32

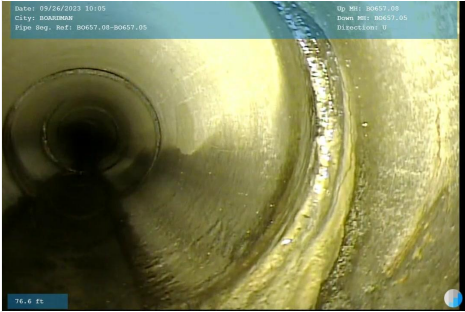
76.6	DAE - Deposits Attached Encrustation Percent: 5 Joint: True Clock from 7 to 5 Grade = 2	00:03:38
 	81.2	DAE - Deposits Attached Encrustation Percent: 5 Joint: True Clock from 7 to 11 Grade = 2	00:03:55

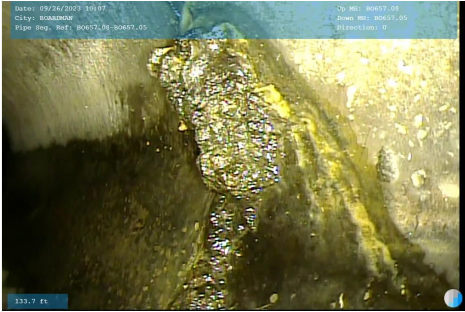
133.7	DAE - Deposits Attached Encrustation Percent: 10 Clock from 3 to 6 Grade = 2	00:05:36
 	154.6	OBB - Obstruction Brick or Masonry Percent: 5 Clock At 6 Grade = 2	00:06:27

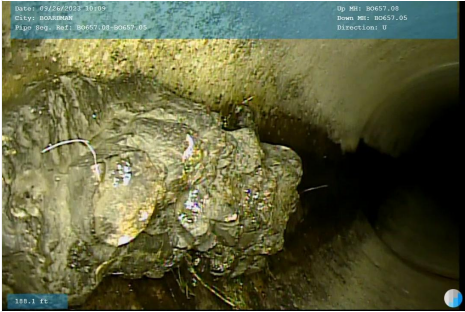
<p>DATE: 09/26/2023 10:15 CLAY: BOARDMAN Pipe Inq. Ref: BO657.08-BO657.05 Up MH: BO657.08 Down MH: BO657.05 Direction: U</p> <p>188.1 ft</p>	188.1	OBR - Obstruction Rocks Percent: 10 Clock At 6 Grade = 2	00:07:48
