Project:	2320059	Date/Time:	September 26 2023 - 10:20
Street and City:	PIERCE DR - BOARDMAN	Weather:	Unknown Weather
Owner:	CITY OF BOARDMAN	Inspection Status:	Complete Inspection
Customer:	ABC WATER	Segment:	BO657.09-BO657.08
Surveyor Name and Certificate:	SHAWN DUNNELL 915-70001437	Direction:	Upstream
Reviewer Name and Certificate:		Up MH:	BO657.09
P.O. #		Down MH:	BO657.08

BOARDMAN — September 26 2023	Up MH: BO657.09
Pipe: BO657.09-BO657.08	Down MH: BO657.08

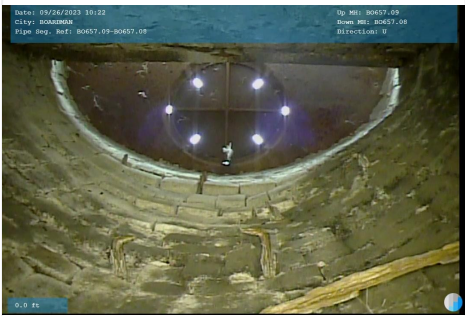
0	AMH - Manhole Remark = BO657.08	00:00:24

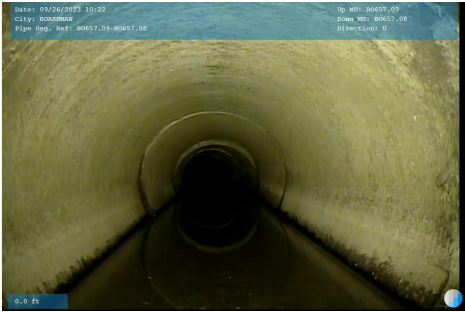
0	MWL - Miscellaneous Water Level Percent: 20	00:00:48

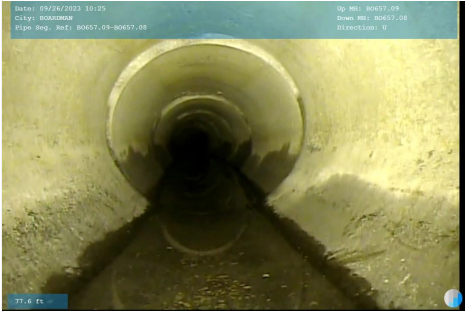
77.6	MWL - Miscellaneous Water Level Percent: 10	00:02:58

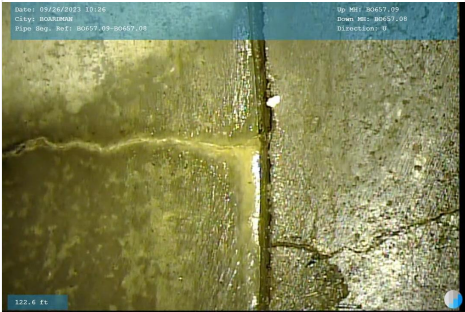
122.6	CL - Crack Longitudinal Joint: True Clock At 12 Grade = 2	00:04:01

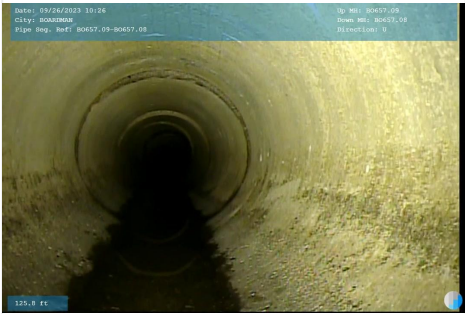
125.8	MWL - Miscellaneous Water Level Percent: 5	00:04:17

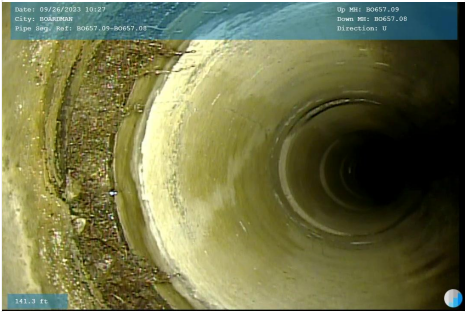
141.3	RMJ - Roots Medium Joint Percent: 5 Joint: True Clock from 8 to 4 Grade = 3	00:05:07

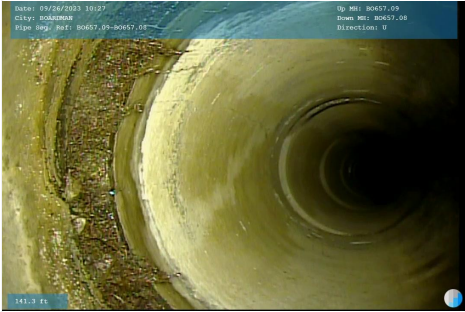
141.3	ID - Infiltration Dripper Joint: True Clock from 10 to 2 Grade = 3	00:05:16

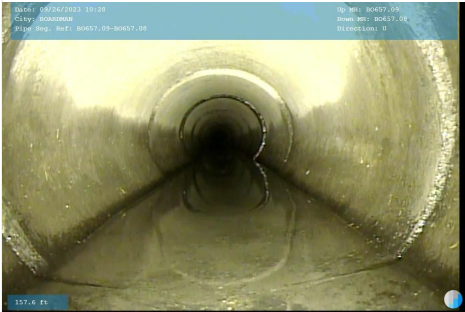
157.6	MWL - Miscellaneous Water Level Percent: 15	00:05:53

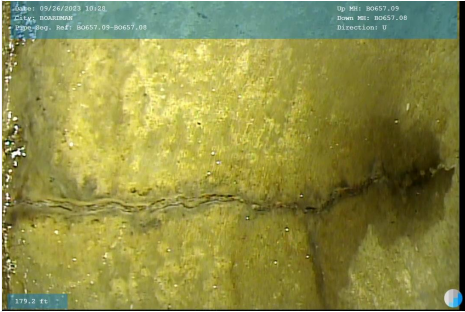
179.2	CL - Crack Longitudinal Continuous: S01 Clock At 12 Grade = 2	00:06:28

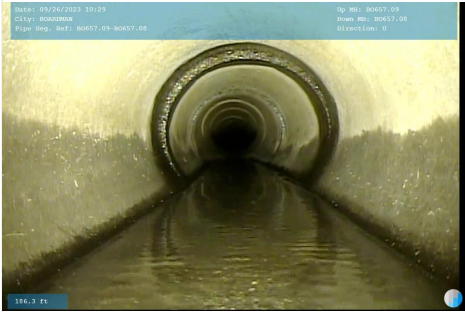
186.3	CL - Crack Longitudinal Continuous: F01 Clock At 12 Grade = 2	00:07:01

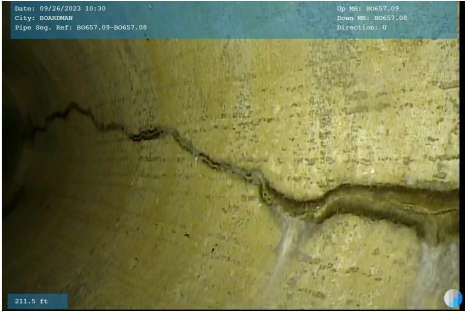
211.5	CL - Crack Longitudinal Continuous: S02 Joint: True Clock At 12 Grade = 2	00:07:51

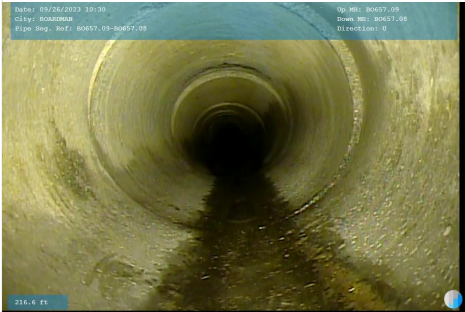
216.6	CL - Crack Longitudinal Continuous: F02 Joint: True Clock At 12 Grade = 2	00:08:10

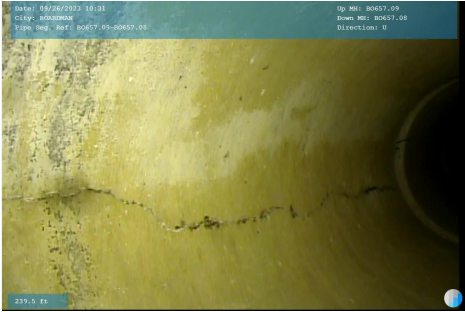
297.3	CL - Crack Longitudinal Continuous: F04 Clock At 12 Grade = 2	00:08:52

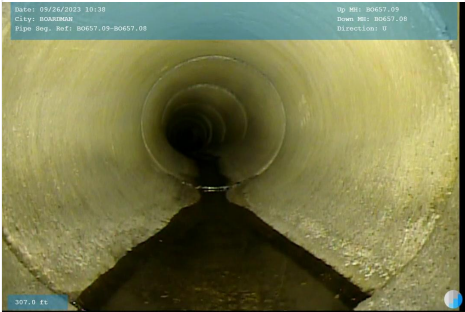
307.2	MWL - Miscellaneous Water Level Percent: 5	00:10:46

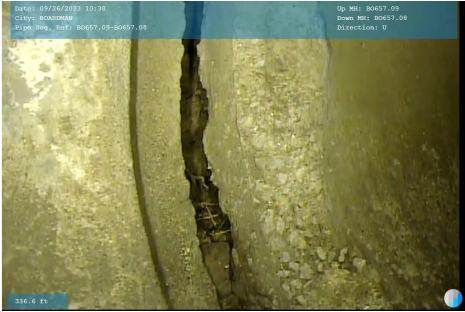
336.6	JSL - Joint Separated Large Grade = 4	00:11:25

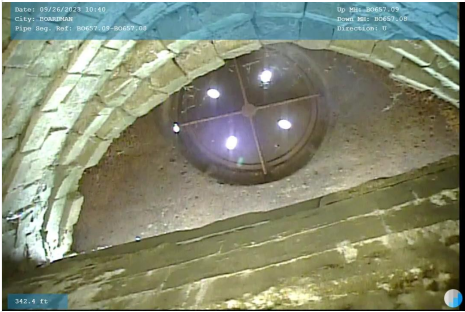
342.4	AMH - Manhole Remark = BO657.09	00:12:30
