Project:	2320059	Date/Time:	September 26 2023 - 12:54
Street and City:	PIERCE RD - BOARDMAN	Weather:	Dry - No precipitation during survey
Owner:	CITY OF BOARDMAN	Inspection Status:	Complete Inspection
Customer:	ABC WATER	Segment:	BO657.09-BO657.10
Surveyor Name and Certificate:	SHAWN DUNNELL 915-70001437	Direction:	Downstream
Reviewer Name and Certificate:		Up MH:	B0657.09
P.O. #		Down MH:	BO657.10

BOARDMAN — September 26 2023	Up MH: B0657.09
Pipe: B0657.09-B0657.10	Down MH: B0657.10

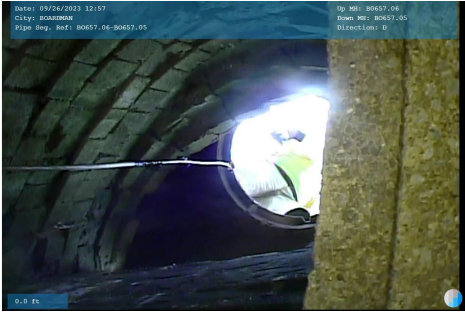
0	AMH - Manhole Remark = B0657.05	00:00:25

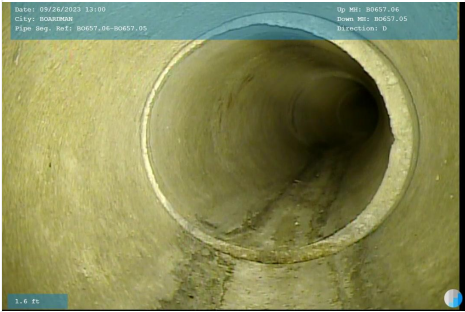
0	MWL - Miscellaneous Water Level	00:00:58

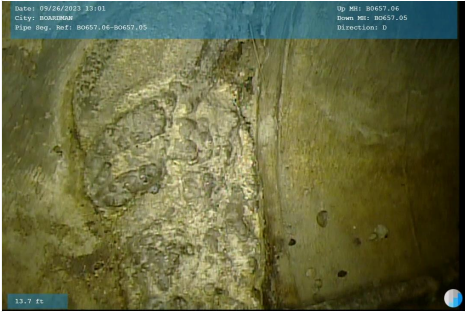
13.7	OBB - Obstruction Brick or Masonry Percent: 5 Joint: True Clock from 6 to 9 Grade = 2	00:01:44

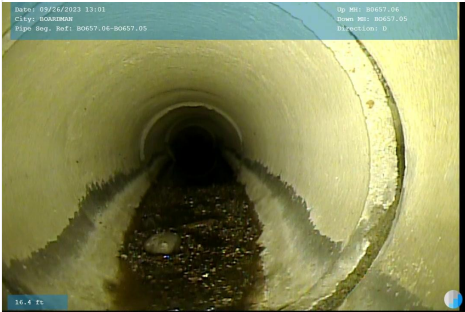
16.4	DSF - Deposits Settled Fine Continuous: S01 Percent: 5 Clock from 5 to 7 Grade = 2	00:02:10

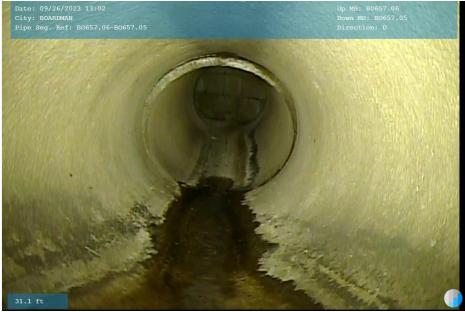
31.1	LD - Line Down Percent: 5 Grade = 1	00:03:03

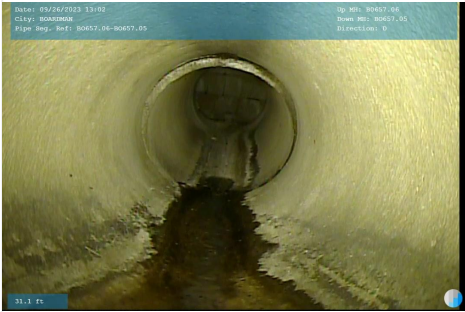
31.1	DSF - Deposits Settled Fine Continuous: F01 Percent: 5 Clock from 5 to 7 Grade = 2	00:03:07

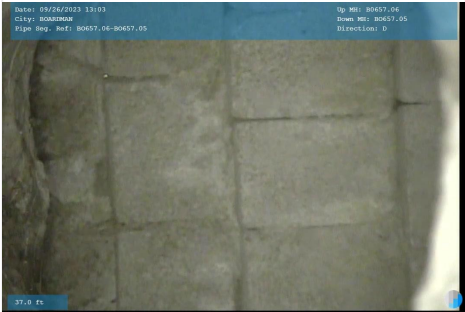
37	ACB - Access Point Catch Basin Remark = B0657.10	00:03:53
