Project:	2320059	Date/Time:	September 26 2023 - 12:34
Street and City:	MILL TRACE RD - BOARDMAN	Weather:	Dry - No precipitation during survey
Owner:	CITY OF BOARDMAN	Inspection Status:	Complete Inspection
Customer:	ABC WATER	Segment:	BO657.11-BO657.11A
Surveyor Name and Certificate:	SHAWN DUNNELL 915-70001437	Direction:	Upstream
Reviewer Name and Certificate:		Up MH:	BO657.11
P.O. #		Down MH:	B0657.11A

BOARDMAN — September 26 2023	Up MH: B0657.11
Pipe: B0657.11-B0657.11A	Down MH: B0657.11A

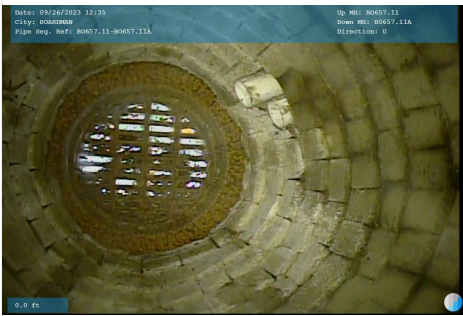
A top-down view of a manhole opening. The interior of the manhole is visible, showing a circular structure with a grid of bars. The walls are made of concrete blocks. A small blue label in the bottom left corner reads "0.0 ft".	0	AMH - Manhole Remark = B0657.11A	00:00:24

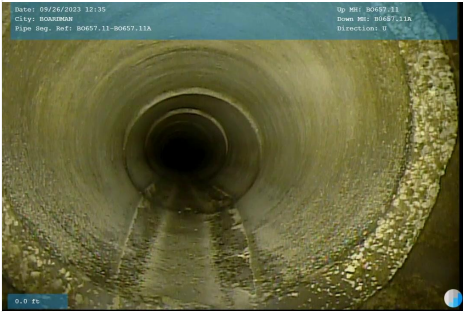
A view looking down into a pipe. The water level is visible, and the pipe walls are made of concrete. A small blue label in the bottom left corner reads "0.0 ft".	0	MWL - Miscellaneous Water Level	00:00:39

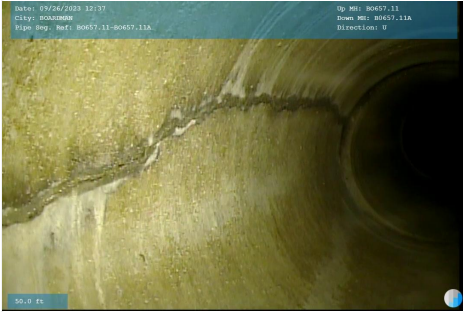
A view of a crack in the pipe wall. The crack is longitudinal and runs along the length of the pipe. The walls are made of concrete. A small blue label in the bottom left corner reads "50.0 ft".	50	CL - Crack Longitudinal Continuous: S01 Joint: True Clock At 12 Grade = 2	00:02:01

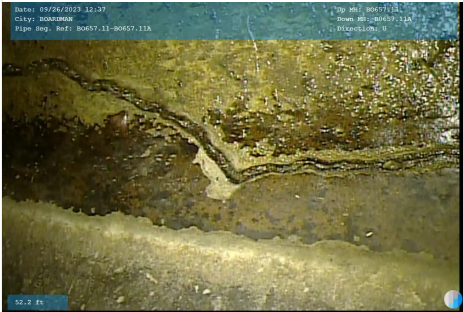
A view of a fracture in the pipe wall. The fracture is longitudinal and runs along the length of the pipe. The walls are made of concrete. A small blue label in the bottom left corner reads "52.2 ft".	52.2	FL - Fracture Longitudinal Joint: True Clock At 6 Grade = 3	00:02:18

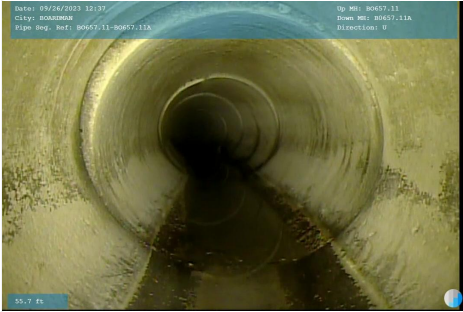
55.7	CL - Crack Longitudinal Continuous: F01 Joint: True Clock At 12 Grade = 2	00:02:33

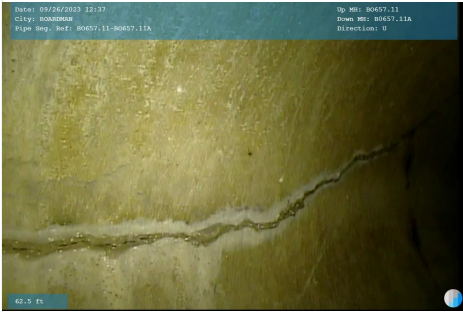
62.5	CL - Crack Longitudinal Joint: True Clock At 12 Grade = 2	00:02:57

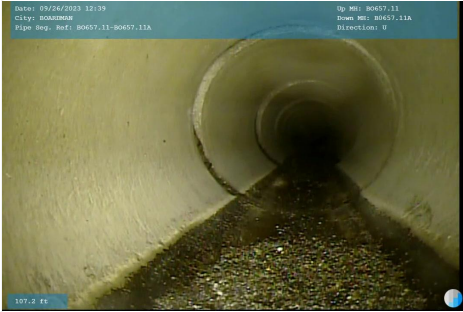
107.2	DSGV - Deposits Settled Gravel Continuous: S02 Percent: 5 Clock At 6 Grade = 2	00:04:12

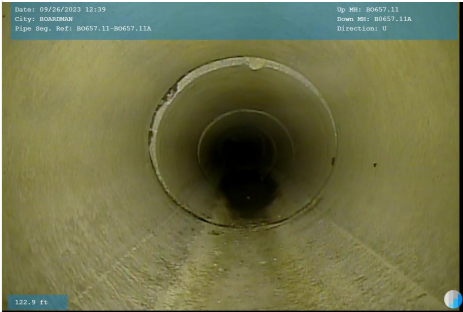
122.9	DSGV - Deposits Settled Gravel Continuous: F02 Percent: 5 Clock At 6 Grade = 2	00:04:41

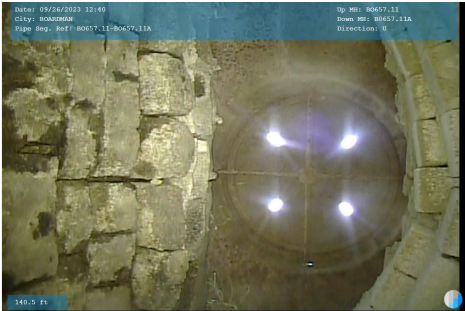
<div><div>Date: 09/26/2023 12:40</div><div>City: BOARDMAN</div><div>Pipe Deg. Ref: BO657.11-BO657.11A</div><div>Up MH: BO657.11</div><div>Down MH: B0657.11A</div><div>Direction: U</div><div>140.5 ft</div></div>	140.5	AMH - Manhole Remark = BO657.11	00:05:52
