Project:	2320059	Date/Time:	September 26 2023 - 10:40
Street and City:	PIERCE DR - BOARDMAN	Weather:	Unknown Weather
Owner:	CITY OF BOARDMAN	Inspection Status:	Complete Inspection
Customer:	ABC WATER	Segment:	BO657.11A-BO657.09
Surveyor Name and Certificate:	SHAWN DUNNELL 915-70001437	Direction:	Upstream
Reviewer Name and Certificate:		Up MH:	BO657.11A
P.O. #		Down MH:	BO357.09

BOARDMAN — September 26 2023	Up MH: BO657.11A
Pipe: BO657.11A-BO657.09	Down MH: BO357.09

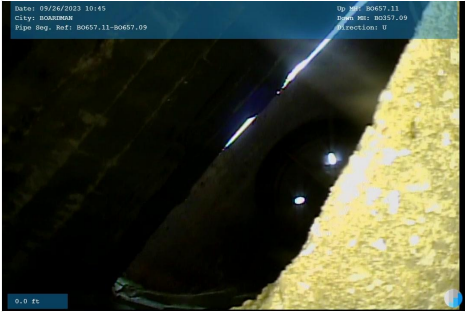
0	AMH - Manhole Remark = BO357.09	00:00:28

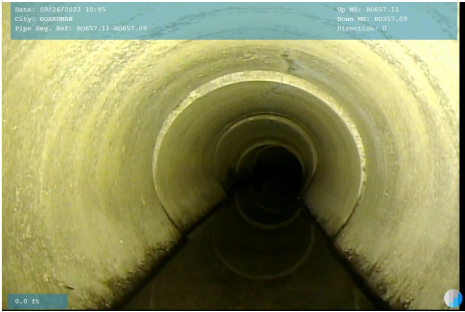
0	MWL - Miscellaneous Water Level Percent: 20	00:00:43

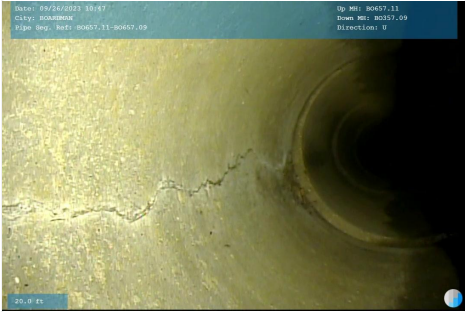
20	CL - Crack Longitudinal Joint: True Clock At 12 Grade = 2	00:02:29

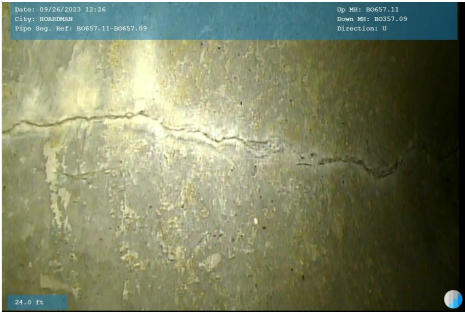
24	CL - Crack Longitudinal Continuous: S01 Clock At 12 Grade = 2	00:03:04

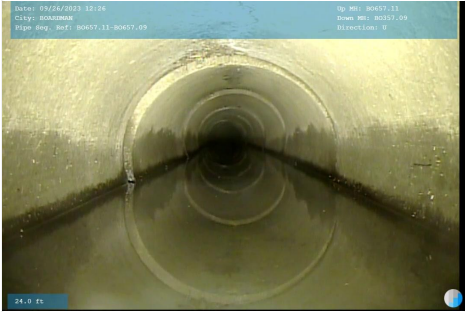
24	MWL - Miscellaneous Water Level Percent: 30	00:03:18

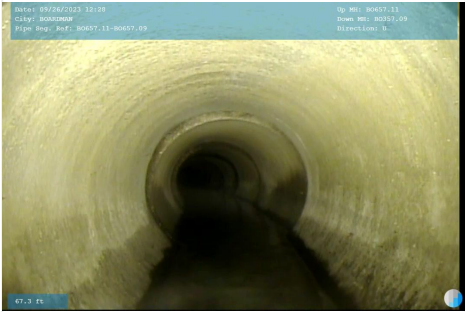
67.3	CL - Crack Longitudinal Continuous: F01 Clock At 12 Grade = 2	00:04:37

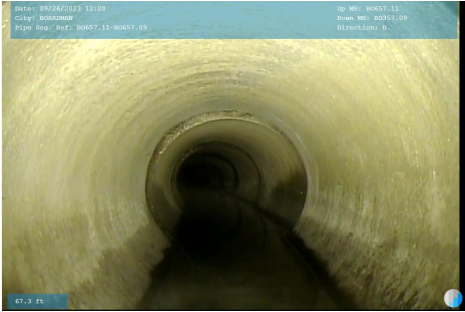
67.3	MWL - Miscellaneous Water Level Percent: 15	00:04:41

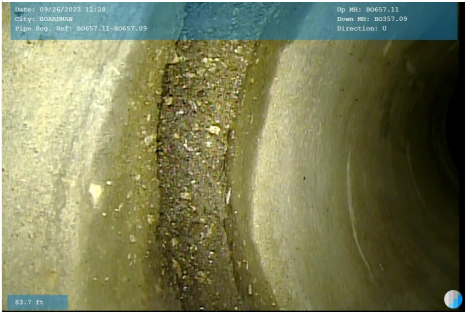
83.7	JOL - Joint Offset Large Grade = 4	00:05:19

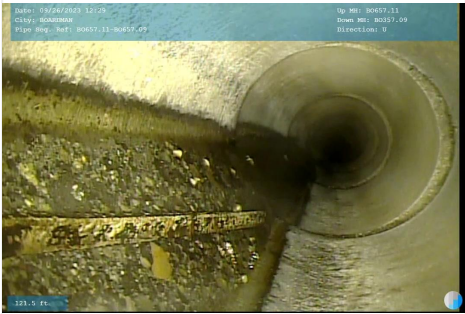
<p>121.5 ft</p>	121.5	OBN - Obstruction Construction Debris Percent: 5 Clock At 6 Remark = ROD Grade = 2	00:06:21

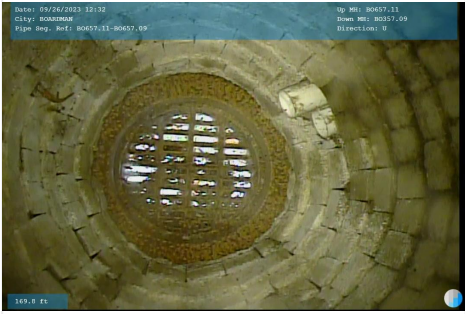
<p>169.8 ft</p>	169.8	AMH - Manhole Remark = BO657.11A	00:08:12
