Project:	2320059	Date/Time:	September 26 2023 - 12:41
Street and City:	MILL TRACE RD - BOARDMAN	Weather:	Dry - No precipitation during survey
Owner:	CITY OF BOARDMAN	Inspection Status:	Complete Inspection
Customer:	ABC WATER	Segment:	BO657.15-BO657.11
Surveyor Name and Certificate:	SHAWN DUNNELL 915-70001437	Direction:	Upstream
Reviewer Name and Certificate:		Up MH:	BO657.15
P.O. #		Down MH:	BO657.11

BOARDMAN — September 26 2023	Up MH: BO657.15
Pipe: BO657.15-BO657.11	Down MH: BO657.11

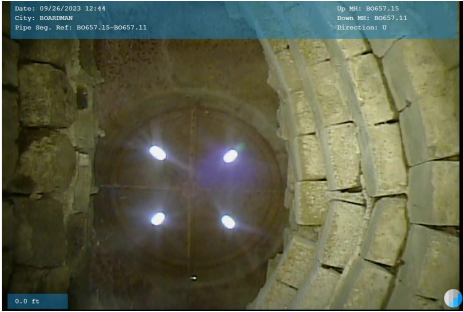
0	AMH - Manhole Remark = BO657.11	00:00:20

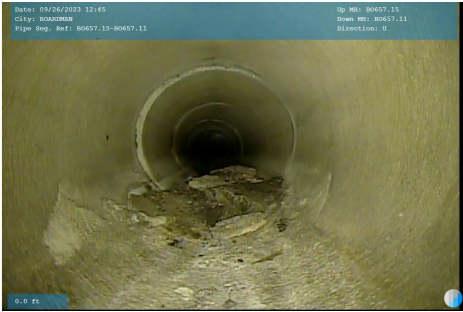
0	MWL - Miscellaneous Water Level	00:00:44

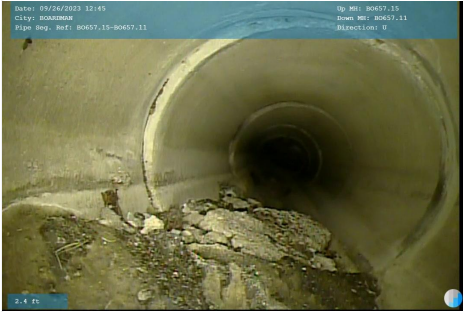
2.4	OBR - Obstruction Rocks Continuous: S01 Percent: 15 Clock from 4 to 8 Grade = 3	00:00:55
 	9.6	OBR - Obstruction Rocks Continuous: F01 Percent: 15 Clock from 4 to 8 Grade = 3	00:01:43

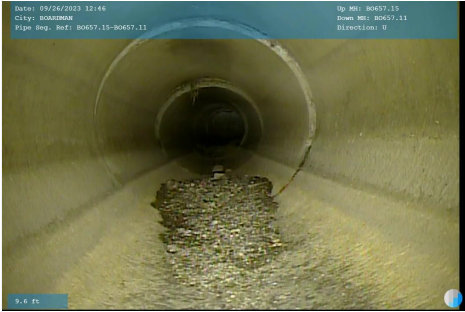
9.6	DSF - Deposits Settled Fine Percent: 5 Clock from 5 to 7 Grade = 2	00:01:46

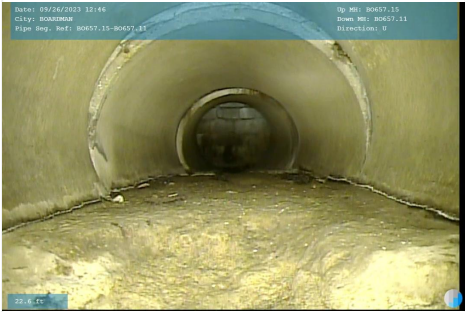
22.6	DSC - Deposits Settled Hard/Compacted Continuous: S02 Percent: 25 Clock from 4 to 8 Grade = 4	00:02:27

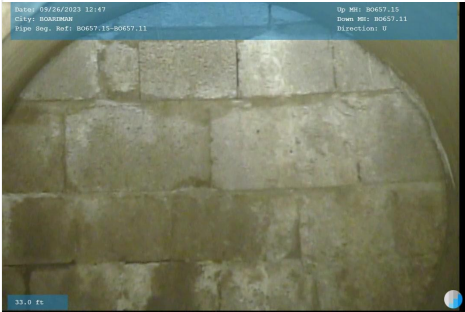
33	ACB - Access Point Catch Basin Remark = BO657.15	00:03:24
