Project:	2420009	Date/Time:	January 31 2024 - 10:02
Street and City:	TURNBERRY DR - YOUNGSTOWNE	Weather:	Dry Weather/Wet Ground
Owner:	CITY OF BOARDMAN	Inspection Status:	Complete Inspection
Customer:	ABC WATER	Segment:	MY00001_P1_M01-MY00001_P1_M02
Surveyor Name and Certificate:	SHAWN DUNNELL U-915-70001437	Direction:	Downstream
Reviewer Name and Certificate:		Up MH:	MY00001_P1_M01
P.O. #		Down MH:	MY00001_P1_M02

Pipe: MY00001_P1_M01-MY00001_P1_M02

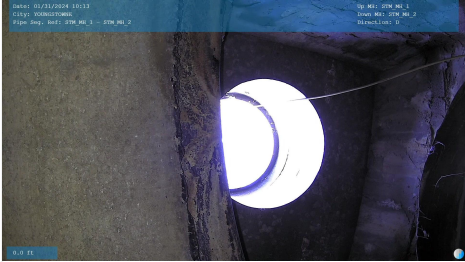
<p>00:00:10</p>	0	AMH - Manhole Remark = MY00001_P1_M01	00:00:10

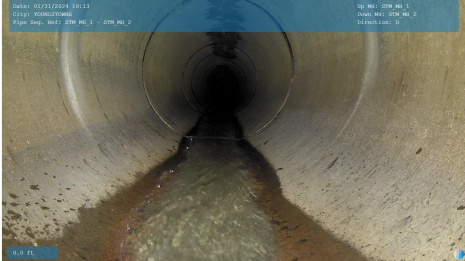
<p>00:00:40</p>	0	MWL - Miscellaneous Water Level Percent: 5	00:00:40

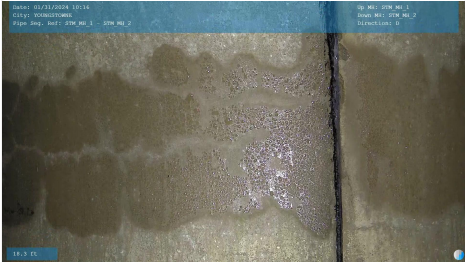
<p>00:01:17</p>	18.3	ISJ - Infiltration Stain Joint Joint: True Clock At 12 Grade = 1	00:01:17

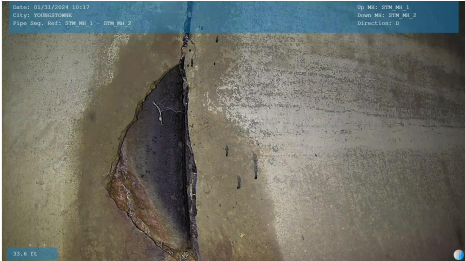
<p>00:02:07</p>	33.6	FC - Fracture Circumferential Joint: True Clock from 8 to 9 Grade = 2	00:02:07

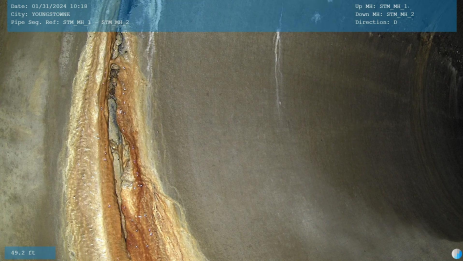
49.2	IR - Infiltration Runner Joint: True Clock from 9 to 3 Grade = 4	00:03:21

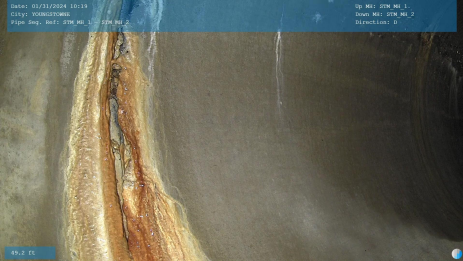
49.2	DAE - Deposits Attached Encrustation Percent: 5 Joint: True Clock from 7 to 5 Grade = 2	00:03:27

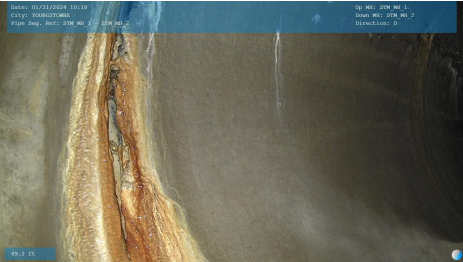
64.2	DAE - Deposits Attached Encrustation Percent: 5 Clock from 7 to 9 Grade = 2	00:03:21

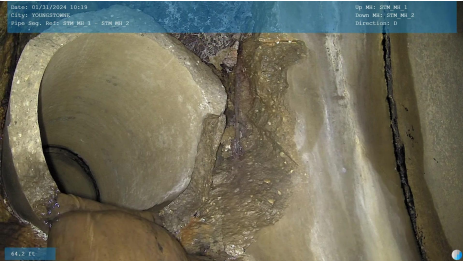
64.2	TBI - Tap Break-in Intruding Measurement 1: 10 Measurement 2: 5 Clock At 10 Grade = 3	00:03:58

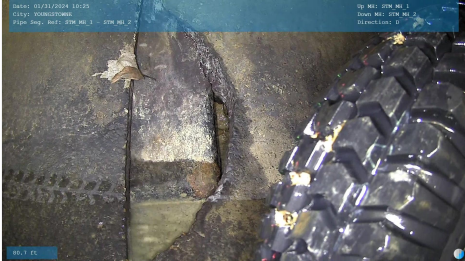
80.7	B - Broken Joint: True Clock from 4 to 5 Grade = 4	00:05:21

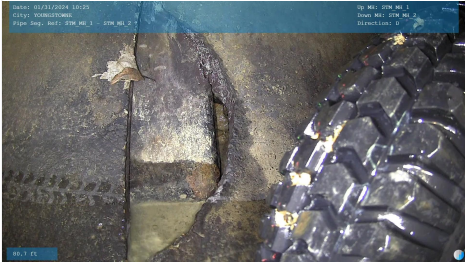
80.7	ID - Infiltration Dripper Joint: True Clock At 5 Grade = 3	00:05:35

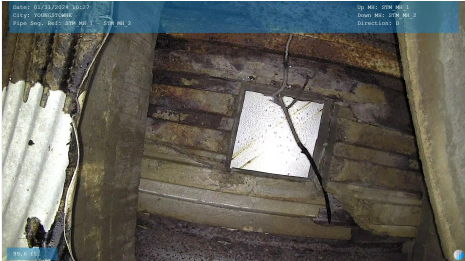
99.6	AMH - Manhole Remark = MY00001_P1_M02	00:06:49
