Project:	2420009	Date/Time:	February 1 2024 - 12:53
Street and City:	TURNBERRY DR - YOUNGSTOWN	Weather:	Dry Weather/Wet Ground
Owner:	CITY OF YOUNGSTOWN	Inspection Status:	Complete Inspection
Customer:	CT CONSULTANTS	Segment:	MY00001_P1_M02-MY00001_P1_M03
Surveyor Name and Certificate:	SHAWN DUNNELL U-915-70001437	Direction:	Upstream
Reviewer Name and Certificate:		Up MH:	MY00001_P1_M02
P.O. #		Down MH:	MY00001_P1_M03

Pipe: MY00001_P1_M02-MY00001_P1_M03

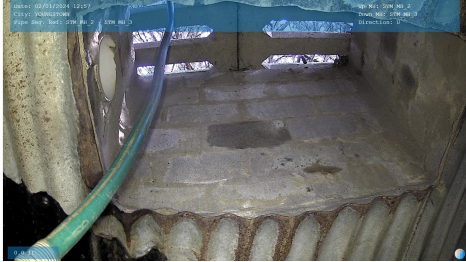
0	AMH - Manhole Remark = MY00001_P1_M03	00:00:12

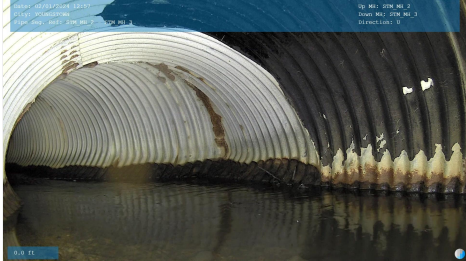
0	MWL - Miscellaneous Water Level Percent: 25	00:00:25

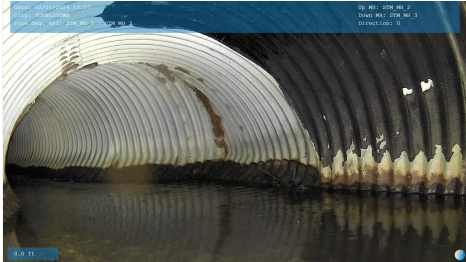
0	DSGV - Deposits Settled Gravel Continuous: S01 Percent: 10 Clock from 5 to 7 Grade = 2	00:00:28

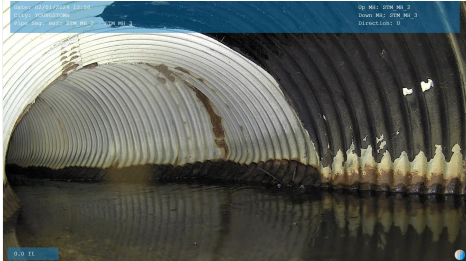
0	LL - Line Left Percent: 10 Grade = 1	00:00:41

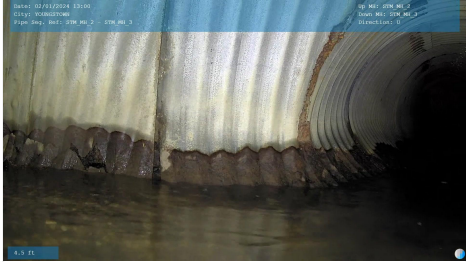
4.5	HSV - Hole Soil Visible Clock At 8 Grade = 5	00:01:43

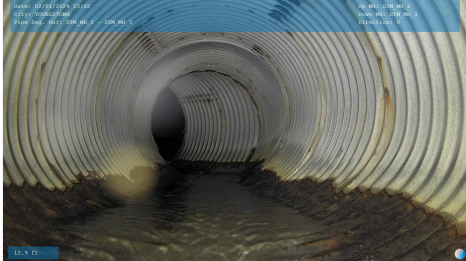
12.9	MWL - Miscellaneous Water Level Percent: 5	00:03:08

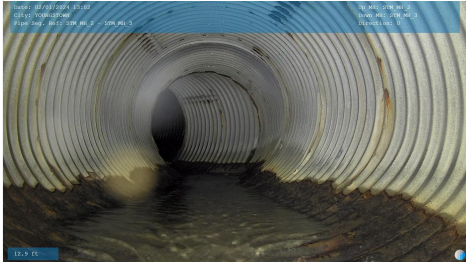
12.9	SCP - Surface Damage Corrosion Continuous: S02 Clock from 5 to 7 Grade = 3	00:03:14

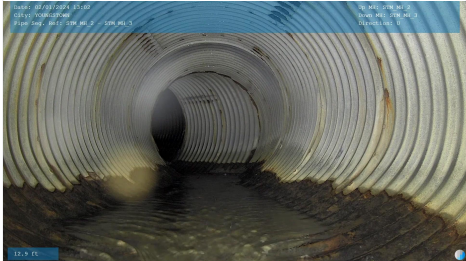
12.9	DSGV - Deposits Settled Gravel Continuous: F01 Percent: 10 Clock from 5 to 7 Grade = 2	00:03:23

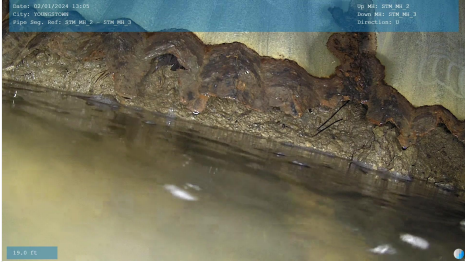
18.6	HSV - Hole Soil Visible Continuous: S03 Joint: True Clock from 4 to 7 Grade = 5	00:06:01

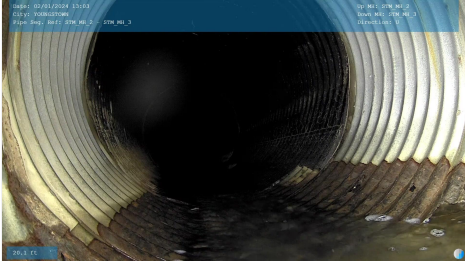
20.1	LL - Line Left Percent: 10 Grade = 1	00:04:04

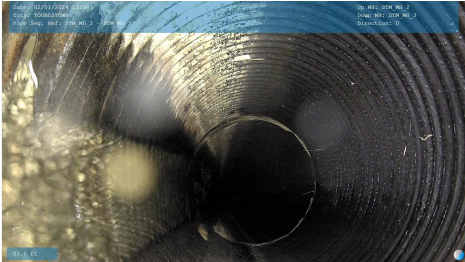
23	HSV - Hole Soil Visible Continuous: F03 Joint: True Clock from 4 to 7 Grade = 5	00:07:35

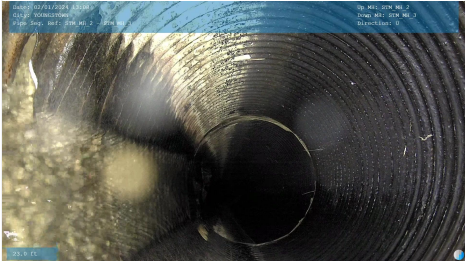
23	SCP - Surface Damage Corrosion Continuous: F02 Clock from 5 to 7 Grade = 3	00:07:40

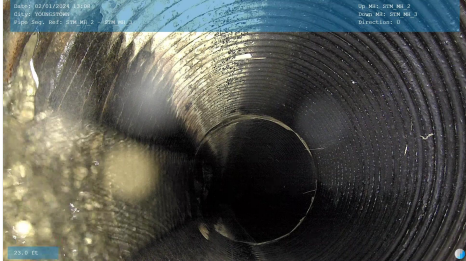
23	MSA - Miscellaneous Survey Abandoned Remark = HOLE IN THE PIPE	00:07:48
