Project:	2420009	Date/Time:	February 1 2024 - 12:29
Street and City:	TURNBERRY DR - YOUNGSTOWN	Weather:	Dry Weather/Wet Ground
Owner:	CITY OF YOUNGSTOWN	Inspection Status:	Complete Inspection
Customer:	CT CONSULTANTS	Segment:	MY00001_P1_M03-MY00001_P1_M04
Surveyor Name and Certificate:	SHAWN DUNNELL U-915-70001437	Direction:	Upstream
Reviewer Name and Certificate:		Up MH:	MY00001_P1_M03
P.O. #		Down MH:	MY00001_P1_M04

Pipe: MY00001_P1_M03-MY00001_P1_M04

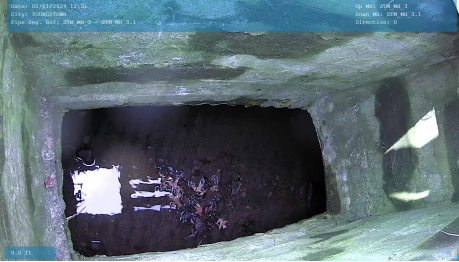
0	AMH - Manhole Remark = MY00001_P1_M04	00:00:14

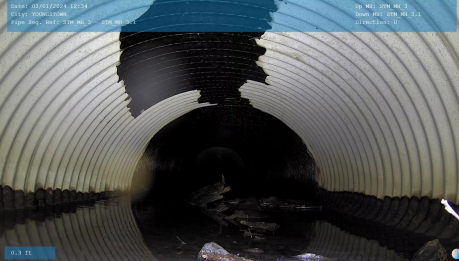
0	MWL - Miscellaneous Water Level Percent: 30	00:00:23

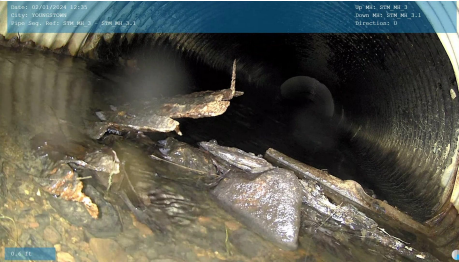
3	HSV - Hole Soil Visible Clock from 5 to 7 Grade = 5	00:00:51

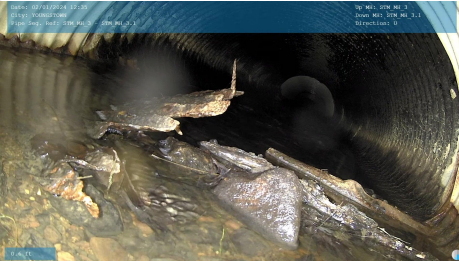
3	OBR - Obstruction Rocks Percent: 15 Clock from 5 to 7 Grade = 3	00:01:12

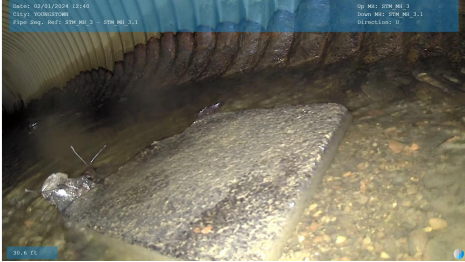
30.6	OBB - Obstruction Brick or Masonry Percent: 5 Clock At 6 Grade = 2	00:03:45

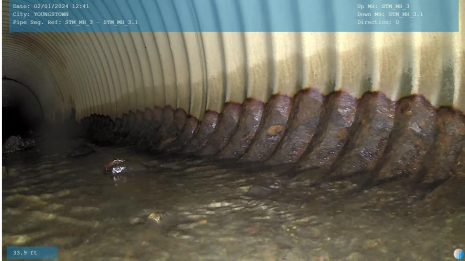
33.9	SRV - Surface Damage Reinforcement Visible Continuous: S01 Clock from 4 to 8 Grade = 4	00:04:03

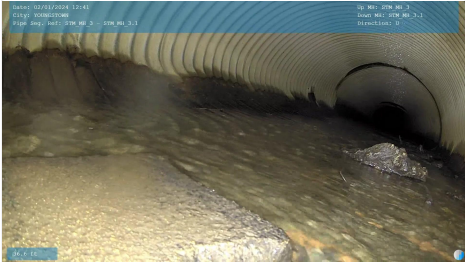
36.6	OBB - Obstruction Brick or Masonry Percent: 5 Clock At 6 Grade = 2	00:04:15

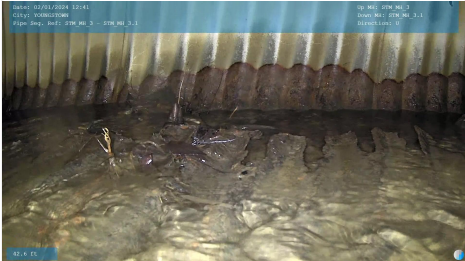
42.6	H - Hole Clock from 5 to 6 Grade = 4	00:04:44

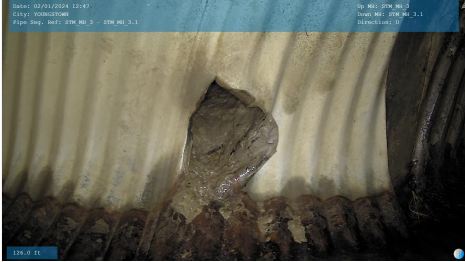
126	HSV - Hole Soil Visible Clock At 9 Grade = 5	00:09:41

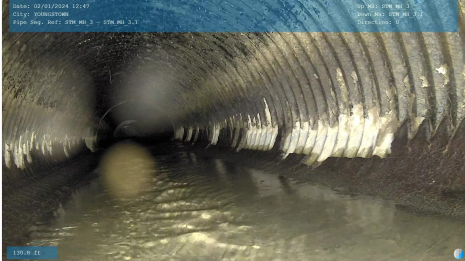
130.8	SRV - Surface Damage Reinforcement Visible Continuous: F01 Clock from 4 to 8 Grade = 4	00:10:07

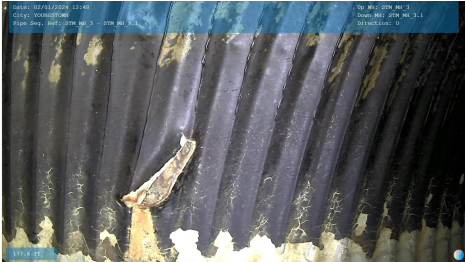
177.6	SSS - Surface Damage Surface Spalling Clock At 1 Grade = 2	00:11:13

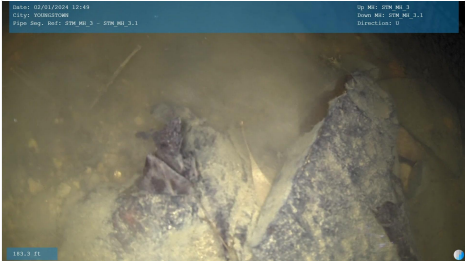
183.3	OBR - Obstruction Rocks Percent: 5 Clock At 6 Grade = 2	00:11:46

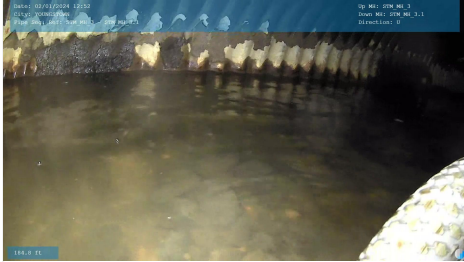
184.8	DSGV - Deposits Settled Gravel Percent: 10 Clock from 5 to 7 Grade = 2	00:12:24

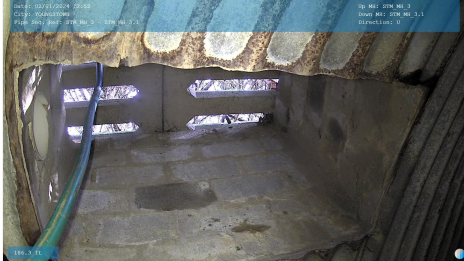
186.3	ACB - Access Point Catch Basin Remark = MY00001_P1_M03	00:12:47
