Project:	2420009	Date/Time:	January 31 2024 - 12:16
Street and City:	TURNBERRY DR - YOUNGSTOWN	Weather:	Dry Weather/Wet Ground
Owner:	CITY OF YOUNGSTOWN	Inspection Status:	Complete Inspection
Customer:	CT CONSULTANTS	Segment:	MY00001_P1_M04-MY00001_P1_M05
Surveyor Name and Certificate:	SHAWN DUNNELL U-915-70001437	Direction:	Upstream
Reviewer Name and Certificate:		Up MH:	MY00001_P1_M04
P.O. #		Down MH:	MY00001_P1_M05

Pipe: MY00001_P1_M04-MY00001_P1_M05

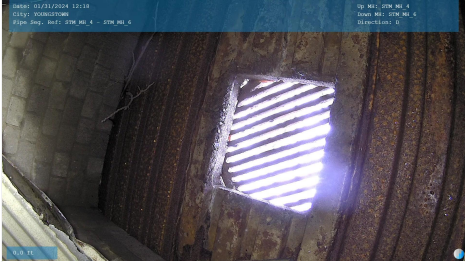
0	AMH - Manhole Remark = MY00001_P1_M05	00:00:27

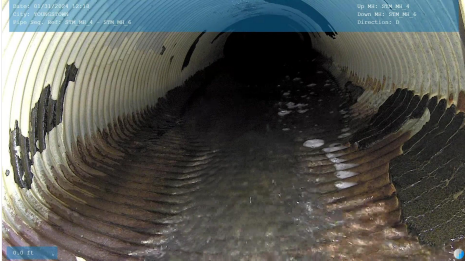
0	MWL - Miscellaneous Water Level Percent: 15	00:00:39

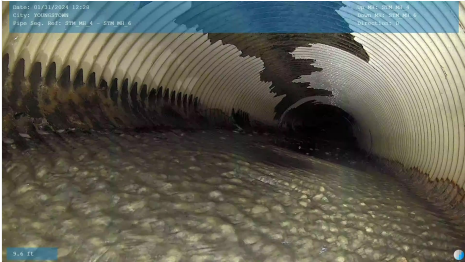
9.6	SCP - Surface Damage Corrosion Continuous: S01 Clock from 4 to 8 Grade = 3	00:01:14

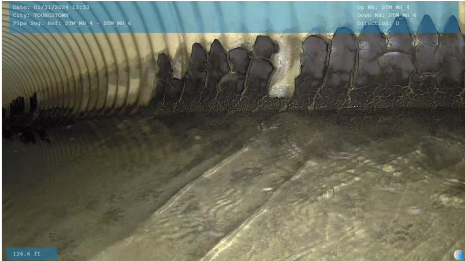
126.6	SCP - Surface Damage Corrosion Continuous: F01 Clock from 4 to 8 Grade = 3	00:05:51

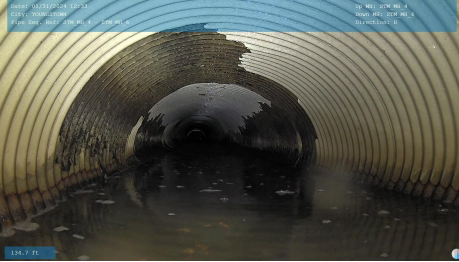
135	MWL - Miscellaneous Water Level Percent: 25	00:06:09

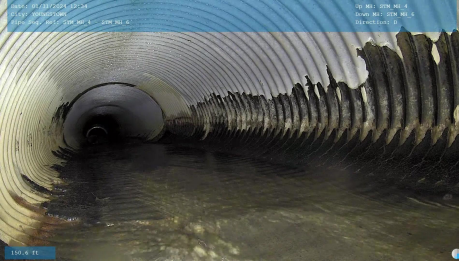
150.6	MWL - Miscellaneous Water Level Percent: 5	00:06:45

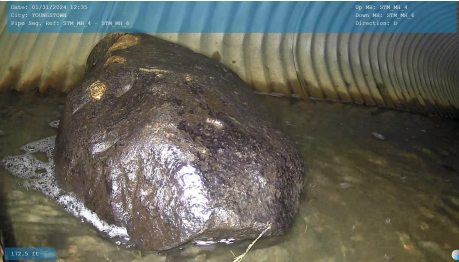
172.5	OBR - Obstruction Rocks Percent: 10 Clock At 6 Grade = 2	00:08:03

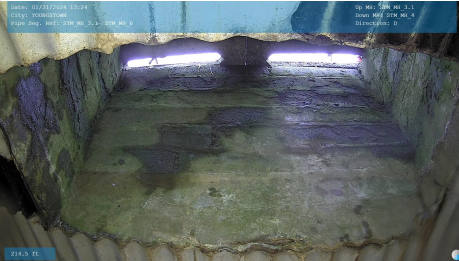
214.5	ACB - Access Point Catch Basin Remark = MY00001_P1_M04	00:10:10
