| Project: | 2420009 | Date/Time: | January 31 2024 - 13:48 |
| Street and City: | TURNBERRY DR - YOUNGSTOWN | Weather: | Dry Weather/Wet Ground |
| Customer: | CT CONSULTANTS | Segment: | MY00001_P1_M05-MY00001_P1_M06 |

Pipe: MY00001_P1_M05-MY00001_P1_M06

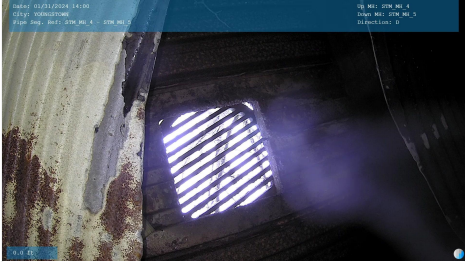
| Photo | Distance | Description | Time |
|---|---|---|---|
| | 0 | AMH - Manhole Remark = STM_MH_4 | 00:00:34 |

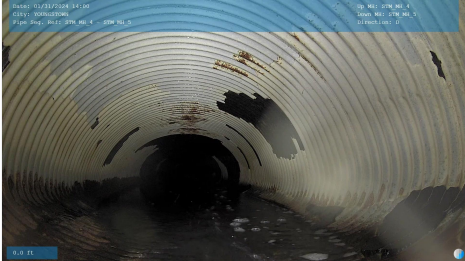
| Photo | Distance | Description | Time |
|---|---|---|---|
| | 0 | MWL - Miscellaneous Water Level Percent: 5 | 00:00:45 |

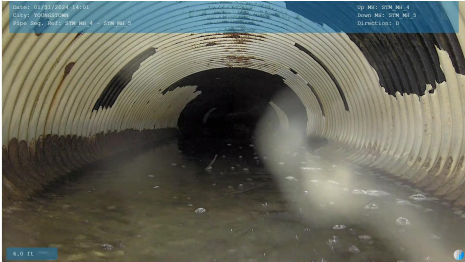
| Photo | Distance | Description | Time |
|---|---|---|---|
| | 6 | MWL - Miscellaneous Water Level Percent: 20 | 00:01:05 |

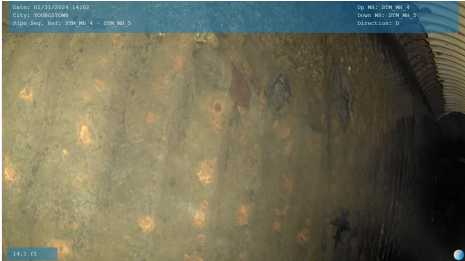
| Photo | Distance | Description | Time |
|---|---|---|---|
| | 14.1 | SCP - Surface Damage Corrosion Continuous: S01 Clock from 5 to 7 Grade = 3 | 00:01:37 |

| Time | Dist. | Code | Cont. | Dim. 1 | Dim. 2 | % | Joint | Clock From | Clock To | Remarks |
|---|---|---|---|---|---|---|---|---|---|---|
| 00:01:37 | 14.1 | SCP | S01 | | | | | 5 | 7 | |

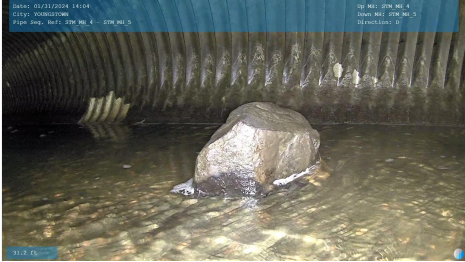
| Photo | Distance | Description | Time |
|---|---|--|---|
| | 31.2 | OBR - Obstruction Rocks Percent: 5 Clock At 6 Grade = 2 | 00:02:51 |

| Time | Dist. | Code | Cont. | Dim. 1 | Dim. 2 | % | Joint | Clock From | Clock To | Remarks |
|---|---|---|---|---|---|---|---|---|---|---|
| 00:02:51 | 31.2 | OBR | | | | 5 | | 6 | | |

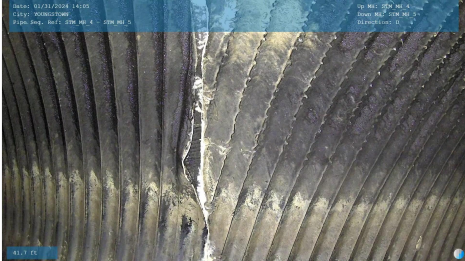
| Photo | Distance | Description | Time |
|---|---|--|---|
| | 41.7 | JSM - Joint Separated Medium Grade = 3 | 00:03:27 |

| Time | Dist. | Code | Cont. | Dim. 1 | Dim. 2 | % | Joint | Clock From | Clock To | Remarks |
|---|---|---|---|---|---|---|---|---|---|---|
| 00:03:27 | 41.7 | JSM | | | | | | | | |

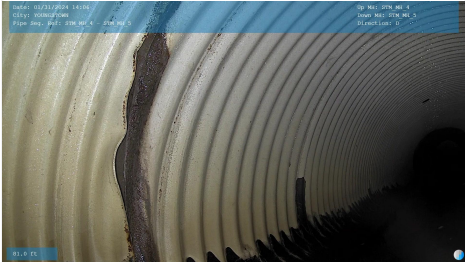
| Photo | Distance | Description | Time |
|---|---|--|---|
| | 81 | JSM - Joint Separated Medium Grade = 3 | 00:05:09 |

| Time | Dist. | Code | Cont. | Dim. 1 | Dim. 2 | % | Joint | Clock From | Clock To | Remarks |
|---|---|---|---|---|---|---|---|---|---|---|
| 00:03:27 | 81 | JSM | | | | | | | | |

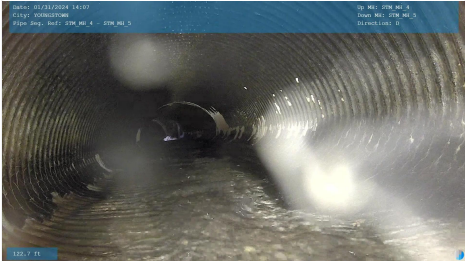
| Photo | Distance | Description | Time |
|---|---|--|---|
| | 122.7 | MWL - Miscellaneous Water Level Percent: 5 | 00:06:21 |

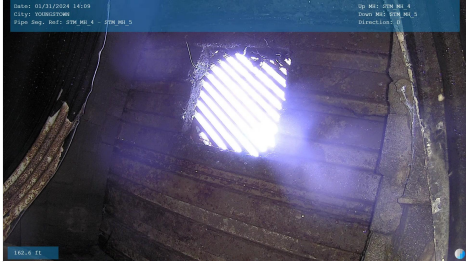
| Photo | Distance | Description | Time |
|--|---|---|---|
| | 162.6 | SCP - Surface Damage Corrosion Continuous: F01 Clock from 5 to 7 Grade = 3 | 00:07:42 |

| Time | Dist. | Code | Cont. | Dim. 1 | Dim. 2 | % | Joint | Clock From | Clock To | Remarks |
|---|---|---|---|---|---|---|---|---|---|---|
| 00:07:42 | 162.6 | SCP | F01 | | | | | 5 | 7 | |

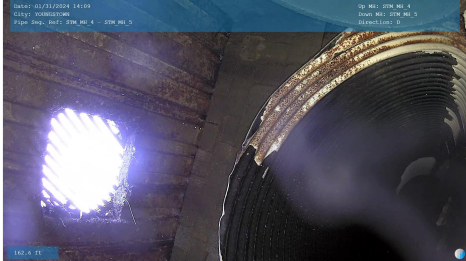
| Photo | Distance | Description | Time |
|--|---|---|---|
| | 162.6 | AMH - Manhole Remark = STM_MH_5 | 00:07:56 |
