Project:	2420009	Date/Time:	February 1 2024 - 09:34
Street and City:	COLLEEN DR - YOUNGSTOWN	Weather:	Dry Weather/Wet Ground
Owner:	CITY OF YOUNGSTOWN	Inspection Status:	Complete Inspection
Customer:	CT CONSULTANTS	Segment:	MY00001_P1_M07-MY00001_P1_M08
Surveyor Name and Certificate:	SHAWN DUNNELL U-915-70001437	Direction:	Upstream
Reviewer Name and Certificate:		Up MH:	MY00001_P1_M07
P.O. #		Down MH:	MY00001_P1_M08

Pipe: MY00001\_P1\_M07-MY00001\_P1\_M08

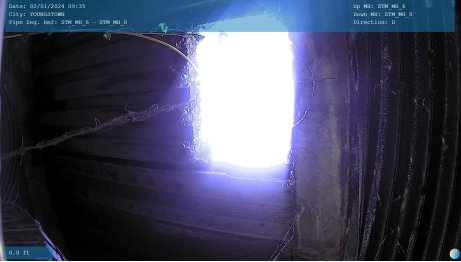
0	AMH - Manhole Remark = MY00001_P1_M08	00:00:13

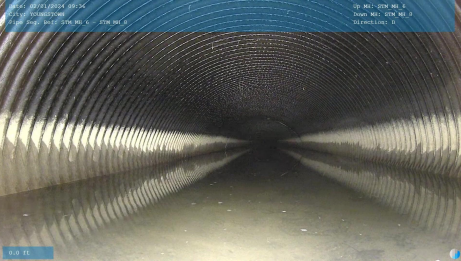
0	MWL - Miscellaneous Water Level Percent: 20	00:00:38

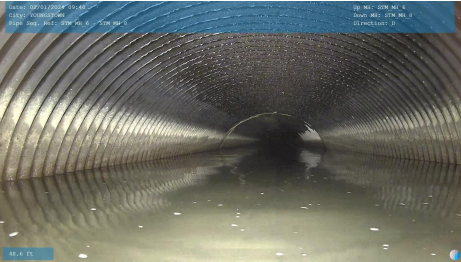
48.6	MWL - Miscellaneous Water Level Percent: 40	00:02:40

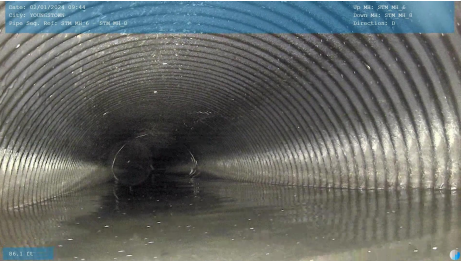
86.1	DSGV - Deposits Settled Gravel Continuous: S01 Percent: 10 Clock from 5 to 7 Grade = 2	00:06:14

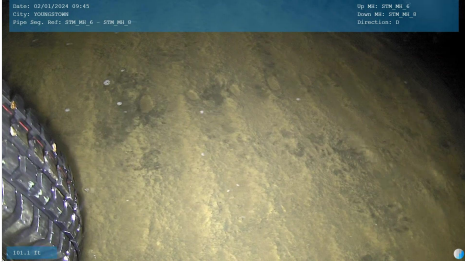
101.1	MWL - Miscellaneous Water Level Percent: 10	00:07:12

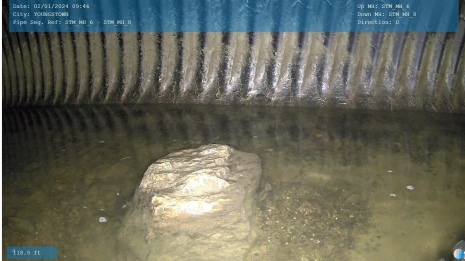
118.5	OBR - Obstruction Rocks Percent: 5 Clock At 6 Grade = 2	00:07:56

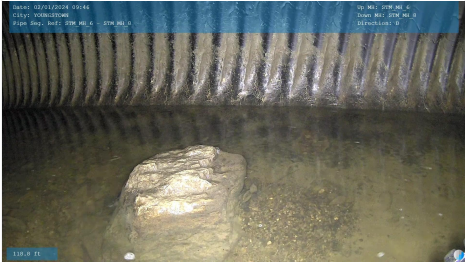
118.8	DSGV - Deposits Settled Gravel Continuous: F01 Percent: 10 Clock from 5 to 7 Grade = 2	00:08:09

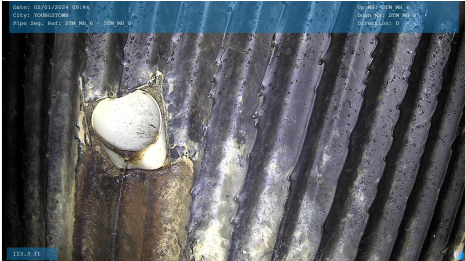
123.3	TBI - Tap Break-in Intruding Measurement 1: 4 Measurement 2: 3 Clock At 10 Remark = ACTIVE Grade = 2	00:08:26

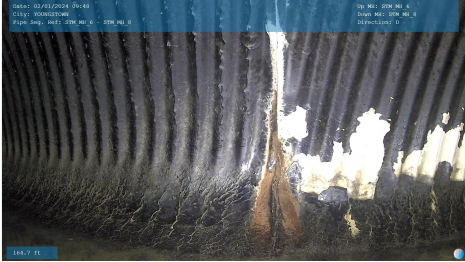
164.7	IR - Infiltration Runner Joint: True Clock At 3 Grade = 4	00:09:58

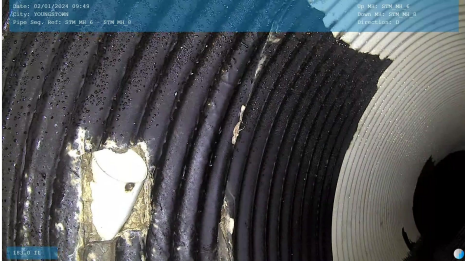
183	TBI - Tap Break-in Intruding Measurement 1: 4 Measurement 2: 5 Clock At 10 Remark = ACTIVE Grade = 2	00:10:57

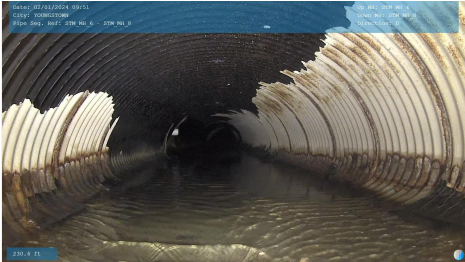
230.4	SRV - Surface Damage Reinforcement Visible Continuous: S02 Clock from 2 to 5 Remark = VARYING POSITION Grade = 4	00:12:56

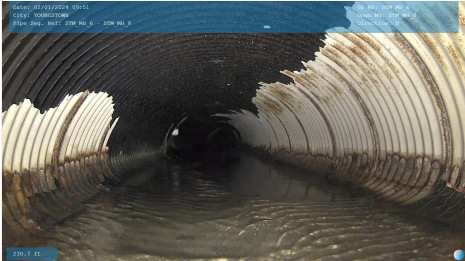
230.7	SRV - Surface Damage Reinforcement Visible Continuous: S03 Clock from 7 to 10 Remark = VARYING POSITION Grade = 4	00:13:13

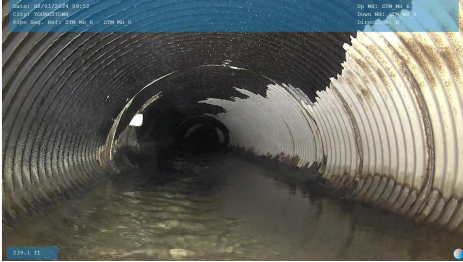
239.1	SRV - Surface Damage Reinforcement Visible Continuous: F03 Clock from 7 to 10 Remark = VARYING POSITION Grade = 4	00:13:51

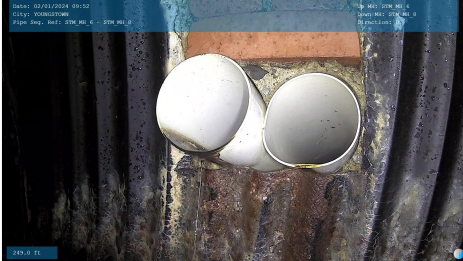
249	TBA - Tap Break-in Activity Measurement 1: 4 Clock At 10	00:14:20

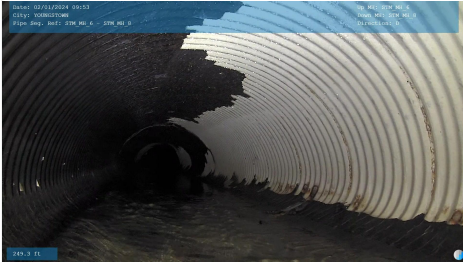
249.3	SRV - Surface Damage Reinforcement Visible Continuous: F02 Clock from 2 to 5 Remark = VARYING POSITION Grade = 4	00:15:08

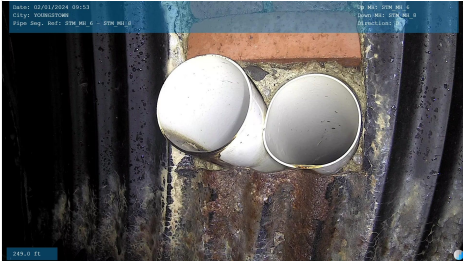
249.5	TBA - Tap Break-in Activity Measurement 1: 4 Clock At 10	00:14:35

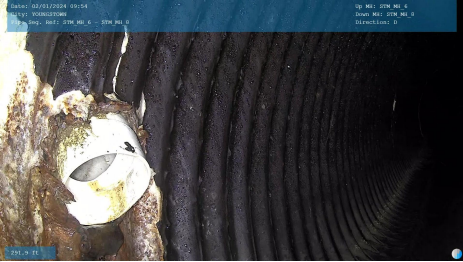
291.9	TBI - Tap Break-in Intruding Measurement 1: 4 Measurement 2: 3 Clock At 10 Remark = ACTUVE Grade = 2	00:16:22

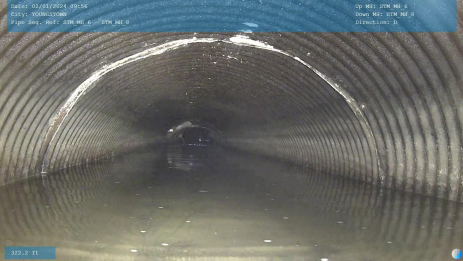
322.2	MWL - Miscellaneous Water Level Percent: 30	00:17:46

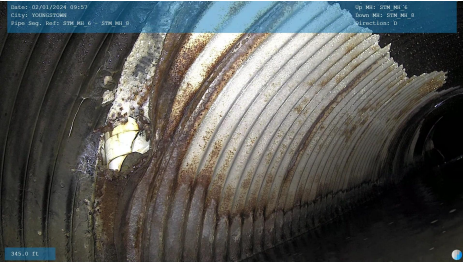
345	TBA - Tap Break-in Activity Measurement 1: 4 Clock At 10	00:18:38

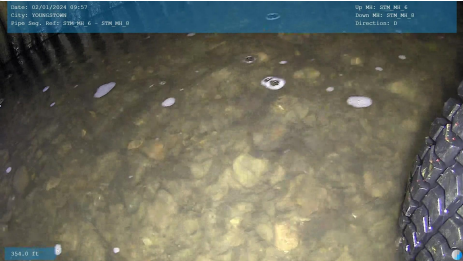
354	DSGV - Deposits Settled Gravel Percent: 5 Clock from 5 to 7 Grade = 2	00:19:23

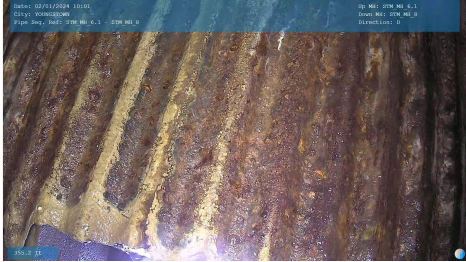
355.2	SCP - Surface Damage Corrosion Clock from 11 to 1 Grade = 3	00:20:01

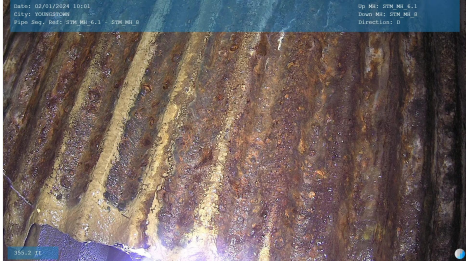
355.2	ACB - Access Point Catch Basin Remark = MY00001_P1_M07	00:20:09
