Project:	2420009	Date/Time:	February 1 2024 - 10:40
Street and City:	COLLEEN DR - YOUNGSTOWN	Weather:	Dry Weather/Wet Ground
Owner:	CITY OF YOUNGSTOWN	Inspection Status:	Complete Inspection
Customer:	CT CONSULTANTS	Segment:	MY00001_P1_M08-MY00001_P1_outlet
Surveyor Name and Certificate:	SHAWN DUNNELL U-915-70001437	Direction:	Downstream
Reviewer Name and Certificate:		Up MH:	MY00001_P1_M08
P.O. #		Down MH:	MY00001_P1_outlet

YOUNGSTOWN — February 1 2024

Pipe: MY00001_P1_M08-MY00001_P1_outlet

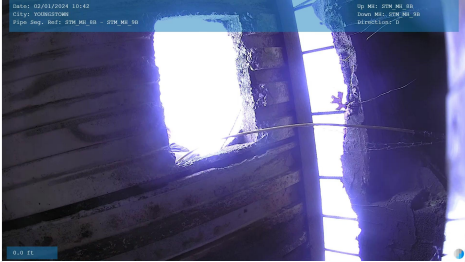
0	AMH - Manhole Remark = MY00001_P1_M08	00:00:20

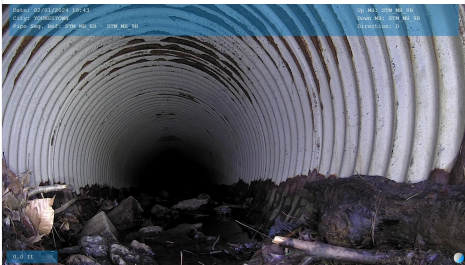
0	MWL - Miscellaneous Water Level Percent: 5	00:00:32

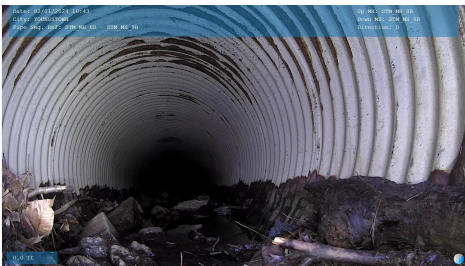
0	OBR - Obstruction Rocks Continuous: S01 Percent: 15 Clock from 5 to 7 Grade = 3	00:00:33

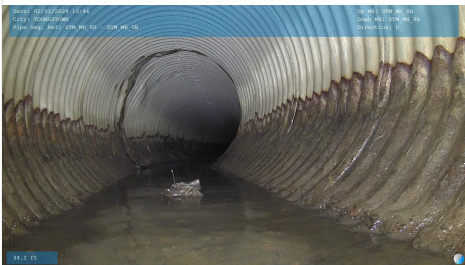
34.2	OBR - Obstruction Rocks Continuous: F01 Percent: 15 Clock from 5 to 7 Grade = 3	00:04:12

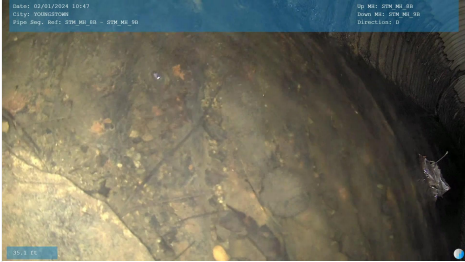
35.1	SCP - Surface Damage Corrosion Continuous: S02 Clock from 3 to 9 Remark = varying position Grade = 3	00:04:22

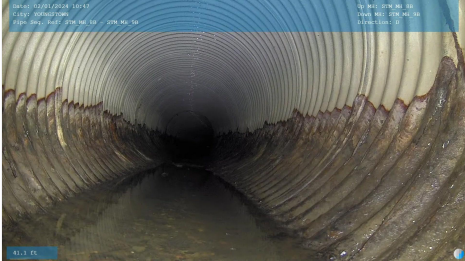
41.1	LR - Line Right Percent: 5 Grade = 1	00:05:00

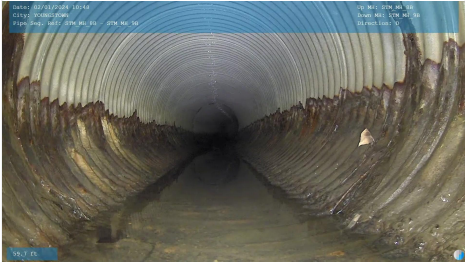
59.7	LR - Line Right Percent: 5 Grade = 1	00:05:40

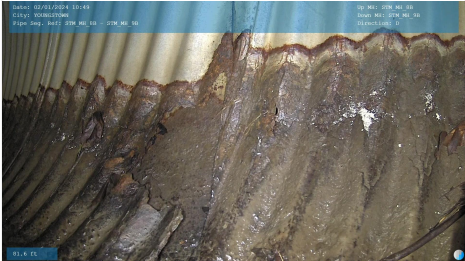
81.6	SSS - Surface Damage Surface Spalling Clock from 3 to 4 Grade = 2	00:06:23

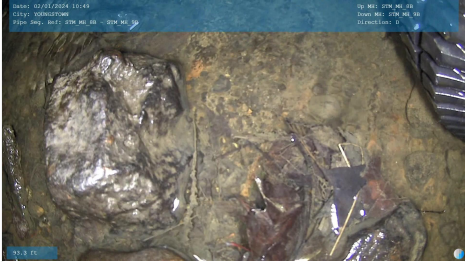
93.3	OBR - Obstruction Rocks Percent: 5 Clock At 6 Grade = 2	00:06:51

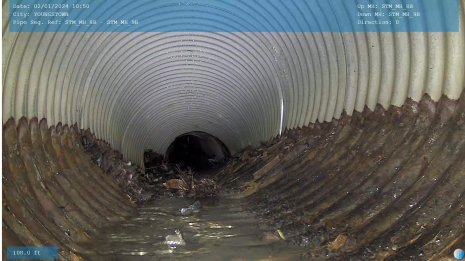
108	LD - Line Down Continuous: S03 Percent: 10 Grade = 1	00:07:26

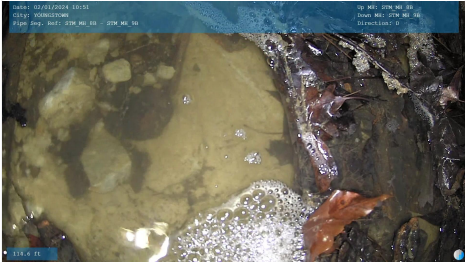
114.6	HWV - Hole Void Visible Clock from 4 to 7 Grade = 5	00:08:26

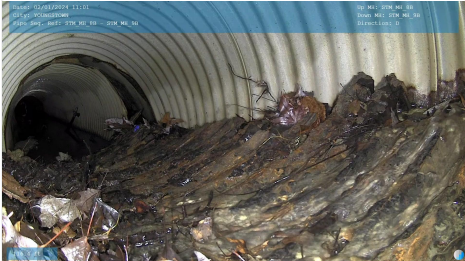
116.4	BSV - Broken Soil Visible Continuous: S04 Clock from 4 to 8 Remark = INVERT BROKEN AND RAISED Grade = 5	00:11:02

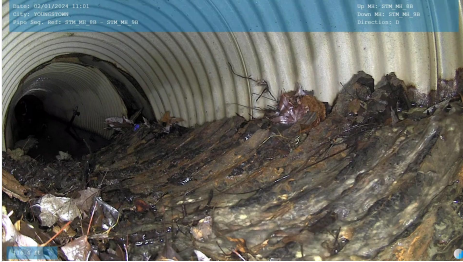
117	LD - Line Down Continuous: F03 Percent: 10 Grade = 1	00:11:02

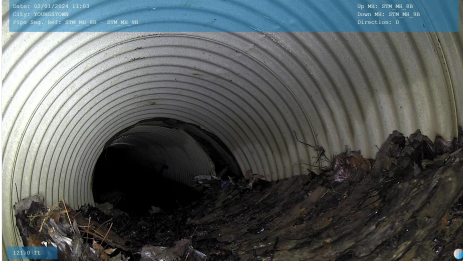
121	SCP - Surface Damage Corrosion Continuous: F02 Clock from 3 to 9 Remark = varying position Grade = 3	00:11:16

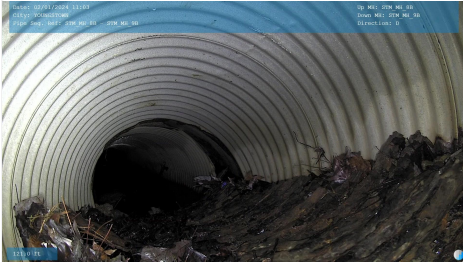
121	BSV - Broken Soil Visible Continuous: F04 Clock from 4 to 8 Remark = INVERT BROKEN AND RAISED Grade = 5	00:11:23

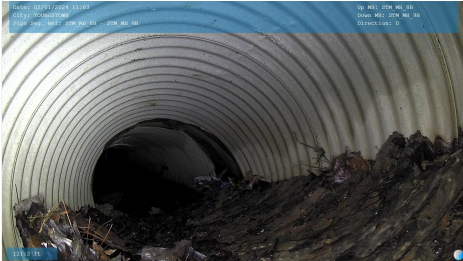
121.2	MSA - Miscellaneous Survey Abandoned Remark = INVERT BROKEN	00:11:29
