PACP Report with Pipe Run and Incident Snapshots

Surveyed by: Mike Brooks	Certificate number: Mike Brooks	Owner:	Customer:	Drainage area:	P/O number:	Sheet number:
Pipe segment ref.: SMH053_SMH054	Start date/time: 20220317 11:36	Street: W CENTER ST	City: SMITHVILLE			
Location details: STREET	Upstream MH No: SMH053	Rim to invert:	Grade to invert:	Rim to grade:		
Pipe use: SS	Direction: D	Flow control:	Downstream MH No: SMH054	Rim to invert:	Grade to invert:	Rim to grade:
Height: 8 in.	Width:	Shape: C	Material: VCP	Lining method:	Pipe joint length:	Total length: 358.900 ft.
Length surveyed: 167.400 ft.	Purpose:	Sewer category:				
Media label:	PreCleaning: L	Date cleaned:	Weather: 1	Location code:	Pressure value:	
Project name: Sewer Cleaning & CCTV - Project No. 210670	Additional info:

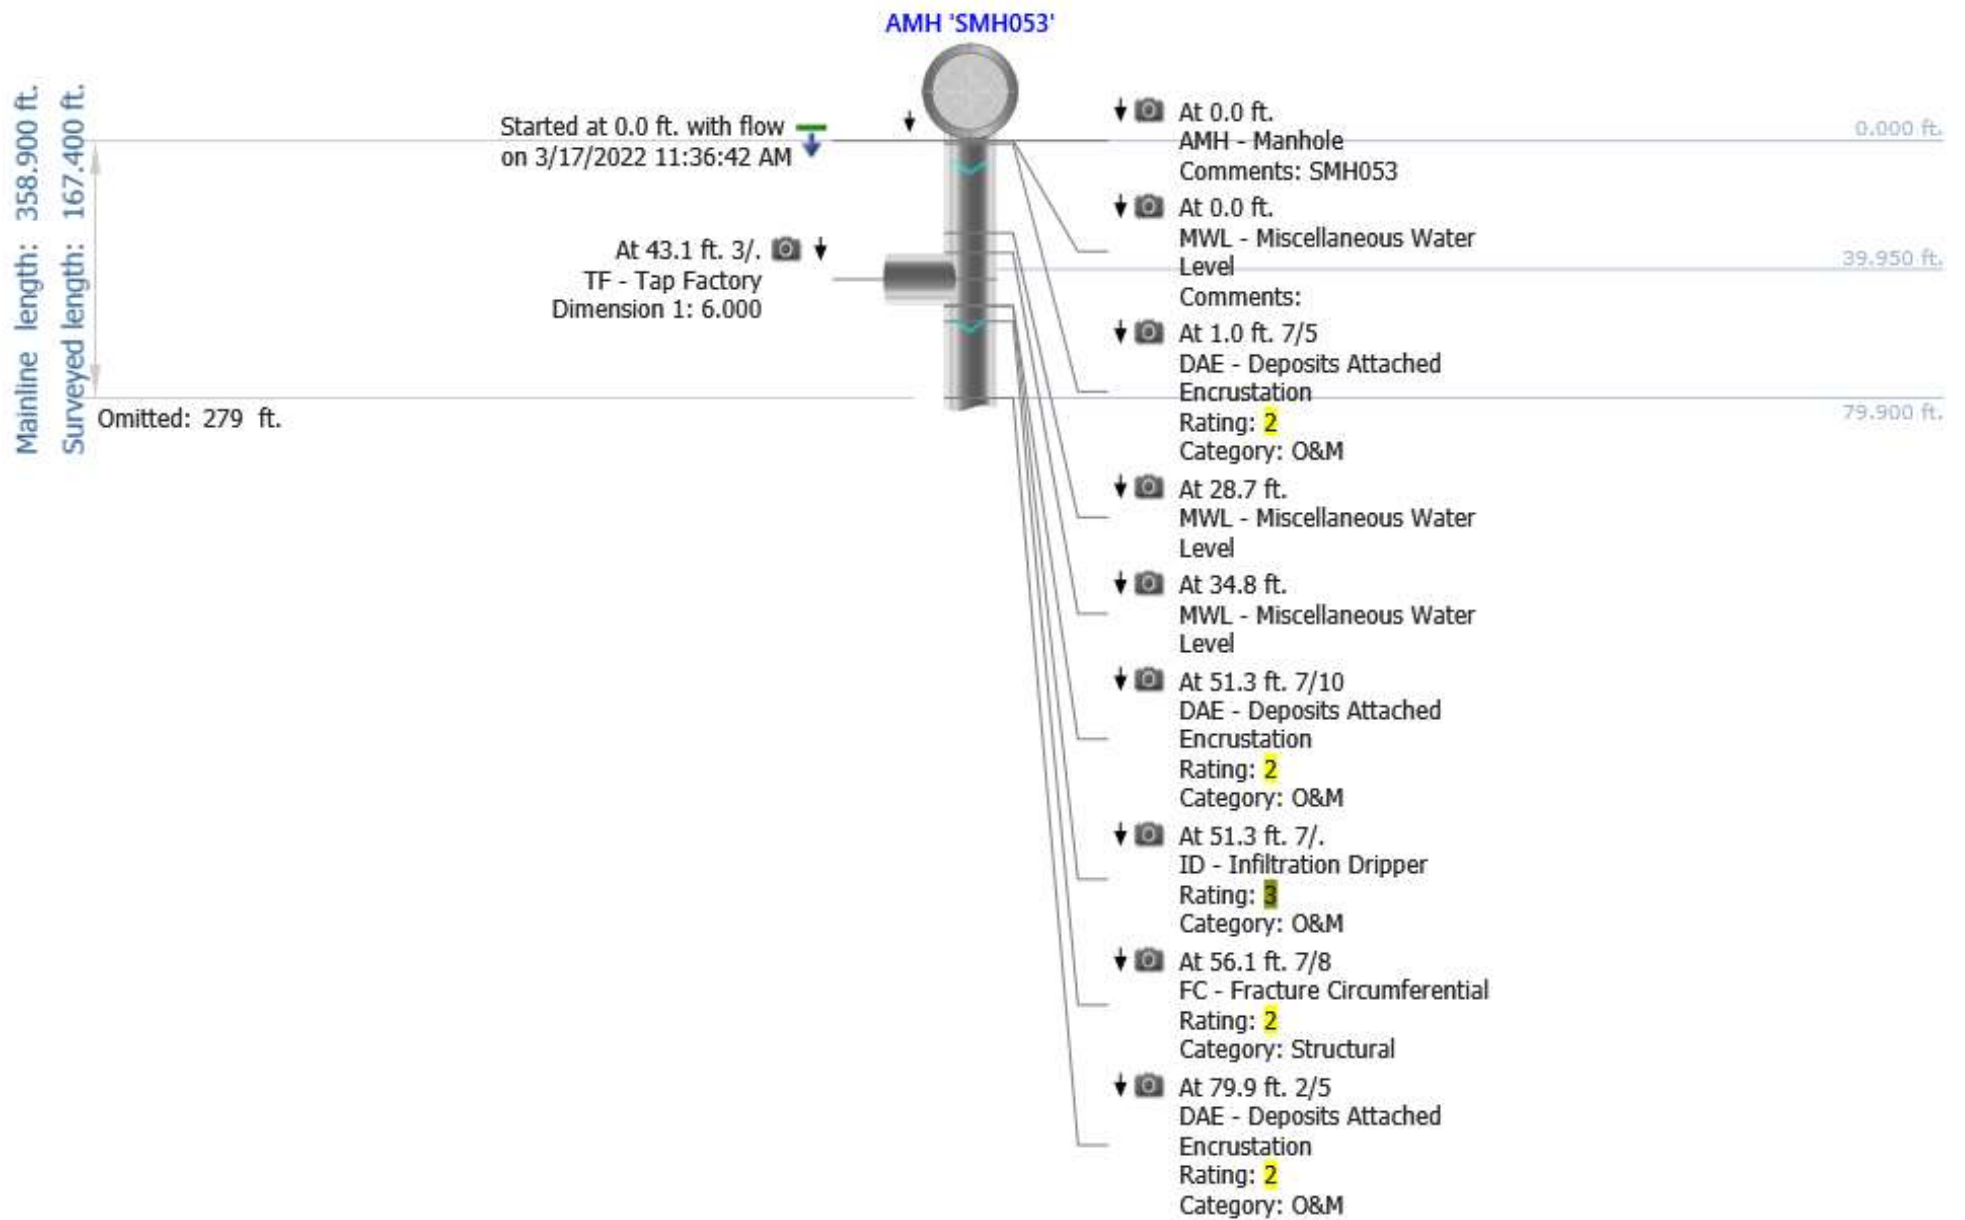
Distance	Video Ref.	PACP Code	Continuous	S/M/L	Value Inches (mm)		%	Joint	Circumferential Location		Rating	Image Ref.	Remarks
					1st	2nd			At/From	To			
167.4 ft.	00:06:58	MSA						<input type="checkbox"/>	/			SMH053_SMH054_MS A_167.4 ft.JPG	STUCK ON DEPOSITE. TRY TO DO A REVERSAL
