**Job #:** 242762      **Project Title:** AJ JOLLY PARK: CONCRETE RISER & VALVE REPLACEMENT AND ANNUAL INSPECTION & EXERCISING OF CONTROL VALVE

# **ANNUAL INSPECTION AND EXERSIZING OF CONTROL VALVE AT AJ JOLLY PARK DAM REPORT:**

**CAMPBELL COUNTY, KY**

**August 11, 2025**

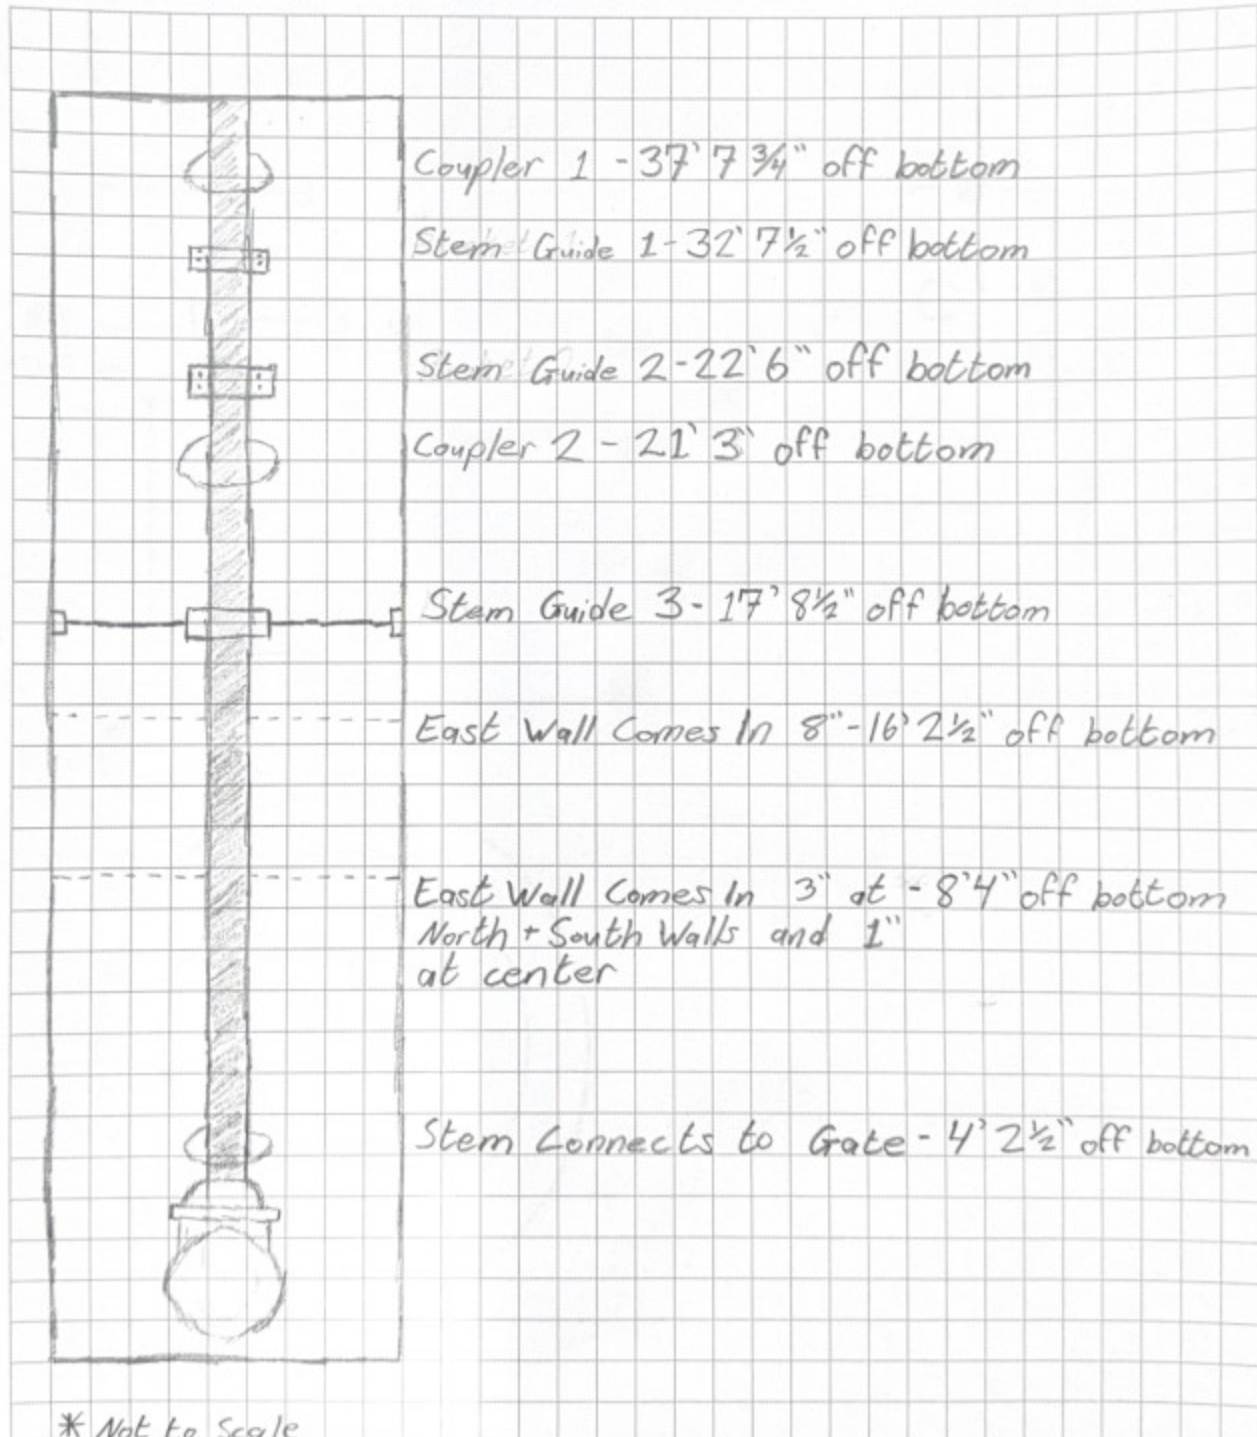
Sheet: 1 of 6

The riser structure was found to be in good condition. The stems and guides were found to be in poor condition; however, they are still operational. The valve was found to be in acceptable condition and is operational. Notable observations are detailed below. At the time of inspection, the distance from the top of the riser to the water was 5' 5 ½". The depth from the water line to the mud line at the east face of the riser was 11'. Refer to Appendix A. Sheet 1 and 2.
