Insight Pipe Contracting LLC
 232 East Lancaster Rd.
 Harmony, PA 16037
 Phone: 724-452-6060
 Fax: 724-452-3226

Main Inspections Small Photos

Mainline ID: A1_B1	City: BOARDMAN	Street: COLLEEN DR	Project name: 011023.221159.ABC STORMWATER.CTV.1123
Start date/time: 1/10/2023 8:04 AM	Total length:	Weather: 3 - Light Rain	Surveyed by: JHIPC
Upstream MH No: A1	Depth US:	Downstream MH No: B1	Depth DS:
Shape: C - Circular	Material: CMP - Corrugated Metal Pipe	Height: 36 in.	Width: 36 in.
Customer: BOARDMAN TWP	Owner: BOARDMAN TWP	Sewer use: SW - Stormwater	Lining method:
Length surveyed: 157.7 ft.	Purpose: F - Routine Assessment	Media label: 221159-1	Pre-cleaning: N - No Pre-Cleaning
Additional info:

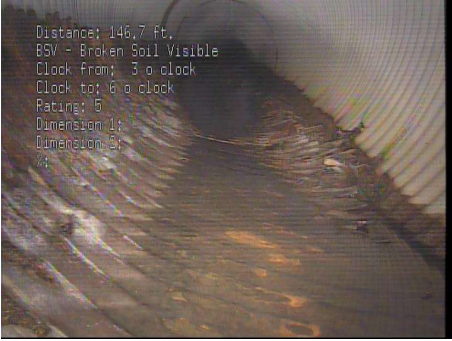
<p>Upstream MH No: RMH A1 Downstream MH No: RMH B1 146.9 Ft.</p> </div> <div style="text-align: center;">

<p>Distance: 146.7 Ft. BSV - Broken Soil Visible Clock from: 3 o'clock Clock to: 6 o'clock Rating: 5 Dimension 1: Dimension 2: %:</p> </div> <div style="text-align: center;">

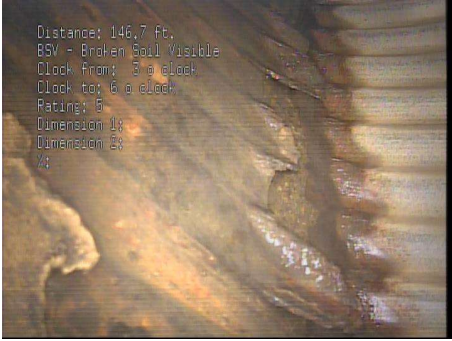
<p>Upstream MH No: RMH A1 Downstream MH No: RMH B1 150.6 Ft.</p> </div> </div>									
<div style="display: flex; justify-content: space-around;"> <div style="text-align: center;">

<p>Distance: 146.7 Ft. BSV - Broken Soil Visible Clock from: 3 o'clock Clock to: 6 o'clock Rating: 5 Dimension 1: Dimension 2: %:</p> </div> <div style="text-align: center;">

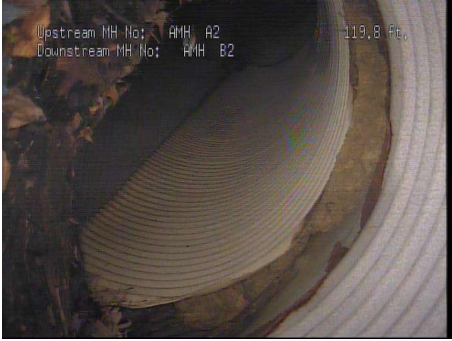
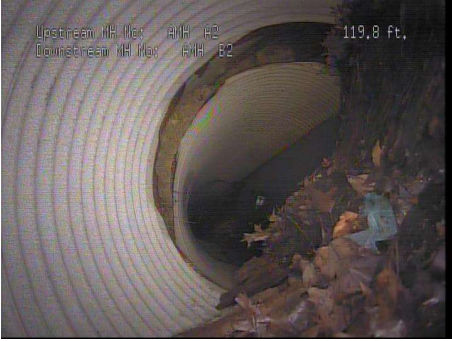
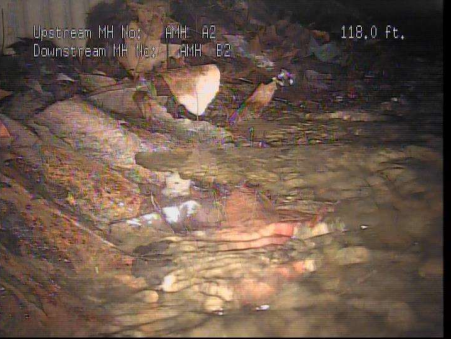
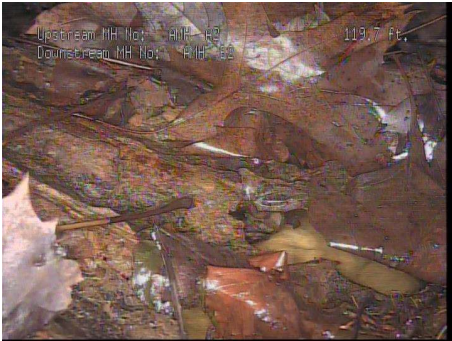
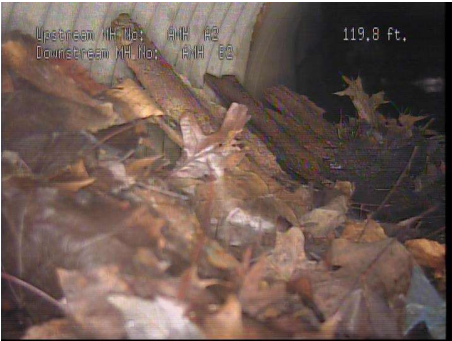
119.8 ft.	U	D	Deformed		/	20	<input type="checkbox"/>	5	
119.8 ft.	U	MSA	Abandoned Survey		/		<input type="checkbox"/>		UNABLE TO PASS BROKEN AND DEFORMED PIPE JOL AND SOIL VISIBLE WHEN ZOOMED IN
<div style="display: flex; flex-wrap: wrap;"> <div style="width: 100%; text-align: center;">

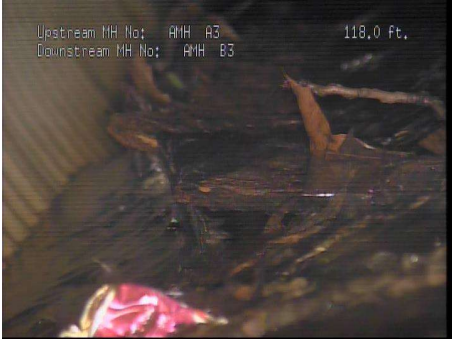
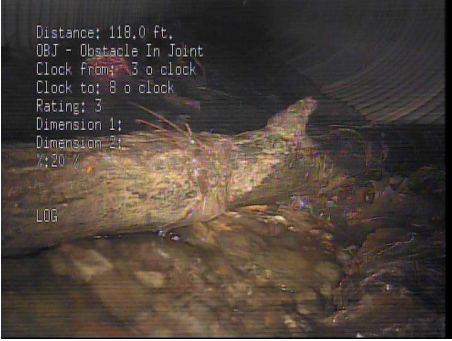
Distance	Dir.	Code	Description	Cont.	From/To	%	Joint	Rating	Remarks
118.0 ft.	D	OBJ	Obstacle In Joint		3 / 8	20	<input checked="" type="checkbox"/>	3	LOG
<div style="display: flex; justify-content: space-around;"> <div style="width: 45%;">

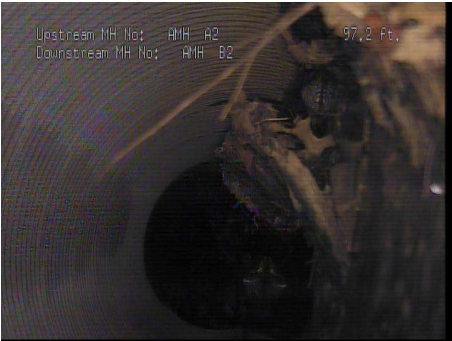
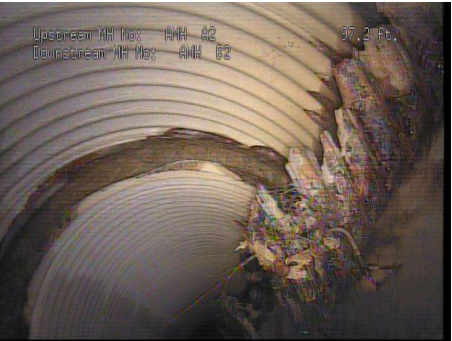
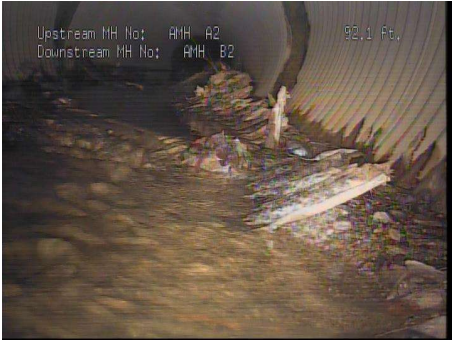
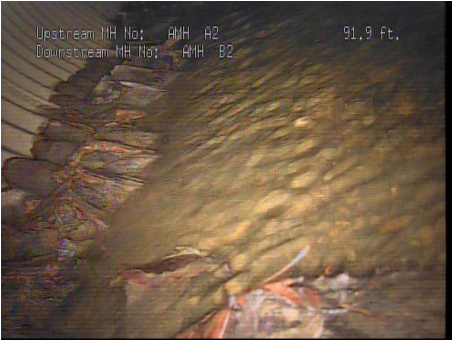
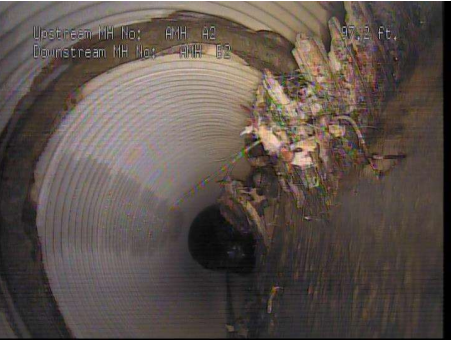
97.2 ft.	U	JOL	Joint Offset Large		/		<input type="checkbox"/>	2

Distance	Dir. Code	Description	Cont. From/To	%	Joint Rating	Remarks	
97.2 ft.	U	BSV	Broken Soil Visible	8 / 4	<input type="checkbox"/>	5	
<div data-bbox="115 218 565 558" data-label="Image"> </div>							
97.2 ft.	U	OBR	Obstacle Rocks	F01 5 / 7	15	<input type="checkbox"/>	3
97.2 ft.	U	MSA	Abandoned Survey	/	<input type="checkbox"/>	UNABLE TO PASS BSV/ JOL WITH SOIL VISIBLE

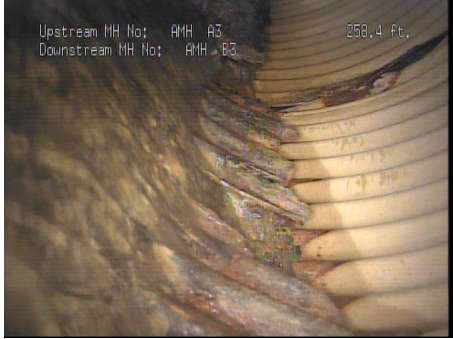
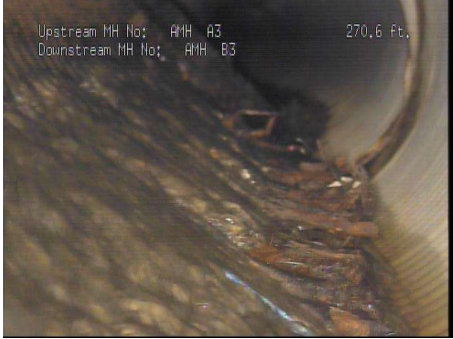
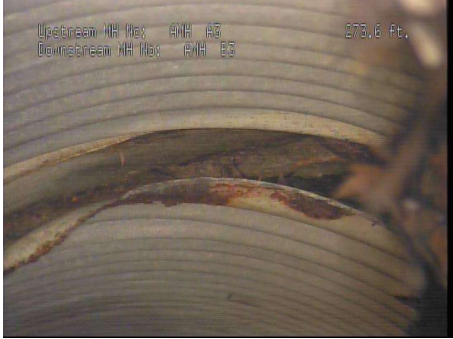
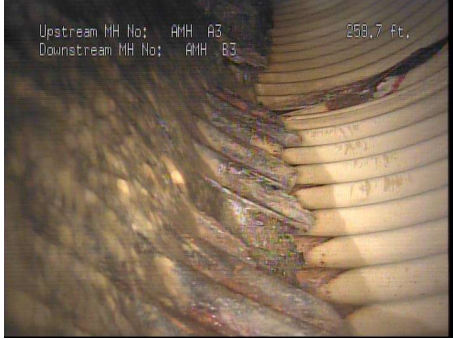
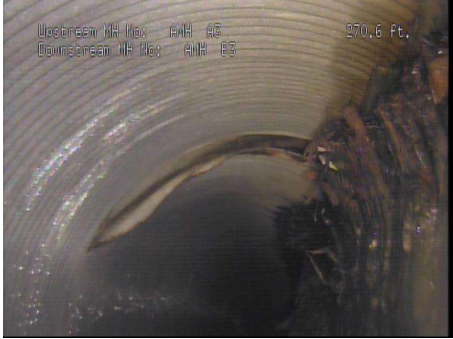
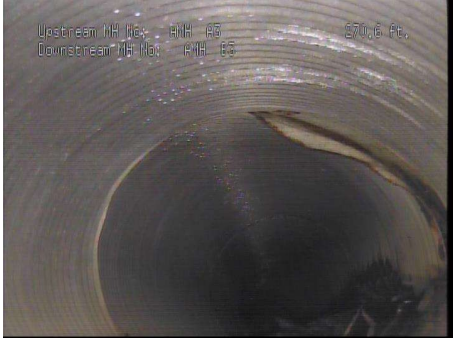
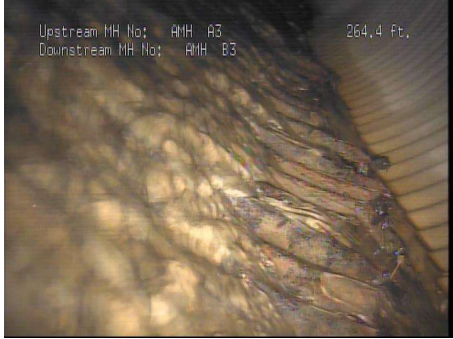
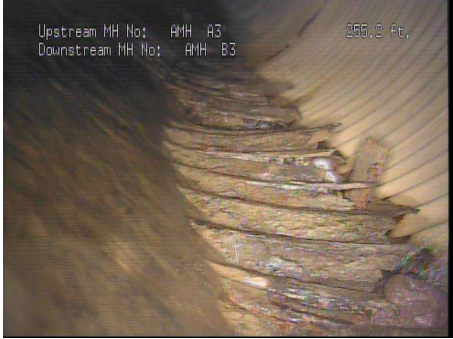
Distance: 253.6 Ft.
 B - Broken
 Clock from: 4 o'clock
 Clock to: 7 o'clock
 Rating: 5
 Dimension 1:
 Dimension 2:
 %:

273.7 ft.	U	OBR	Obstacle Rocks	F02	4 / 8	15	<input type="checkbox"/>	3
273.7 ft.	U	BSV	Broken Soil Visible	F03	4 / 7		<input type="checkbox"/>	5
