PACP Report with Pipe Run and Incident Snapshots

Surveyed by: ANDREW	Certificate number: T-507-4975	Owner: CITY OF MARION	Customer:	Drainage area:	P/O number:	Sheet number:
Pipe segment ref.: MH1_HB	Start date/time: 20240627 13:44	Street: HOLLAND ROAD NEAR ROCK SWALE	City: MARION, OH			
Location details:		Upstream MH No: MH1	Rim to invert:	Grade to invert:	Rim to grade:	
Pipe use: CB	Direction: D	Flow control:	Downstream MH No: HB	Rim to invert:	Grade to invert:	Rim to grade:
Height: 72 in.	Width:	Shape: C	Material: BR	Lining method:	Pipe joint length:	Total length: 175.300 ft.
Media label:	Pre-cleaning: N	Date cleaned:	Weather: 1	Length surveyed: 175.300 ft.	Purpose: B	Sewer category:
Project name: ROCK SWALE 72 IN INSPECTION	Additional info:					
Location code: C						
Pressure value:

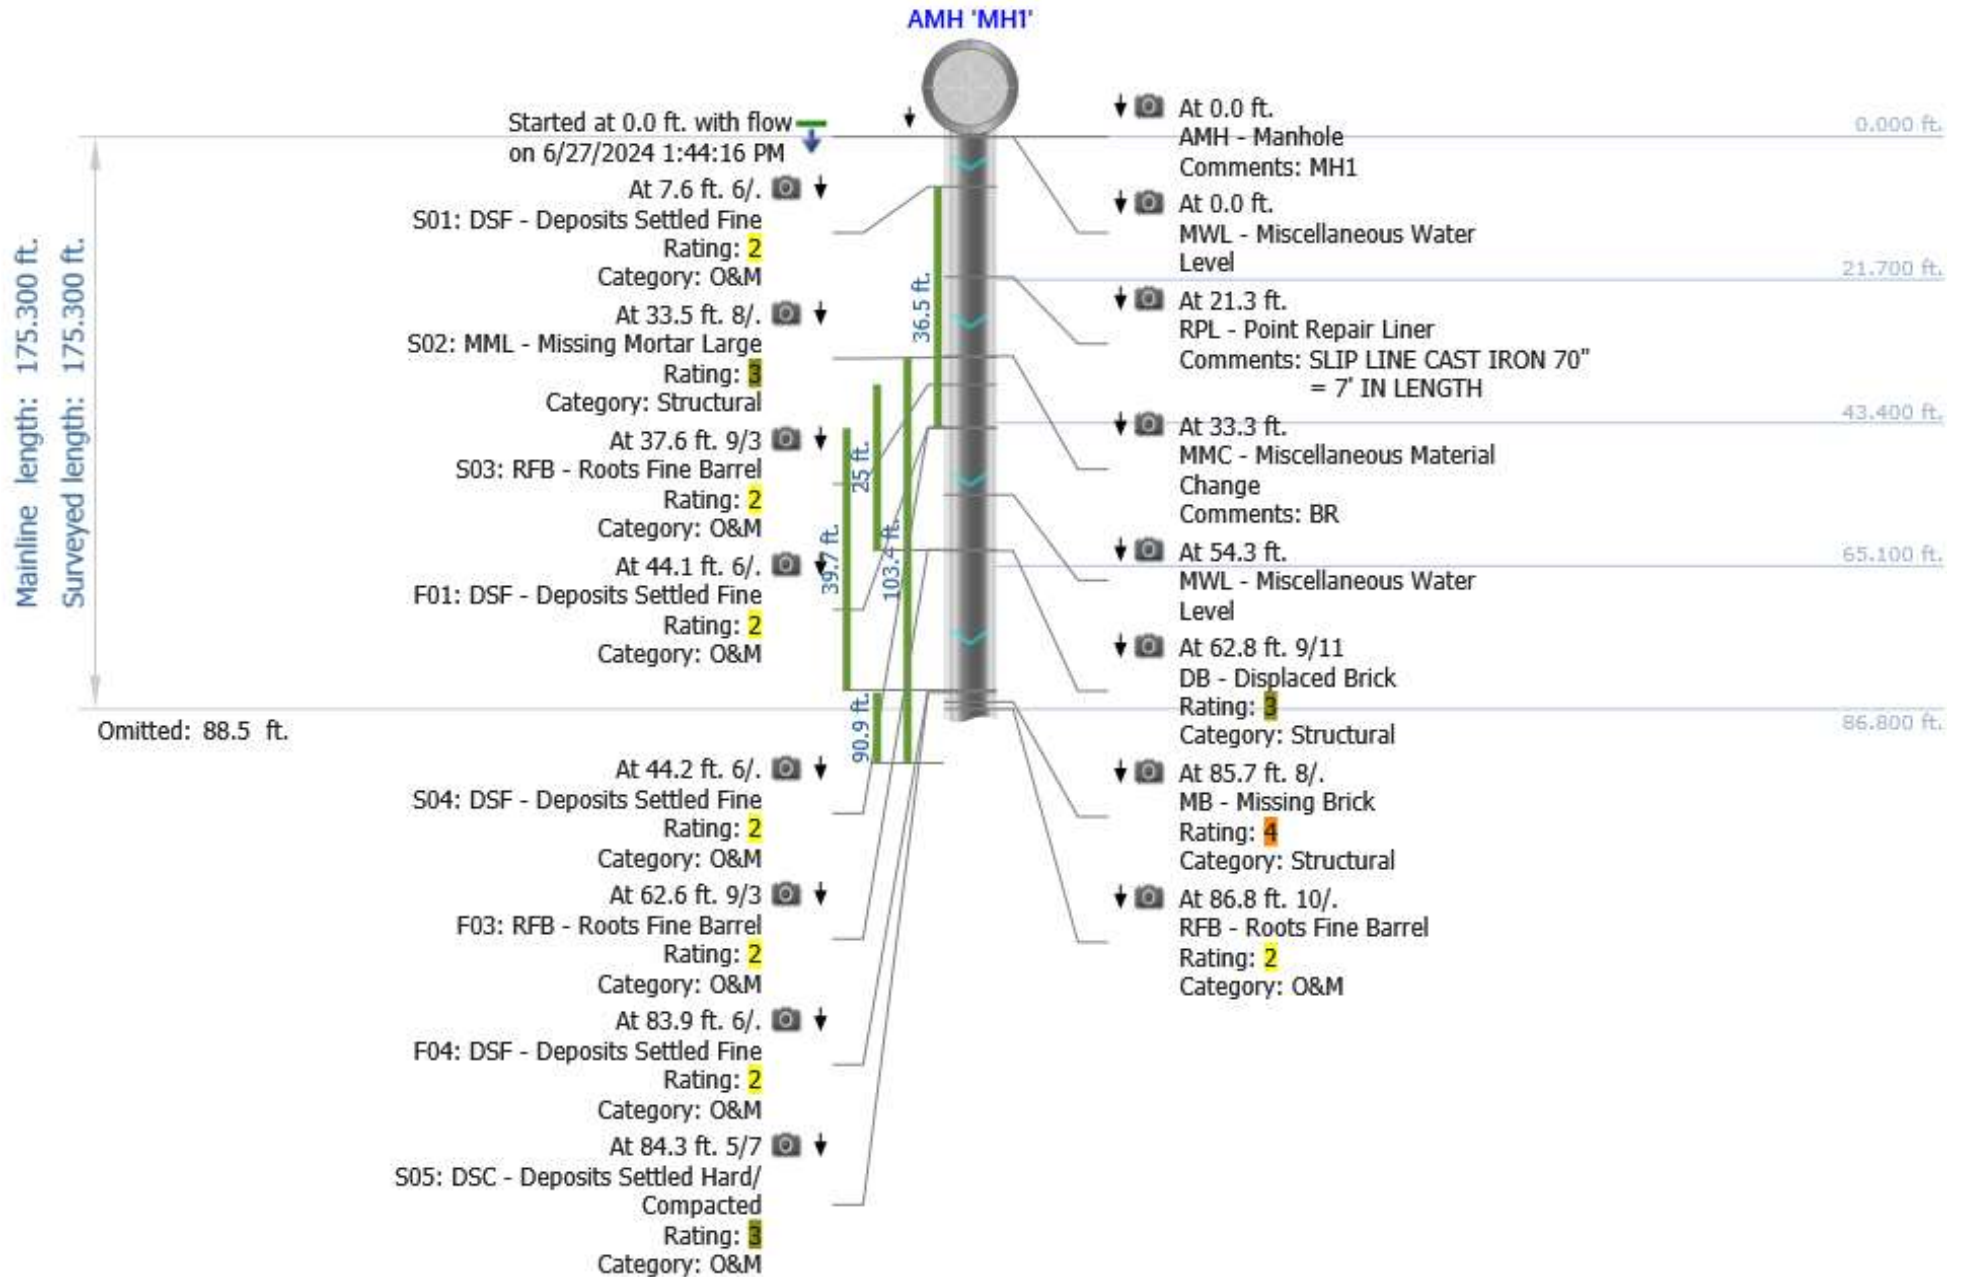
Mainline length: 175.300 ft.
Surveyed length: 175.300 ft.

Omitted: 136.9 ft.

- At 136.9 ft. 8/.
F02: MML - Missing Mortar Large
Rating: ■
Category: Structural
- At 136.9 ft.
S06: DR - Deformed Rigid
Rating: ■
Category: Structural
- At 162.5 ft.
F06: DR - Deformed Rigid
Rating: ■
Category: Structural
- At 175.2 ft. 5/7
F05: DSC - Deposits Settled Hard/
Compacted
Rating: ■
Category: O&M
- Stopped at 175.3 ft. with flow
on 6/27/2024 1:56:38 PM

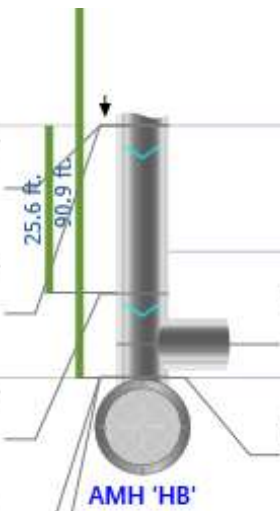
- At 170.2 ft. 7/.
TBA - Tap Break-in Activity
Dimension 1: 24.000
Comments: OUTLET PIPE
- At 175.3 ft.
AMH - Manhole
Comments: HB
